## Ground deformation caused by fault reactivation: some examples

LAURANCE J DONNELLY<sup>1</sup> MARTIN G CULSHAW G<sup>2</sup>, FRED G BELL<sup>2</sup> AND DOUG TRAGHEIM<sup>2</sup>

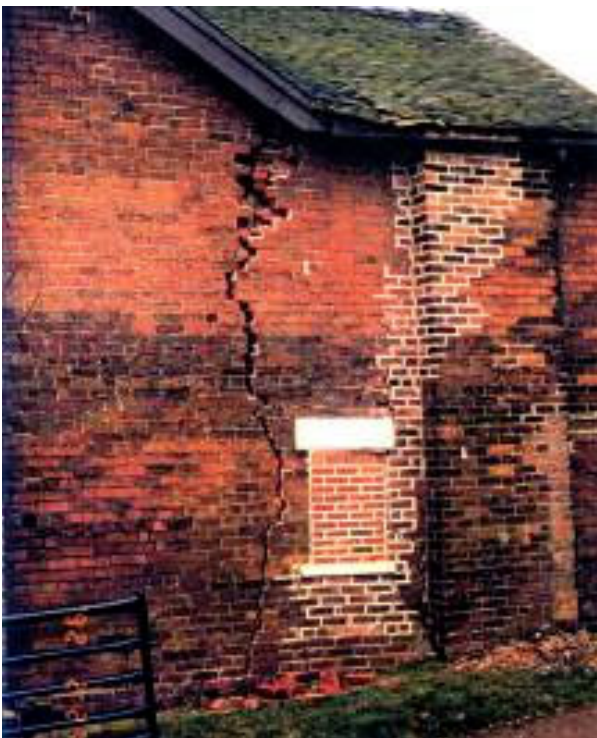
Damage to detached houses by fault reactivation may vary from the subtle (cracking of plaster and bricks) to the severe (evacuation of occupants and subsequently demolition). Examples occur throughout Britain. For instance, a large detached house was situated on the outcrop of the Hopton Fault, Oulton, Staffordshire (Figure 1). This suffered repeated damage each time the fault was undermined by longwall workings. By January 1993, the scarp was distinct, high-angled, 1.0 to 1.5 m high and could be traced for 2 km. The house was eventually demolished due to severe structural damage. The scarps were subsequently ploughed flat on adjacent land, road 'steps' were eventually repaired and a new house built on the same sites, a few metres from the original fault scarp and house position.

**Figure 1.** Damage to houses caused by the mining-induced reactivation of the Hopton Fault, Oulton, Staffordshire, UK.

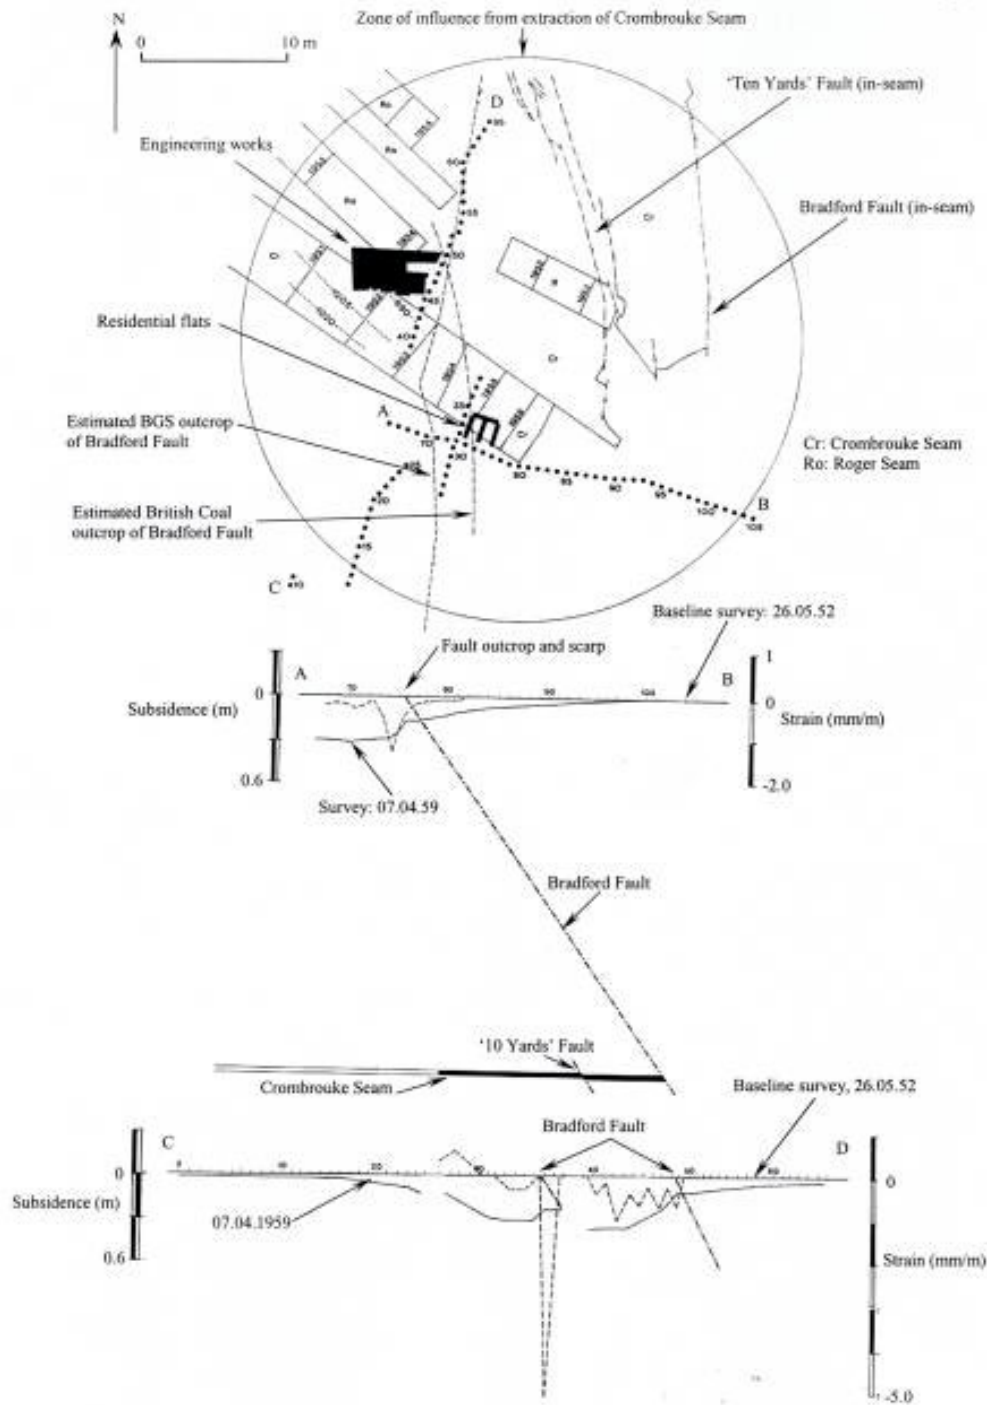
Crompton Hall residential apartments building, built in the early part of the 1900s, was located in the densely populated, industrialised part of the East Lancashire Coalfield (known as the Bradford Coalfield) to the east of Manchester. The Bradford Fault, one of the principal faults that cross the coalfield, outcrops approximately 5 km to the east of Manchester city centre. The Bradford Fault was observed in underground workings at the former Bradford Colliery, not as a single dislocation, but as a shatter zone up to 90 m wide, consisting of numerous broken and interlocking discontinuities. At least six seams had been extracted from the beneath the fault. The reactivation of this fault was detected on two survey lines, one at an acute angle to the fault, the other perpendicular. Reactivation resulted in the generation of a scarp along the ground surface with compressive strains of 4.91 mm/m (Figure 2). The flats suffered moderate to severe damage, and they were subsequently demolished (Marr 1961, Lee 1965, Donnelly 1994).

**Figure 2.** Schematic illustration documenting the reactivation of the Bradford Fault, Lancashire, UK, showing the suspected outcrop and in-crop positions of faults and survey lines (upper), subsidence data recording the development of the subsidence trough and fault reactivation along the cross sectional (middle) and transverse (lower) subsidence monitoring lines.

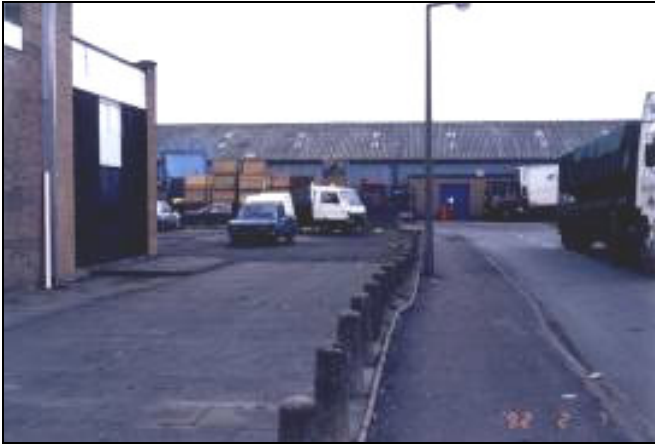
Moderate damage was caused to an industrial estate and sewerage treatment works at Newstead, Stoke-on-Trent, during the reactivation of the Hollybush Fault in the early 1990s. Damage was consistent with the mining of the Yard and Great Row seams from the former Trentham Colliery. Dextral shear displacements of up to 0.2 m occurred along the fault, which outcropped through the industrial estate and a conspicuous scarp, with vertical displacements of up to 1.0 m, were observed (Figure 3).

**Figure 3.** Lateral shear along the outcrop position of the Hollybush Fault, Staffordshire, UK. Note the 0.1 to 0.3 m of shear displacements to the kerbstones, paving slabs and the building's wall.

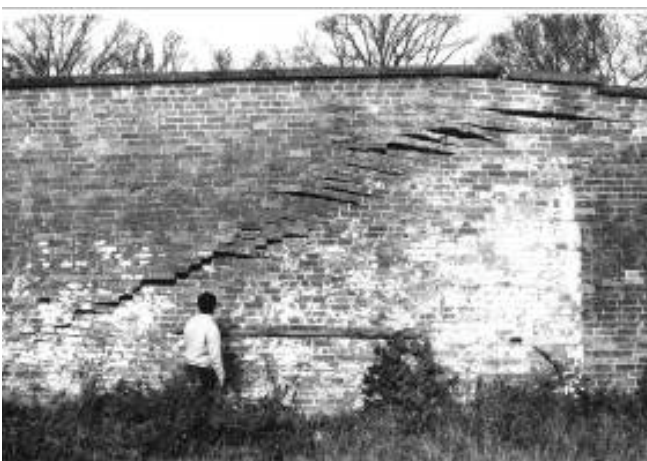
Walls are particularly vulnerable to damage by mining subsidence fault reactivation. They may become tilted, distorted, skewed or fractured. Frequently, it is the damage to perimeter walls and retaining wall, which provides the first evidence that fault reactivation may have occurred. A typical example was the reactivation of a fault at Eastwood Hall, Nottinghamshire, in the 1980s. This caused a high degree of localised buckling to a 5.0 m high brick wall accompanied by the appearance of fault scarp 0.3 m high (Figure 5). Surface buildings were also severely damaged and required rebuilding (Donnelly 2000b, Whittaker & Reddish 1989).

**Figure 5.** Compression to a 5.0 m high retaining wall, caused by fault reactivation and subsidence, Eastwood Hall, Nottinghamshire, UK.

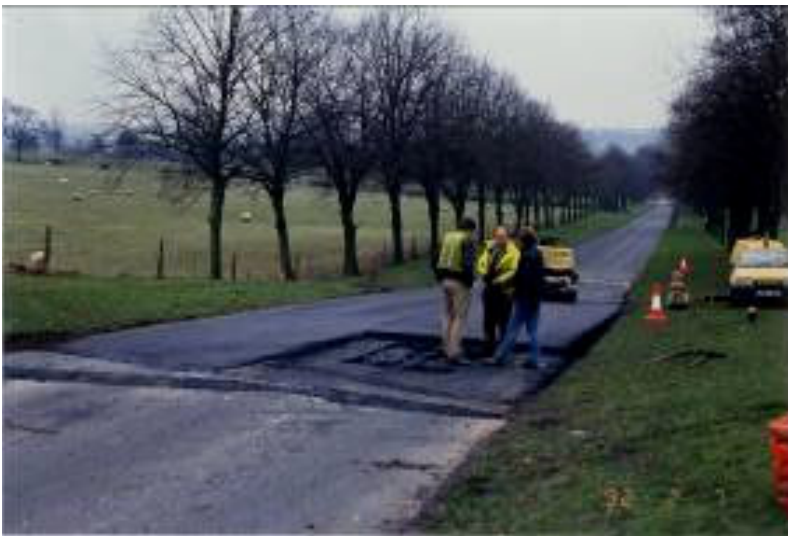
Fault reactivation and road damage was caused by workings at Hem Heath (previously Trentham) and Florence collieries (Donnelly & Rees 2001). These scarps across roads may reach 2.0 m in height and may be traced across the ground surface for distances of several hundreds of metres. The Crowcrofts Fault outcrops on Wedgwood Drive, near Barlaston, south of Stoke-on-Trent in Staffordshire and from the 1960s to the 1990s underwent several phases of reactivation separated by periods of relatively stability. This was caused by the longwall working of multiple coal seams. A fault step, varying from a subtle flexure to a distinct steep-sided fault scarp over 1 m high, could be traced for a distance of over 3.5 km. Road repairs were necessary on a regular basis causing local traffic delays (Figure 6). The road was repeatedly surveyed over a period of several years and, more recently; these results have been compared with those obtained from satellite radar interferometry (Culshaw *et al.* 2006).

**Figure 6.** Repairs to Wedgwood Drive, Barlaston, Staffordshire, UK, caused by the reactivation of the Crowcrofts Fault. This generated a scarp at least 1.0 m high and 1.5 km long, during multiple phases of reactivation from the 1960s to 1990s.

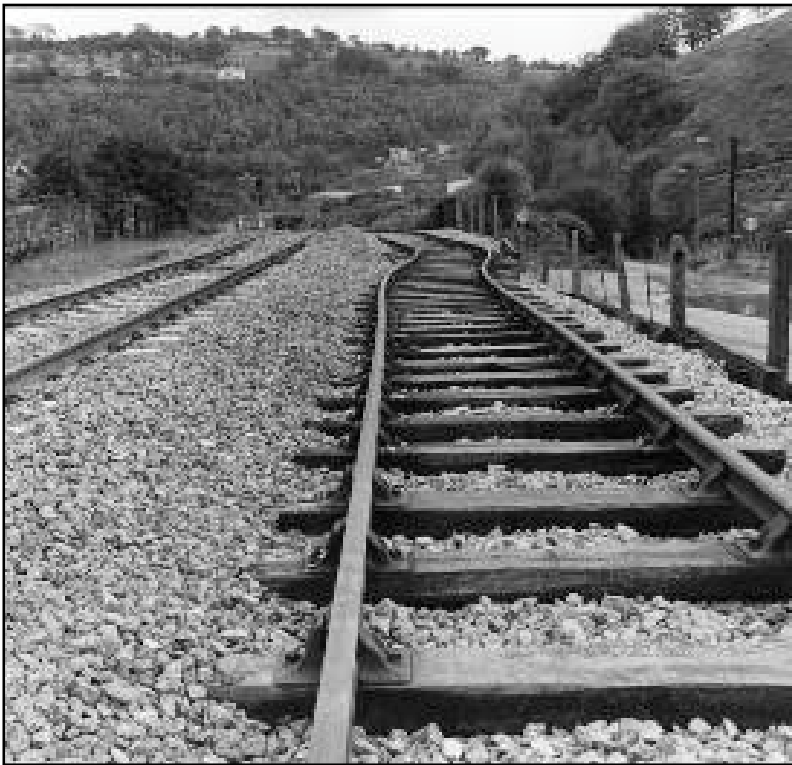
There are few examples of mining-induced fault reactivation damage to railways lines. In South Wales, the reactivation of the Kilkenny Fault in the 1990s and 1990s generated a fault scarp 1.5 m high, which caused severe buckling of the Cardiff to Merthyr Railway, nearby roads, a railway bridge and associated infrastructure (Figure 7). The longwall working of the Seven Feet Seam caused the most widespread and extensive damage to the railway line at Quakers Yard. The fault trends northwest-southeast, consistent with the main regional trend for major faults across the coalfield.

**Figure 7.** Reactivation of the Kilkenny Fault, South Wales, UK causing severe damage (compression) and buckling to the Cardiff to Taff Merthyr railway tracks.

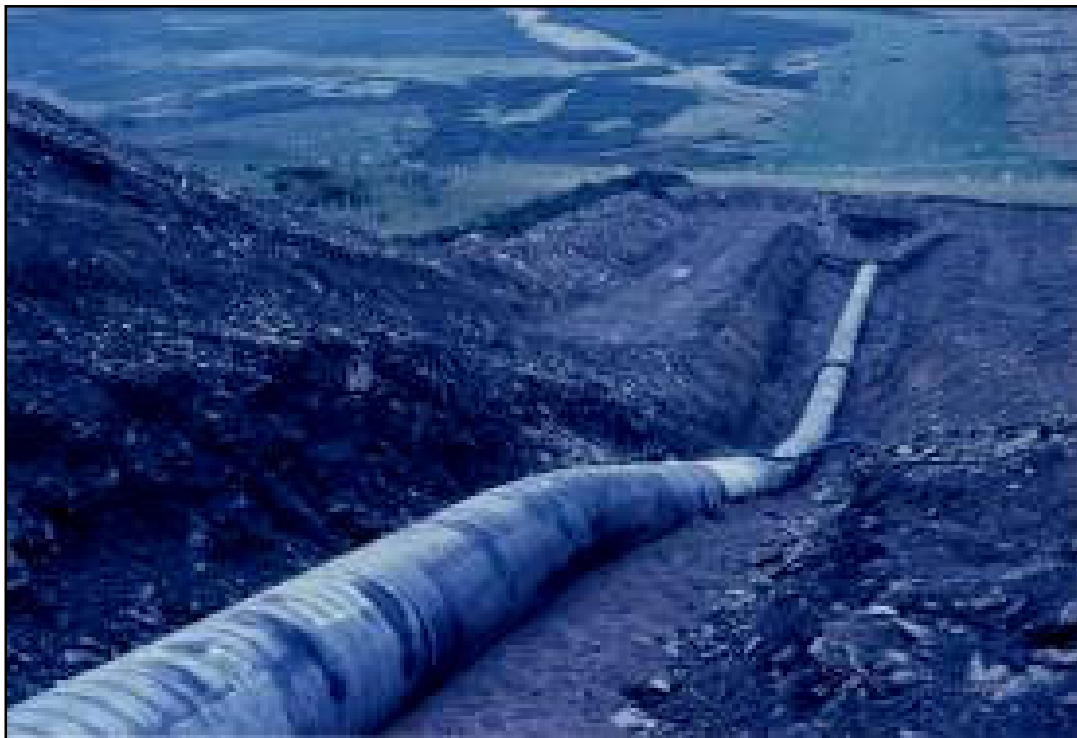
In South Wales, the northwest-southeast trending Rhos Fault forms the south-western edge of the Dowlais Trough and has a throw of 119 m in the Brithdir Seam and 91 m in the Seven Feet Seam. The fault was observed in underground workings from the Taff Merthyr Colliery and consisted of highly slickensided rock with prominent ductile drag folding of the strata adjacent to the fault. The Rhos Fault crossed the 1.2 m diameter, very high pressure (VHP) Dowlais to Nelson Gas Main, on Gelligaer Common. This is an elevated area of ground in an urban part of the coalfield. The fault was scheduled to be undermined by an advancing longwall panel in the Brithdir Seam, which occurs at a depth of approximately 660 m. A ground monitoring programme was implemented to ensure that the gas main did not buckle and rupture during the anticipated reactivation of the Rhos Fault, accompanying the subsidence. The survey consisted of precise levelling observations, total station and electronic distance measurements. The gas main was exhumed and exposed in a deep observation trench to monitor strain accumulations (Figure 8). Approximately 0.6 m of vertical displacement was measured along the fault, accompanied by fissuring on the moorland and road. As a result, the extraction of the seam was terminated to prevent further damage to the gas main (Donnelly 1994, 2000a).

**Figure 8.** Influence of fault reactivation on gas mains. The Nelson to Dowlais gas main, exposed for strain accumulations and subsidence monitoring where it crossed the Rhos Fault, South Wales, UK.

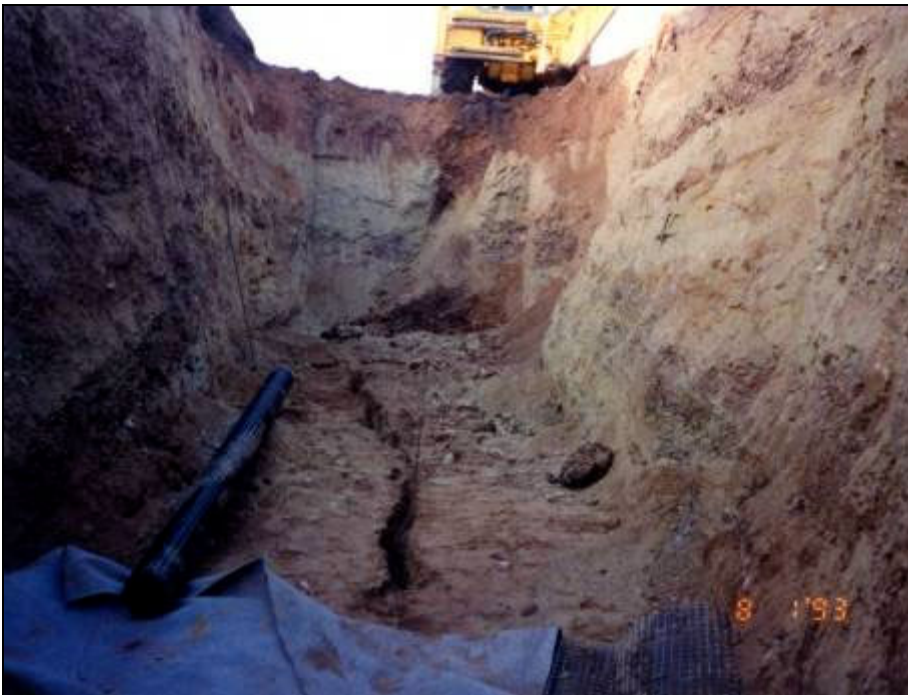
Buried communication cables, located about 0.5 m below ground level, were damaged by the generation of ground fissures in the Triassic rocks of Downes Bank, Staffordshire. The area rises to almost 50 m in height above the Carboniferous Coal Measures rocks of the area and is generally free of Quaternary cover, but is covered by a thin sandy soil. Several faults were subjected to subsidence in the 1990s. This caused the dilation of the fault plane with, or without, a component of vertical slip and resulted in the generation of the ground fissures. Some fault-fissures strike for a distance of over 1 km; their depths are unknown but have been estimated to be at least several metres. These represent the dilation of faults and joint sets during mining subsidence. Where observed in cross-section, in 10 m deep trenches, the faults consist of distinct, parallel and sub-parallel dislocations with a loose sandy gouge. Fissures in the ground surface caused by fault reactivation have been observed in other parts of Britain where the Productive Coal Measures underlie strong, brittle and well-jointed rock. These include the Triassic Sherwood Sandstone Group in the English Midlands, the Permian Magnesian Limestone in the Eastern Pennine Coalfield and Carboniferous Coal Measures sandstone, such as the Pennant Sandstone, in South Wales and the Wickersley Sandstone in the East Midlands (Figure 9).

**Figure 9.** Fissuring associated with the reactivation of a fault, Downes Bank, Staffordshire. This caused disruption to underground communications cables. The fault is exposed in a trench and the ground stabilised using a geotextile mesh and granular fill.

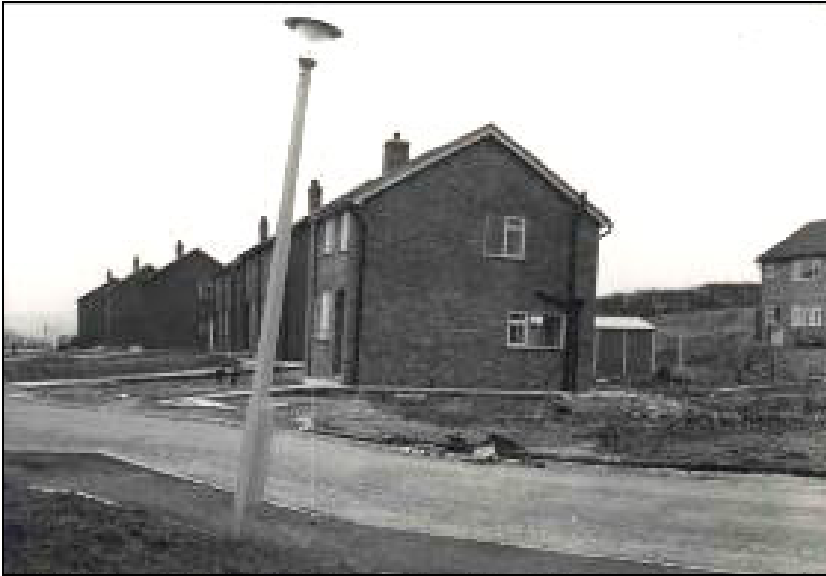
Lamp posts and telegraph poles located in areas prone to subsidence and fault reactivation may undergo an appreciable amount of tilt. A notable example occurred in Knutton, Staffordshire, during the reactivation of the Apedale Fault in 1963 (Figure 10).

**Figure 10.** Reactivation of the Apedale Fault, in 1963, causing tilt to a lamp post, (note the vertical string hanging from the lamp post), Knutton, Staffordshire, UK

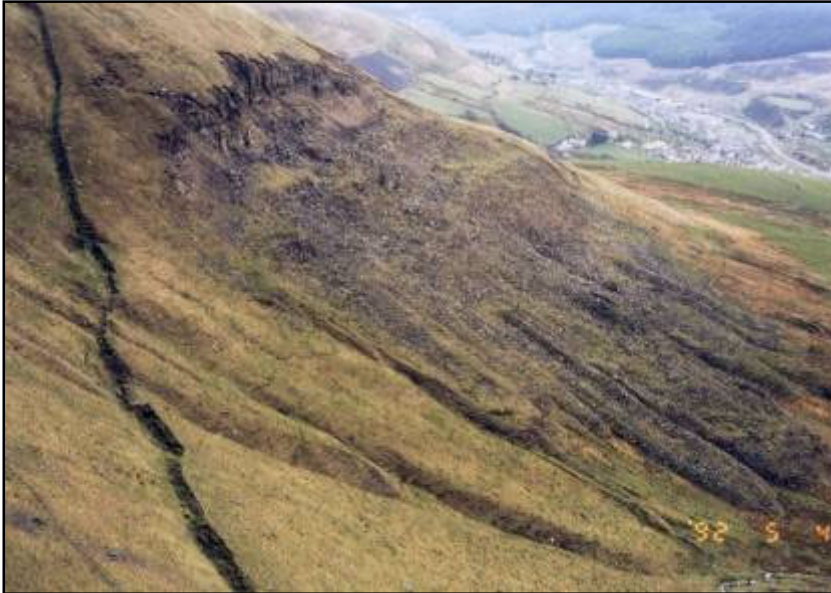
Fault reactivation can influence the stability of natural and engineered slopes. This can result in slope failure and the generation of landslides, which, in turn, may potentially damage land and infrastructure. Fault reactivation has contributed to deep-seated rotational landslides in South Wales as well as causing first time failures of slopes, long after normal ground movement caused by mining had ceased (Donnelly 2005, 2006) (Figure 11).

**Figure 11.** The 3-4m high and 4km long Tableland Fault scarp, which has influenced the Darren Goch landslide and displaced stream valleys, South Wales.
