Landslides and slope deformation caused by water impoundment in the Three Gorges Reservoir, China

Abstract: The Three Gorges Dam on the Yangtze River in China is the largest hydro-electricity project in the world. The first impoundment started from 95 m and reached 135 m on June 15th, 2003. Shortly after the water reached 135 m, many slopes began to deform and some landslides occurred. In this paper, two landslides, the Qianjiangping landslide which occurred on July 14, 2003, and the Shuping landslide which is deforming actively, are discussed. Concerning the Qianjiangping landslide, field investigation revealed that failure occurred when the reservoir reached 135 m, but the stability of the slope was already reduced by pre-existing bedding-plane shears, quarrying of mudstone from the landslide toe, and previous heavy rain. The Shuping landslide is located on a slope in the main stream of the Yangtze River. After the first impoundment, obvious deformation appeared and became intense from February 2004. Through monitoring, bore-hole investigation and physical exploration, the possible deformation mechanism is analyzed.

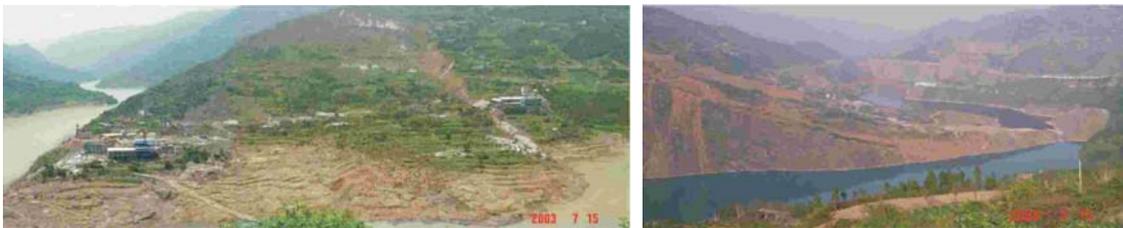
Figure 2 shows photographs of the landslide taken from the opposite bank of the river and upstream side of the landslide. The landslide had been elongate shaped in plan, with a length of 1200 m, and a width of 1000 m. It moved

about 250 m in the main sliding direction of S45°E. The average thickness of the sliding mass was about 20 m. It was thinner in the upper zone and thicker at the lower zone. The total volume was estimated to be more than 20 million cubic meters. The elevation of the main scarp was 450 m, and the elevation of the Qinggan-he River water level was 135 m when the landslide occurred. The landslide release surface was along a bedding plane in the bedrock (Figure 2). Factory buildings on the sliding mass still remained standing after sliding for about 250 m. However, because serious cracks developed in the buildings, they were rendered unsafe for occupation and were subsequently demolished. The building materials were recycled.

Figure 2. View of the Qianjiangping landslide from the opposite bank (Left: Taken by Y.M. Zhang, July 15, 2003) and upstream side of Qinggan-he River (Right: Taken by F.W. Wang, March 15, 2004)

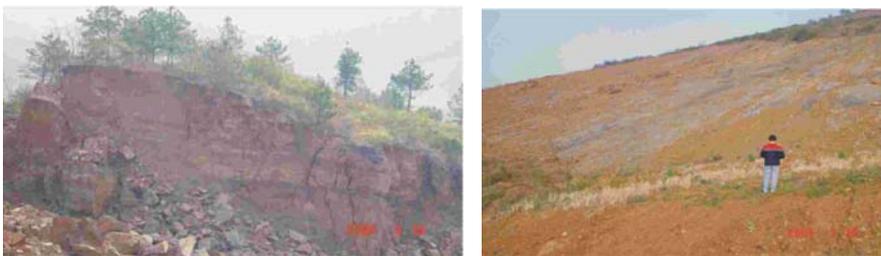
Figure 3. View of un-rotated trees on the sliding mass in the middle of the Qianjiangping landslide (left) and the exposed planar sliding surface (right), which is also a sandstone-bedding plane (there is a damaged rice paddy in front of the person)

Standing trees on the sliding mass in the middle of the landslide (Figure 3) indicate that the angle of the sliding surface remained constant and no rotation occurred. The exposed sliding surface at the upper part was planar, and sub-parallel to the sandstone bedrock strata (Figure 3). All of these phenomena show that the sliding mass slid along a planar sliding surface. When the sliding mass entered Qinggan-he River, the dip direction of the strata was changed to N45°W, which is opposite to the original dip direction of S45°E. The dip angle is about 5° in the bed of Qinggan-he River (Figure 4). The deposits at the distal landslide margin contain white gravel with clasts up to approximately 100mm in diameter. The dip angle of the sandstone bedding at the distal margin exceeds 30° (Figure 5).

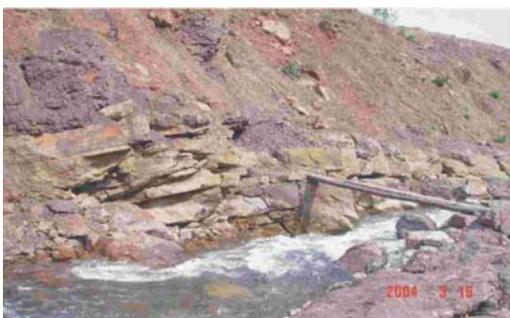
Figure 4. View of the reversed dip direction of the sandstone beside Qinggan-he River (Taken by F.W. Wang, March 16, 2004)

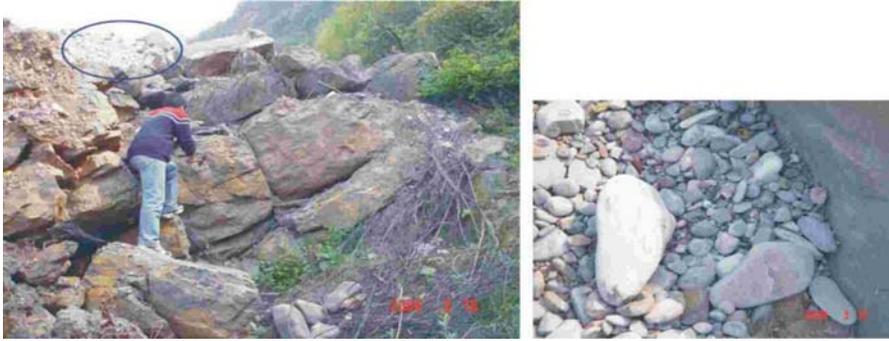
Figure 5. Gravels displaced from the bed of Qinggan-he River and deposited in the toe of the landslide deposit (circled in the left photograph). Note that the sandstone dip direction is reversed and the dip angle has become steeper compared with Figure 4)

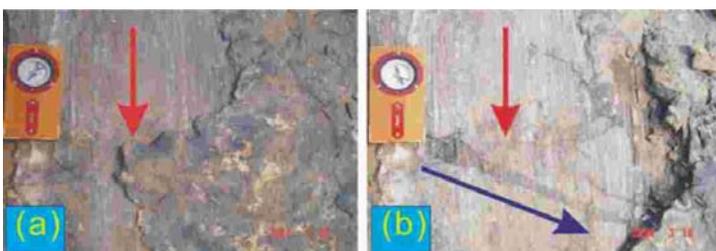
Figure 6 shows a sequence of two photographs of striations on the sliding surface at the upper part of the landslide. Figure 6a shows the pre landslide bedding plane whereas in Figure 6b a slice of sandstone has been removed from the bedding plane to reveal more striations. This shows that some striations were present beneath the landslide failure surface before the landslide occurred. The strike direction of the striations was S15°W (red arrow). The sliding direction (S45°E) of the July 2003 event (blue arrow) is shown by the water flow in Figure 6b. The angle between the sliding direction and the striations is about 60°. Comparison of the two photographs shows that the striations were not formed by the event of July 2003. They must have formed earlier, probably in a much older geological processes, because calcite mineralisation is widely distributed along them. This site lies between the Zigui syncline and Baifulai-Liulaiguan anticline that were folded during the Cretaceous period (Wang *et al.* 2002). The striations may be interpreted as slickensides formed by bedding-plane translational shear during folding of the strata.

Figure 6. Photographs (a) and (b) showing striations on sliding surface from the July 2003 event (the blue arrow shows the sliding direction, red arrows show the strike direction of the pre-existing striations). The striations are inferred to be slickensides formed by bedding-plane translational shear during folding of the rocks in the Cretaceous period.

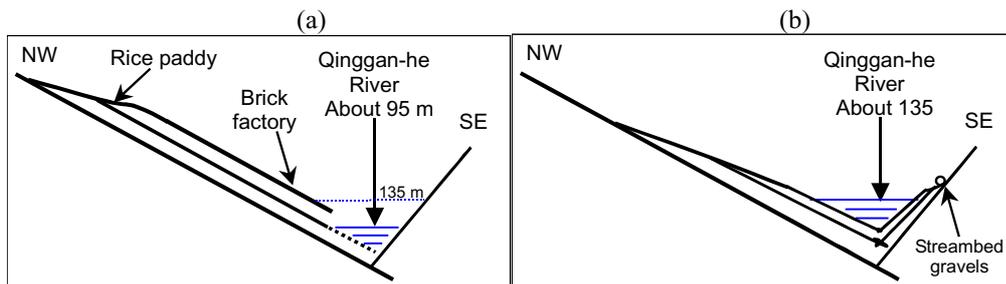
The landslide toe had been eroded by the Qinggan-he River long ago, and offered little resistance to sliding. Only the left lateral boundary offered side friction and tension resistance from the neighbouring rock mass. For such a huge landslide, the mechanical model can be simplified as a two-dimensional longitudinal model as shown in Figure 8(a). The model of the landslide after failure is sketched in Figure 8(b).

Figure 8. Structural model of the Qianjiangping slope before failure (a) and a sketch of the landslide after failure (b).

With the slope in a critical state (Figure 8a), an increase in water level in the river would decrease the effective normal stress in the toe of the slope, and the shear resistance would decrease at the same time. These changes in the mechanical balance resulted in the slope failure.

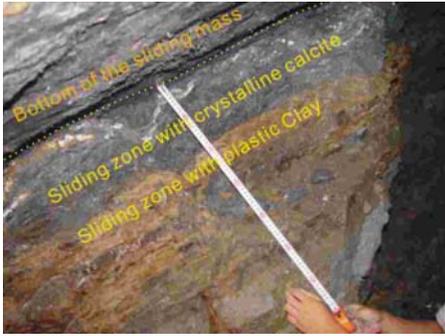
Figure 9. Photograph of the sliding zone taken at a horizontal tunnel. Under the bottom of the sliding mass, the sliding zone can be observed with two layers. The upper layer in grey colour includes crystallized calcite, and the lower layer in yellow colour is plastic clay with high water content

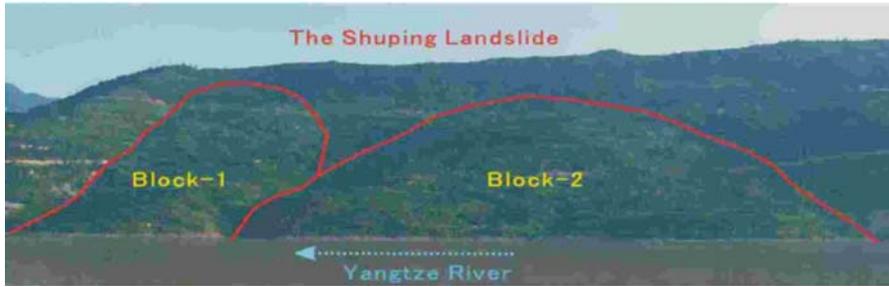
Figure 10. Shuping landslide consisting of two blocks in the main channel of the Three Gorges Water Reservoir

The Shuping landslide is an ancient landslide which composed of two blocks (Figure 10). After the first impoundment of the Three Gorges reservoir ended on June 15, 2003, ground deformation was observed on the slope, and these become more common from February 8, 2004 onwards. Also, the two blocks shows different deformation rates on the slope surfaces. These ground movements posed a risk to 580 inhabitants and 163 houses situated directly in the vicinity of the landslide. As a precaution all of the inhabitants were evacuated, by central government, and placed in temporary tented accommodation to reduce the possibility of a disaster. In May 2004, most of the inhabitants relocated their homes beyond the area of the landslide.

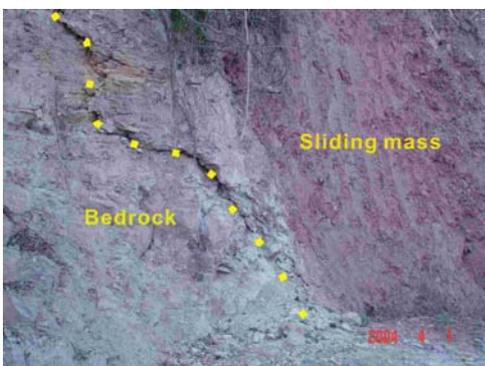
Figure 12 shows a fissure at the right boundary of 'Block 1' which is situated adjacent to a local road. The right-hand side is the sliding mass consisting of a red, muddy-debris which forms part of an old landslide. The left-hand side is exposed bed rock of Triassic age. This consists of sandy mudstone and muddy siltstone of the Badong Formation.

Figure 12. Fissure at the right boundary of Block 1, observed at a roadside exposure.

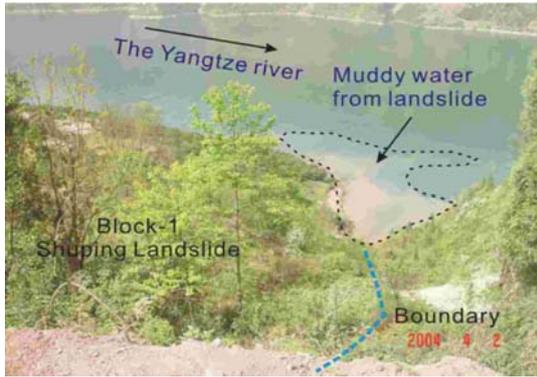
Figure 13 shows discoloured water which is derived from streams flowing from 'Block 1'. This is a consistent feature, which is also present on dry, warm days when rainfall is less. This sediment plume appears to show no

relationship to the water in the Yangtze River. But instead appears to be related to groundwater flows from the landslide on the adjacent slope.

Figure 13. Groundwaters containing sediments in suspicion flowing from the toe of the Shuping landslide into the Yangtze river.

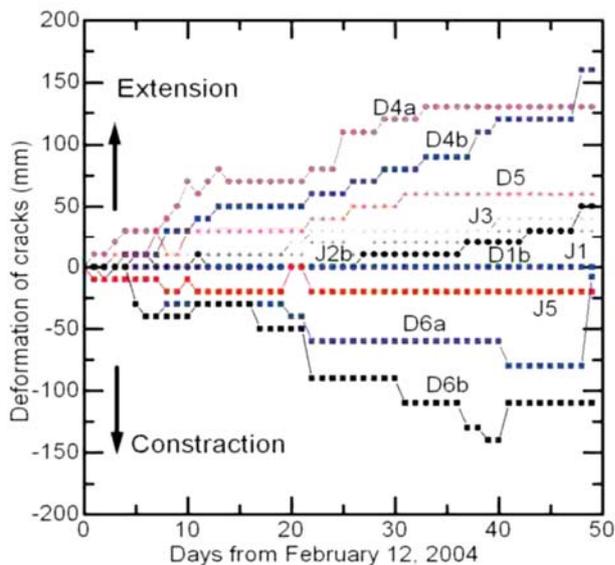
The data shows that the fissures underwent extension within the main body of the landslide and along its periphery, whereas contraction of the fissures occurred within other parts in the displaced block. The monitoring period lasted for 50 days from February 24, 2004. The maximum displacements were approximately 140 mm, including both extension and contraction, this being indicative of active ground deformation.

Figure 14. Results showing the measurement of fissures on the slope in Block 1.

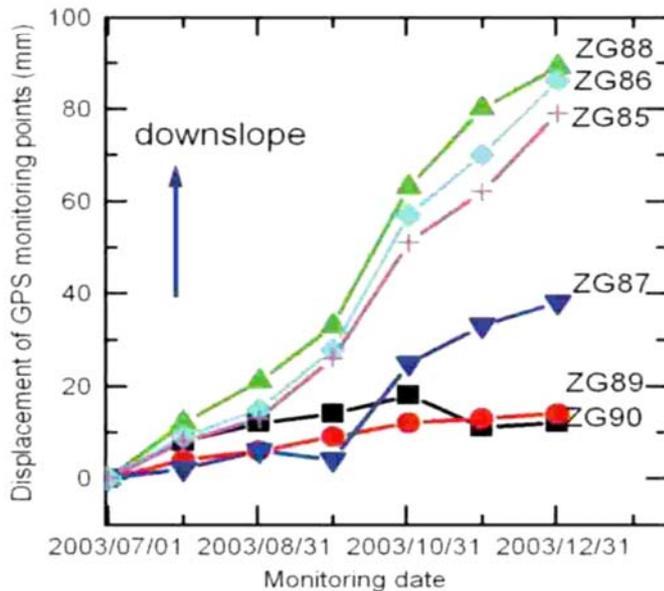
Figure 15. GPS monitored results along the central section lines of Block 1 and Block 2 (obtained by the Rockfall and Landslide Research Institute of Three Gorges University).

Figure 15 shows the results of the GPS monitoring for the first six months period after the impoundment. The displacement rate for Block 1 increased rapidly after October 2003. Other observations include (a) the displacements on the lower part of the slope are larger than that the upper slope, this may be caused by water buoyancy induced by the impoundment of the reservoir, and (b) the displacement of Block 1 is more active than Block 2, showing that the two blocks behave independently from each other.

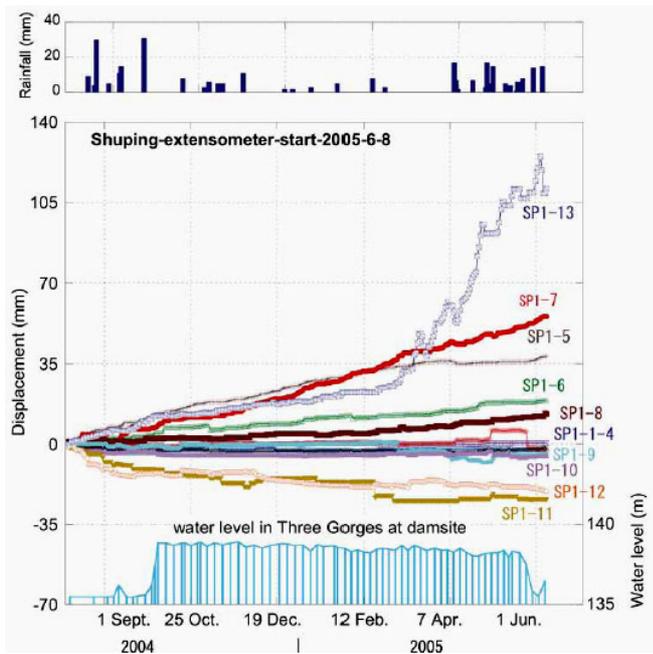
Figure 17. Extensometer monitored results (middle), precipitation data in Yichang City (top) and water level in the Three Gorges Dam site (bottom).

The monitoring results show the following: (a) The SP1-1 and SP1-2 at the main scarp did not record any obvious displacement. (b) The deformations at SP1-5, SP1-6, SP1-7 and SP1-8 were the most active showing extension. Because of localised failure, the SP1-13 showed the most extension. (c) The toe of the landslide showed compression behaviour.

In mid-September, the water level at the Three Gorges reservoir was raised about 3 m. Corresponding to this water level rise the displacement velocity of monitoring stations SP1-5, SP1-6 and SP1-7 increased, reflecting the influence of the impoundment on slope deformation. Furthermore, during the rainy season, after April 2005, displacement acceleration (at SP1-6, 7, 8) was also monitored and this showed that the displacement of the landslide was also influenced by fluctuating groundwater conditions.

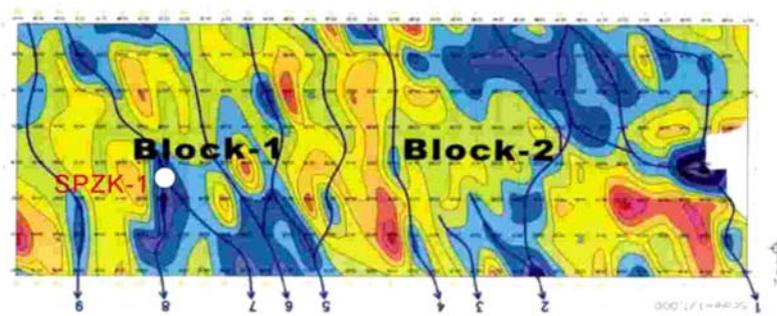
Figure 19 shows the results and the ground temperature distribution. Two independent groundwater channels were inferred in Block 1 and Block 2. The discharge of the groundwater channel in Block 1 is at a lower elevation than in Block 2. It is estimated that the groundwater channels No. 5, 6, 7, 8 and 9 correspond to the discoloured water seeps from Block 1.

Figure 19. Groundwater channels distribution, estimated from the measurements of ground temperature, taken 1 m below ground level.

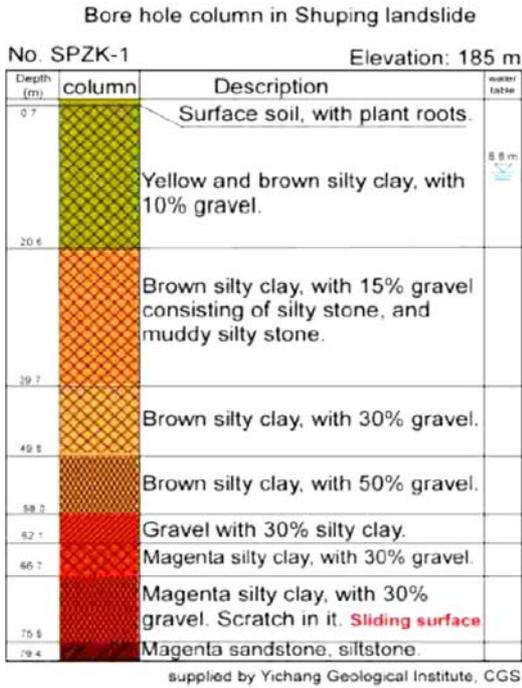
To confirm the above and to investigate the sliding surface, a borehole was drilled at SPZK-1, as shown in Figure 19. The borehole log is shown in Figure. 20. The groundwater table was observed at 8.8 m below ground level, and the sliding zone was observed between 66.7 and 75.9 m below ground level. The sliding zone consisted of silty clay, with 30% gravel. Striations caused by sliding were abundant in this zone.

Figure 20. Summary of borehole log drilled at position SPZK-1 in Block 1 of Shuping landslide

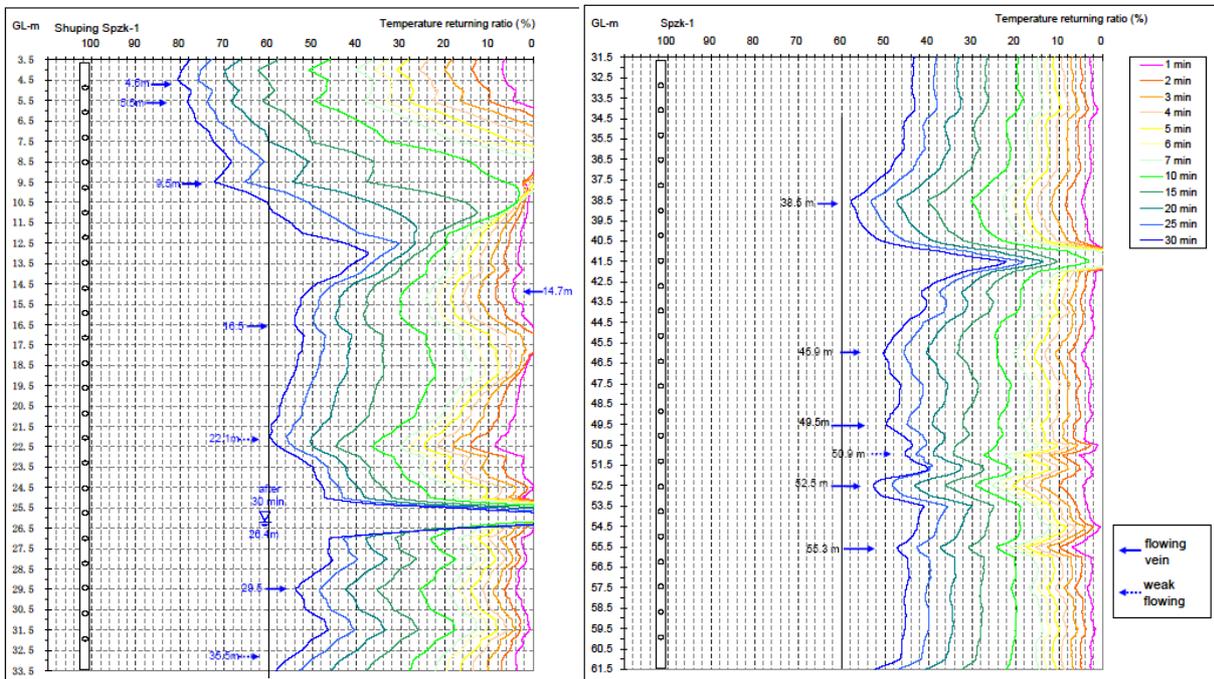
Figure 21. Borehole logging result showing groundwater flowing layers in the Shuping landslide

Figure 21 shows the measured results. Near the slope surface, at a depth of 4.5 m and 5.5 m, the flowing layers may be caused by rainfall infiltration. Below that, at a depth of 9.5 m, 16.5 m, 22.1 m, flowing layer of groundwater may exist. The 9.5 m deep flowing layer was confirmed by an excavation when the groundwater level was initially observed. The flowing layer at 16.5 m deep was also influenced by the flowing at 14.7 m deep. Below the stable groundwater level, there are several weakly flowing observed. These are at the depth of 29.5 m, 38.5 m, 45.9m, 50.9

m, 52.5 m, and 55.3 m, respectively. To determine which flowing layer has affected the landslide, pipe strain gauges are planned to be installed in the borehole. The information on groundwater flow horizons will be important for analyzing the factors which have influenced the Shuping landslide. These include including reservoir impoundment and groundwater flowing caused by rainfall.

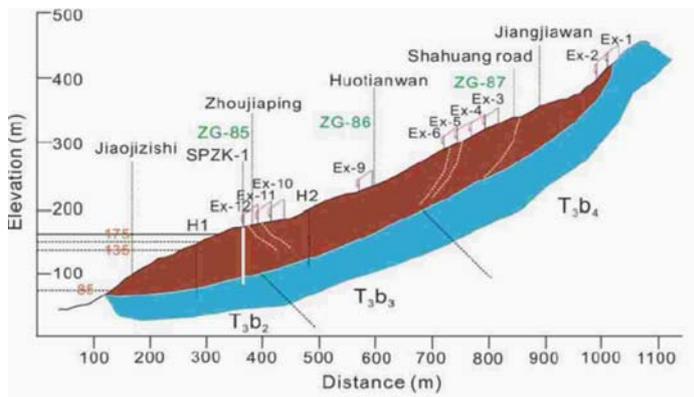
GPS monitoring, fissure displacement measurements and extensometer monitoring have enabled a conceptual model through Block 1 of the Shuping landslide, this is presented in Figure 22. Soon after the impoundment of the reservoir, the toe of the slope became displaced in a downslope direction faster than the upper part of the slope. Two years after the first impoundment, the slope deformation style changed. The displacement of the lower part almost terminated while the upper part displaced downward gradually, and compressed the toe.

The Shuping landslide represents the reactivation of an existing landslide and the factors which influence instability and sliding are complex. About one after year monitoring with the extensometers, it became clear that the slope displaced took place soon after impoundment. It is important to continue with the monitoring specially since the next stage of impoundment is estimated to commence in June 2006 (the water level will be raised from 139 m to 156 m). Any remedial works may require more detailed investigations on the effect of groundwater, slope deformation and drainage of the slope.

Figure 22. Longitudinal section of the Shuping landslide showing the deformation mechanism.
