Landslides affecting the Vía Interoceánica, East of Quito, Ecuador

KATRIN SILVERS¹ & JAMES GRIFFITHS²

Abstract: Quito, the capital of Ecuador, is surrounded by steep and unstable terrain, and landslides are a common hazard that often cause damage to the infrastructure, especially roads. In this study failures along a strategic transportation route, the Vía Interoceánica, are investigated. This is the only road linking Quito, and the entire northwest of the country, to eastern Ecuador. A series of failures occurred on the road leading up to its closure in 1999. The question is why a road was attempted in an area where the costs of construction and maintenance were liable to be so high? The conclusion is that road construction in Ecuador is not just a geotechnical issue as influential individuals or sectors can bring political pressure to bear to ensure construction takes place in specific areas. In the case study presented the result was a rapid transit road link between high socio-economic status neighbourhoods and the capital.

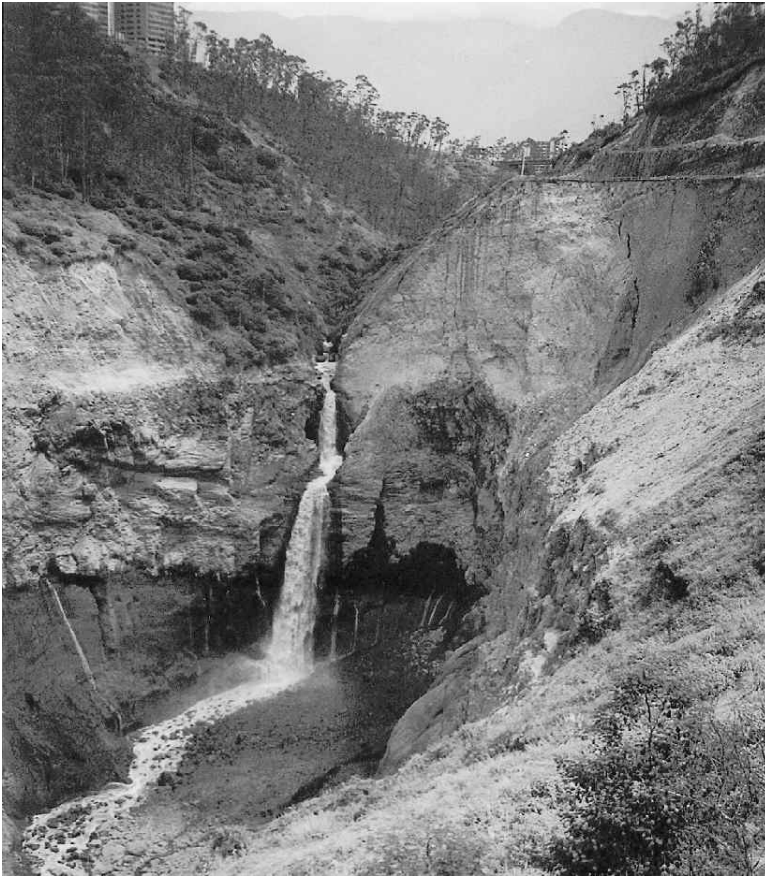
Figure 3. The Quebrada del Batán Grande gorge and waterfall

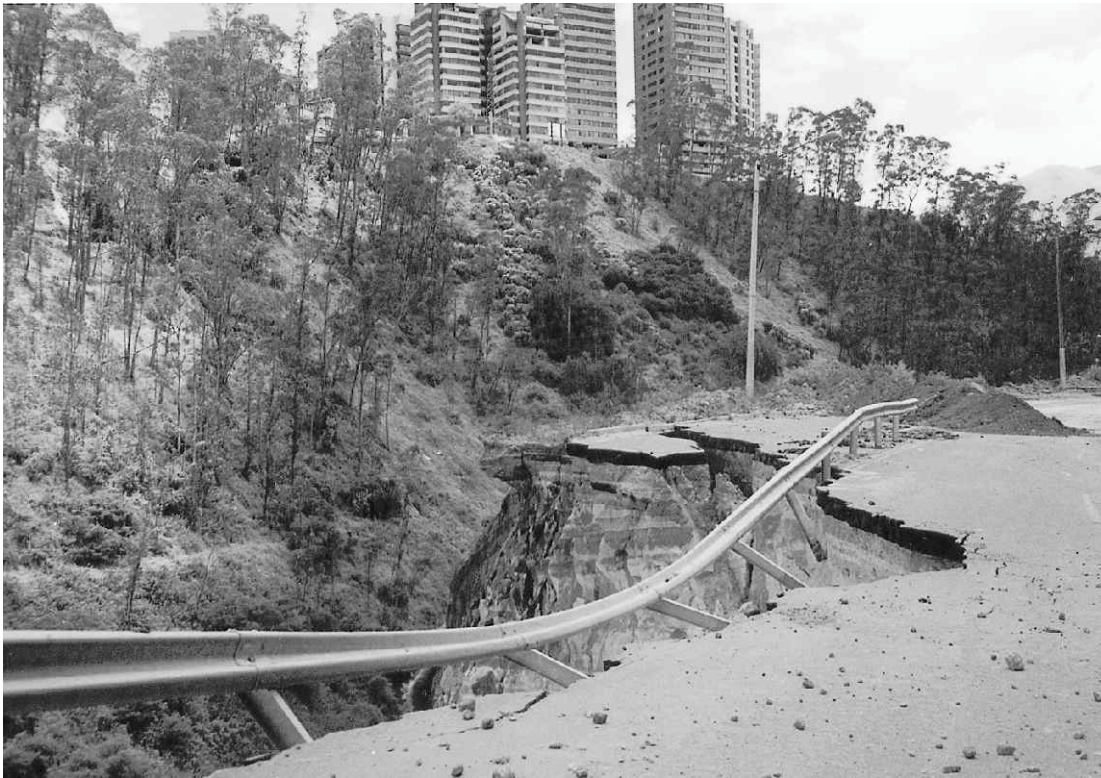
System 2 appeared to be continually active. In an aerial photograph of the site taken in 1996, the landslide backscar was located at 10 metres from the road. In 1998 the pavement of the Interoceánica became involved in movements (El Comercio, 1999a). A new design shifted the road another 6m horizontally into the slope, nevertheless it became subject to failure again in 1999 and an additional 5m of the carriageway was lost by the beginning of August 2000. During the period of field investigation the maximum rate recorded was approximately 5 metres per month. This very

high rate could have been triggered by the heavy road clearing works carried out during that period. The extent of the damage to the road by September 2000 is illustrated in Fig. 5.

Figure 5. Instability that closed the road in September 2000

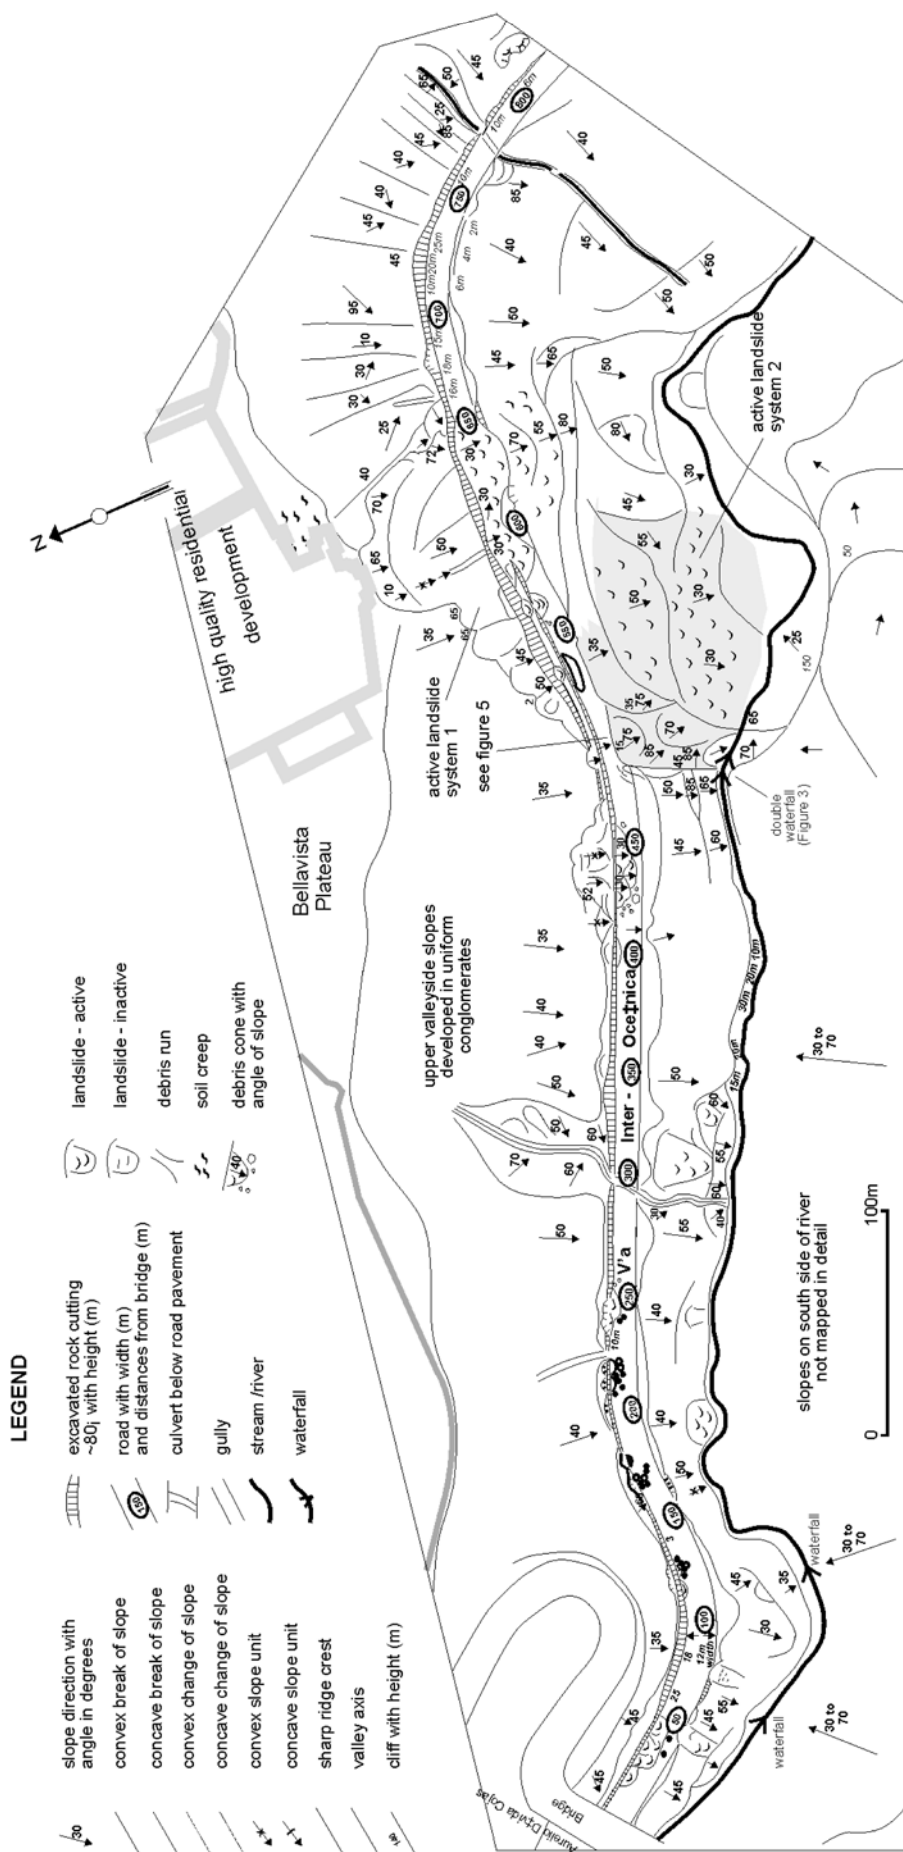
Geomorphological mapping for this study was carried out in August 2000, using the methods recommended by Cooke & Doornkamp (1990), and identified two landslide systems (Fig. 4 – at end of paper):

- System 1 was located on the upper slope between 470 and 670 metres from the bridge and involving more than seven translational landslides. The failure that blocked the road at the end of 1999 was by far the largest. The scar of this failure extended 80 metres across and from 25 to 65 metres above the road. It destroyed the upper 10 – 12 metres of the designed rock cut slope. An estimated volume of over 30,000 m³ of material was displaced, completely blocking the road. Some of the debris cone was also displaced by other failures down to the riverbed. Observations of broken estate walls on the upper slope slightly east of the area (at 725 m from the bridge) suggested that the failure had started with small-scale creep movements.

- System 2 involved the retreat of the northern face of the waterfall and was found on the lower slope between 450 and 630 metres from the bridge. Four metre deep tension cracks in the crown of the failure were located in the road pavement, and a near vertical rock face suggested that this retreat took place primarily as rock falls.

Figure 4. Engineering geomorphological map of the study area shown in figure 2
