# Observations on the tilting of multi-story buildings founded on Pliocene sands in Maputo, Mozambique

ALAN FORSTER<sup>1</sup>

<sup>1</sup> British Geological Survey. (e-mail: [af@bgs.ac.uk](mailto:af@bgs.ac.uk))

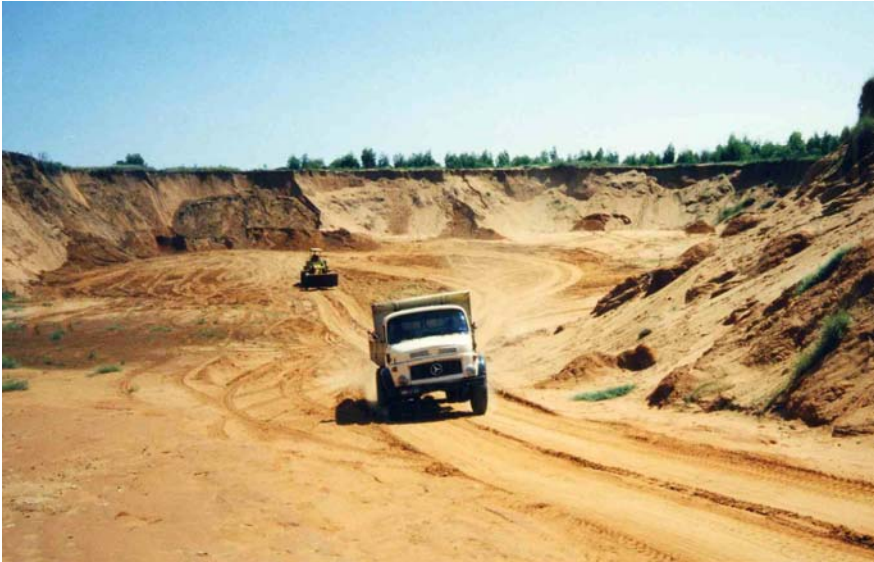
An exposure in a sand quarry at Albazinie north of Maputo shows the Ponta Vermelha Formation to be remarkably uniform in its composition with no visible variation in lithology or structure (Fig. 2). The quarry walls stand at a steep angle, almost vertical in places where material is being worked. The sand could be easily crushed by hand.

**Figure 2.** Sand quarry in Ponta Vermelha Formation at Albazinie.

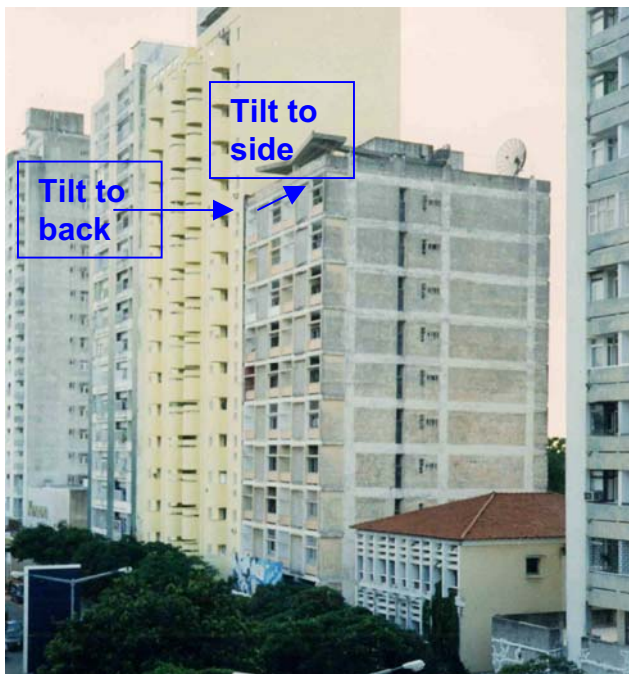
Figure 4. Site 1, Avenida Julius Nyerere

This was the most severely tilted building (Fig. 4). It comprised 10 floors (including the ground floor) and was approximately 30 m high and 15 m wide. It was built in 1960 but the tilting started many years later (1990s). The present backward tilt has been measured at its highest point of contact with the adjacent building as 0.37 m and the side tilt 0.15 m to the right (as seen facing the building) (Fig. 4). The damage seen at ground level at the back of the building was due to the backward and sideways rotation of the building causing it to crush the end of the right hand side boundary wall and damage a single story construction on the left hand side (Fig. 5). The caretaker reported that after the start of the movement the mains water supply pipe to the building was found to be damaged and the surrounding soil was in a saturated condition. It was not known if the fractured pipe preceded the movement or was a

result of the movement. The pipe had been replaced and a new water tank installed on the ground surface to replace the one that had been damaged.

The removal of material by internal erosion due to a flow of water would be a strong possibility for a building founded on silty sand since the silt component may be removed by flow through the intergranular pore spaces. It is likely that this process was responsible for the worsening of the tilt on site 1 following the fracturing of the water supply pipe to the building but if an earlier leakage from the pipe was the cause of the initial tilt is not known. The original water supply tank below the ground surface at the back of the building was believed to be of concrete construction and it is possible that it may have cracked due to settlement and have leaked for a considerable time causing a slow subsidence that eventually fractured the supply pipe that fed water into it. If such a leakage were to be the cause it would have to be accepted that all four buildings had suffered from a similar leaking water tank at the back of the building and this would be an unlikely coincidence.

Regarding future actions to deal with the problem continued monitoring of the amount and rate of increase of the tilt would be advisable and remedial actions would probably be best directed at stabilising the movement by drainage or underpinning. Restoring the buildings to the vertical is unlikely to be cost effective in view of the likely cost of such works and the relatively minor inconvenience of the tilting which is currently insufficient to significantly impair the function of the buildings.

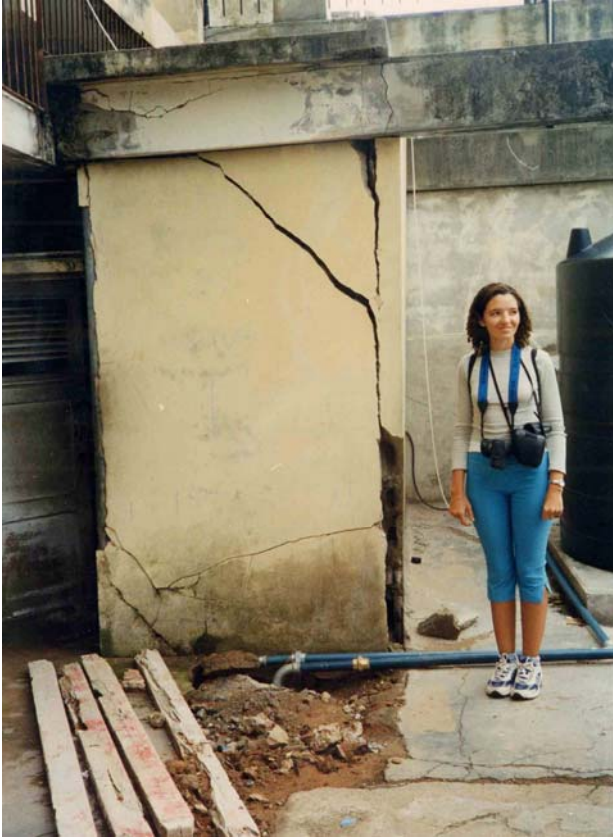
**Figure 5.** Site 1, damage to a single story construction on the left hand side at the back of the building.
