Rockfall geohazard assessment and protection measures on the highway network, North Wales.

DOUGLAS NICHOL¹

¹ *NWTRA Geotechnical Group, Crown Buildings, Wrexham LL13 8BG, UK
(e-mail: doug.nichol@wrexham.gov.uk)*

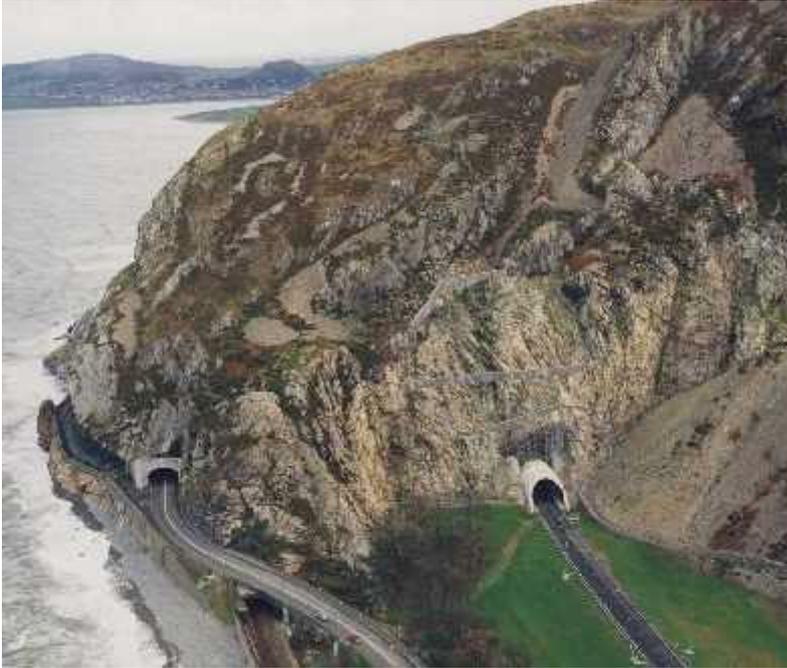
Figure 2. The headland at Penmaenbach looking eastwards

The high rocky crags around the headland feature overhanging fretted edges that are naturally spalling and shed rock debris of all sizes. Moreover, the open aspect of the headland in a coastal setting results in high exposure during stormy weather. Additional factors which cause disturbance to both vegetated slopes and rock faces include stress relief, freeze-thaw action, wedging tree roots, grazing sheep and nesting birds. These features combine to increase susceptibility to rockfall activity that presents several hazards to road users.

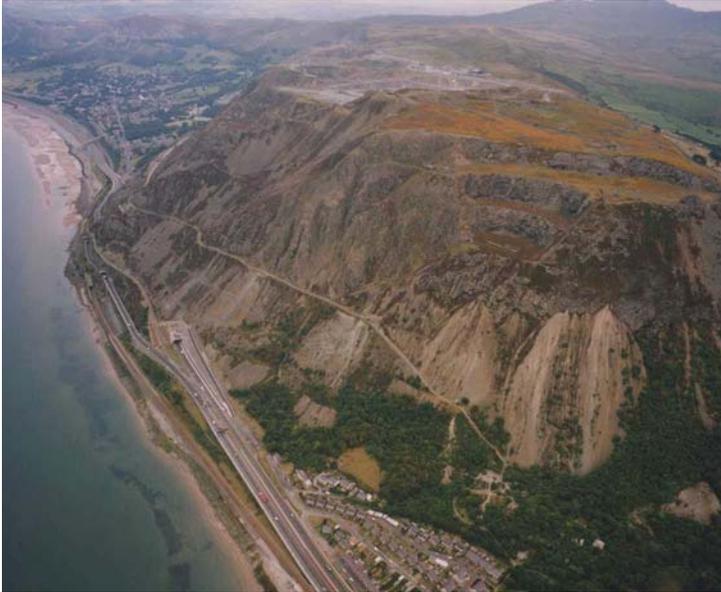
Figure 3. The mountain promontory at Pen-y-Clip looking eastwards

The principal concerns for rockfall activity involve ravelling rock from roadside rockfaces, loose material associated with the scree slopes and large boulders falling from high on the mountainside.

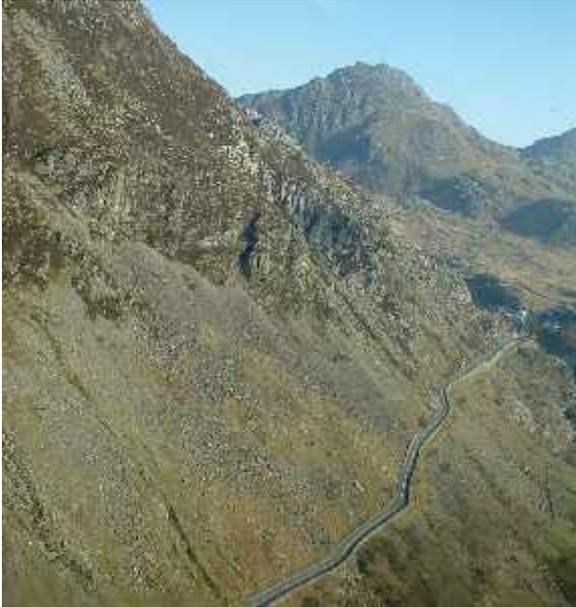
Figure 4. Nant Ffrancon Pass looking southwards

The principal concerns for rockfall activity involve ravelling rock from roadside rockfaces, loose material on scree slopes, debris flows associated with stream channels and large boulders falling from high on the mountainside.

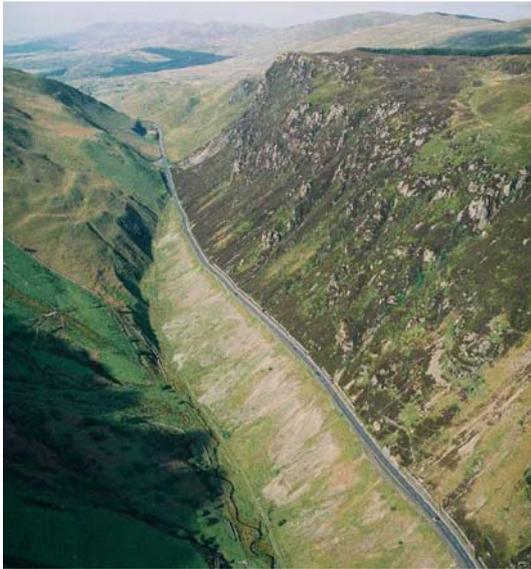
The high rocky crags and precipitous natural cliffs of Craig-y-Llam feature overhanging fretted edges that are naturally spalling and shed rock debris of all sizes. On the lower slopes, outcrops with intervening scree-covered areas predominate. In two quarries at the head of the Pass, tuffs and mudstones are crossed by numerous fault crush zones and slickensided minor faults.

A series of streams flowing down the hillside are incised into the scree deposits. During rainstorm events, the stream culverts beneath the road frequently become blocked with rocky debris that spills over onto the road and affects the highway. The principal concerns for rockfall activity involve ravelling rock from roadside rockfaces, loose

material on scree slopes, debris flows associated with stream channels and large boulders falling from high on the mountainside.

Figure 5. Tal-y-llyn Pass looking northeastwards

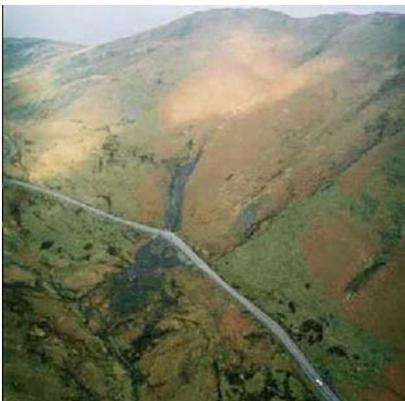
Figure 6. Bwlch Oerddrws looking northwestwards

At Bwlch Oerddrws heterogeneous glacial materials and deposits of scree, colluvium and peat mantle the bedrock. A series of streams flowing down the hillside are incised deeply into these superficial deposits. During rainstorm events, the stream culverts beneath the road frequently become blocked and rocky debris spills over onto the road and affects the highway. Many of these blockages appear associated with minor landslides further up the hillside within the stream tracts. The principal concerns for rockfall activity involve debris flows associated with the stream channels.

More recently, Doherty & Scott (2005) described the debris flows in January 2005 at Bwlch Oerddrws that closed the A470 trunk road for several weeks (Figure 6).

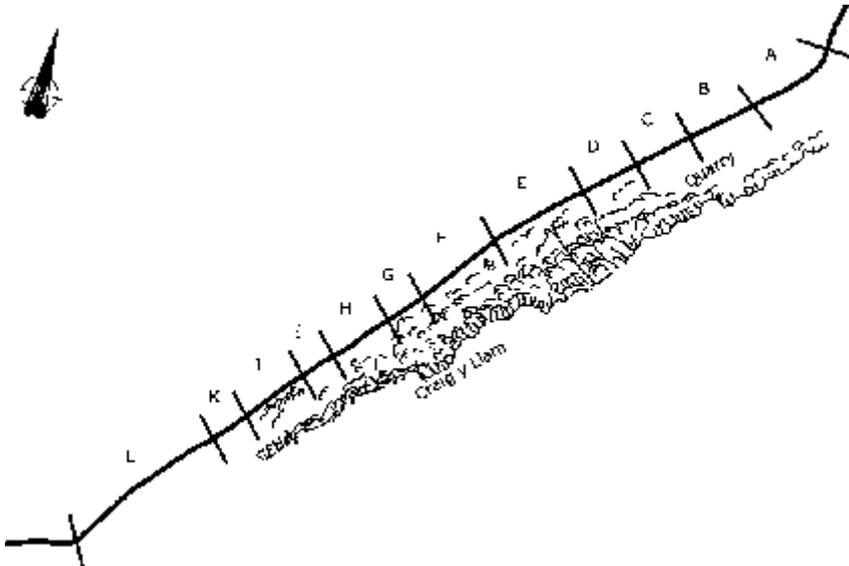
Figure 7. Rockfall Hazard Rating System (RHRS) Zones A to L inclusive along the A487 Tal-y-llyn Pass

Zones A and B include the north approach to the Pass and relatively little rockfall activity on this stretch gives a comparatively low rating. The slopes in Zone C are considerably higher than within the other sections, but this does not affect the scores because an upper limit of 100 applies to each of the category scores in RHRS. The percent sight distances are low in Zone C due to poor vertical alignment and in Zones D and E due to poor horizontal alignment. Zones C, D, E and F contain areas of fractured rock and receive high scores for geological structure. High scores for ditch effectiveness and road width together with unfavourable rockfall history gives Zone E the highest total score.

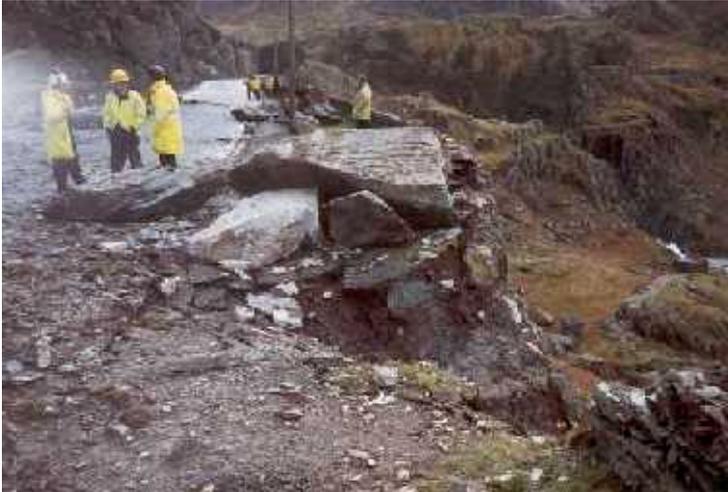
Similarly, Williams & Doherty (2002) outlined the history of rockfall at Nant Ffrancon starting with the earliest event recorded in 1645. Several huge blocks of rock together with loose soil and gravel blocked the highway in the central part of the Pass in 1954. Multiple debris flows severed the road in 1983 when some 800 tonnes of material fell at several locations through the Pass and stranded four cars in intervening areas. In 1998, another major fall in the central part of the Pass involved some 50 tonnes of material including a single block of rock weighing around 25 tonnes that demolished a 6 m section of masonry parapet (Figure 8).

Figure 8. A5 Nant Ffrancon rockfall event of 3 November 1998; looking south

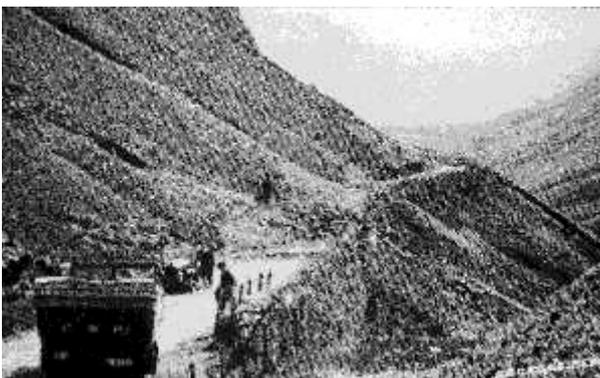
In addition, Flower & Roberts (1987) recorded noteworthy rockfall events in 1926 and 1927 that blocked Tal-y-llyn Pass and closed the road for 4 months (Figure 9). Interestingly, both of these rockfall events occurred in RHRS Zone E which also yielded the highest total RHRS score for the Pass.

Figure 9. A487 Tal-y-llyn Pass rockfall event of 18 July 1926; looking southwest

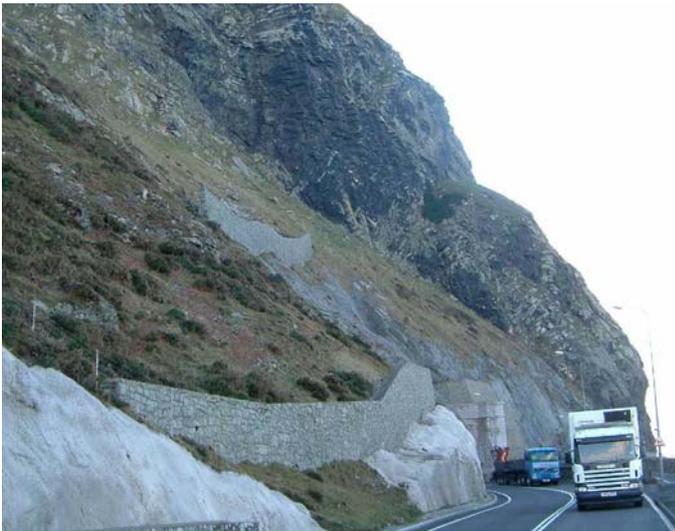
Figure 10. Rocktrap walls at Penmaenbach

Concrete retaining walls built on the hillside form a rigid barrier to intercept free falling rocks as large as 2 m in size and prevent them from reaching the road. The walls must be long enough to cover the rockfall hazard zone, sufficiently high to cover the path of bouncing rocks and sufficiently robust to withstand impacts of the largest blocks of rock. A series of rocktrap walls have been built on the headlands at Pen-y-Clip and Penmaenbach (Figures 2 & 10). Here, the walls are generally founded on rock outcrops and pinned by stainless steel dowels grouted into the rock. They are either mass concrete or reinforced concrete and faced with masonry.

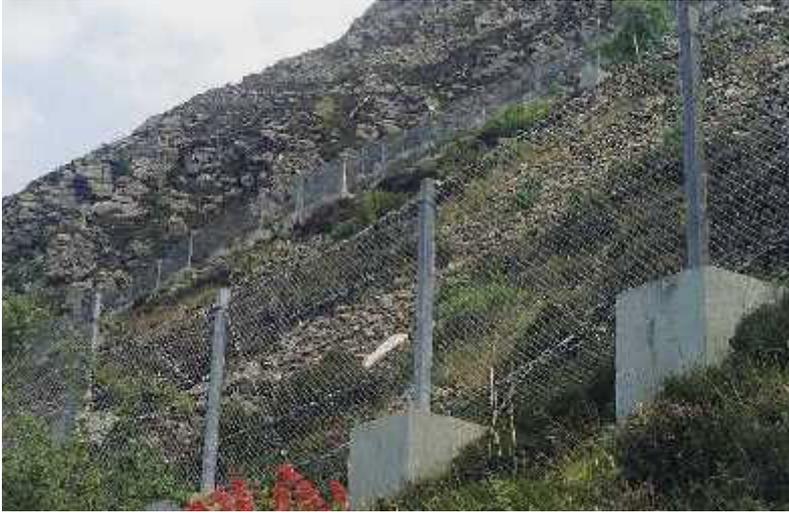
Figure 11. Rockfall checkfences at Pen-y-Clip

Impressive arrays of checkfences have been erected across the headland at Pen-y-Clip (Nichol, 1999). Here, there are 110 checkfence units on the mountainside. They range from 9 to 55 m in length depending on local conditions but are commonly about 30 m long by 3 m high. The total length of checkfencing exceeds 3.25 km. Layout generally comprises at least two and usually three horizontal lines of checkfencing with the independent bays in a staggered configuration.

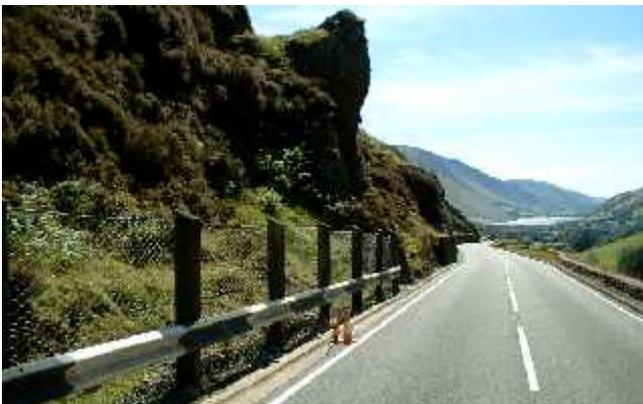
Figure 12. Barrier fence at Tal-y-llyn Pass

Barrier fences around 1 m high of wire mesh supported on posts are generally employed along roadside verges or at the base of a slope to prevent rocks rolling on to the road (Figure 12). They are suited to rock slopes where only minor or local instability is likely to occur and where the slope is liable to slow degradation. Rock debris accumulates along the bottom of the fence and needs to be removed at regular maintenance intervals.

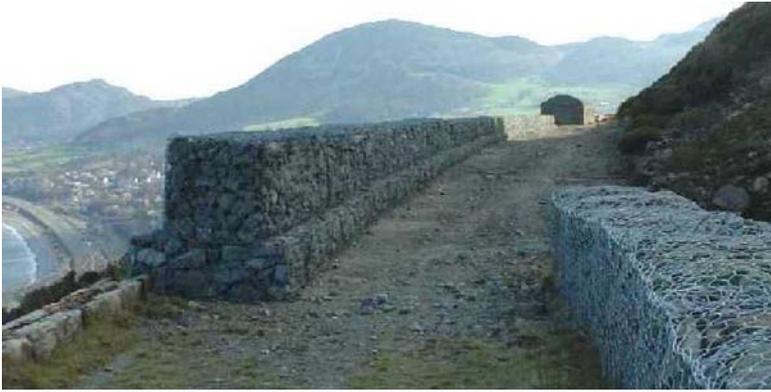
Figure 13. Gabion barrier on mountainside at Pen-y-Clip

Gabion walls can be used to form a barrier to catch rolling or bouncing rocks up to a size of about 1.5 m (Figure 13). Gabion baskets are flexible under impact and cheaper than concrete, but the mesh is susceptible to damage. In addition, gabion barriers may appear unsightly and obtrude on the local landscape in environmentally sensitive sites.

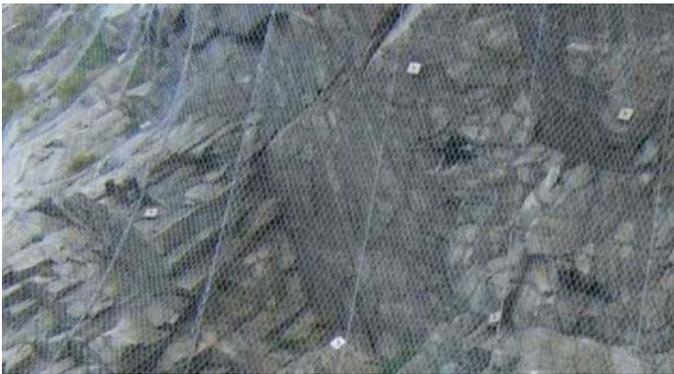
Figure 14. Heavy-duty mesh netting drape on rockface at Penmaenbach

Heavy-duty mesh netting draped over rock surfaces can restrain rockfall and prevent raveling of loose material from roadside rockfaces (Figure 14). It is also deployed on scree slopes and boulder fields for stabilization purposes.

Netting is most appropriate for rockfaces with moderate to widely spaced discontinuities and medium to large block sizes. Generally, the netting is fixed in place using a combination of rock bolts and wire cables. A typical wire mesh slope protection system consists of a main cable support anchored along the top of the slope from which the mesh is suspended. The mesh drapes down the rockface, seams are wired to form a continuous blanket, rock bolts are installed to fix the netting around irregularities or protrusions in the rockface and the bottom and sides of the mesh blanket are secured by additional anchored straining-cables.

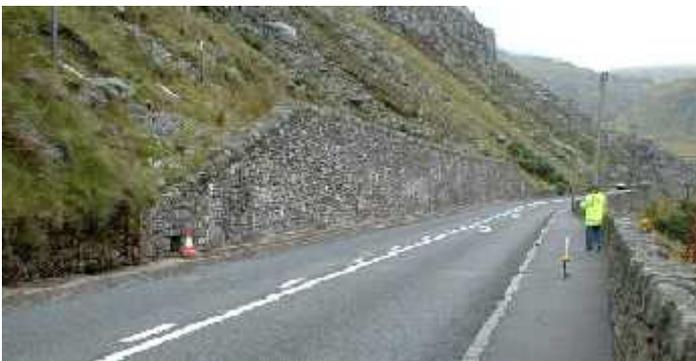
Figure 15. Retaining wall on roadside at Nant Ffrancon Pass

Retaining walls provide strength by applying direct support to a rockface or a scree slope and are extensively employed at roadside positions (Figure 15).

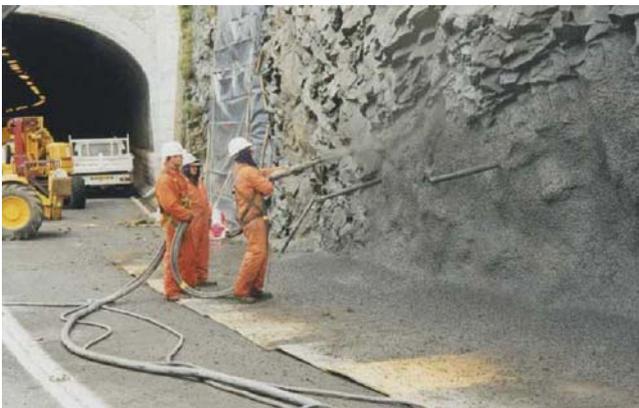
Figure 16. Application of fibrecrete to rockface at Penmaenbach

Sprayed fibre concrete (fibrecrete) provides a strong and durable ground reinforcement skin that follows the structure and relief of a rockface (Figure 16). A thin layer of fibrecrete has a considerable capacity to limit rock displacement.

The fibres improve the material properties, including post-crack ductility, toughness, and most importantly, flexural strength. Fibrecrete systems also bond and seal the rock surface and preserve the integrity of the rock mass by the application of support pressure. Nichol (2002) describes the extensive treatment of roadside rockfaces around Penmaenbach Headland using fibrecrete.

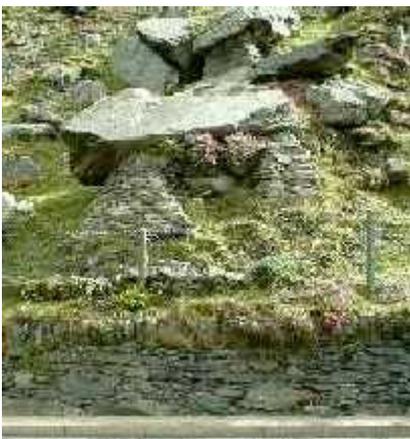
Figure 17. Buttress at Nant Ffrancon

Buttresses provide a simple, effective and permanent support under larger rocks in danger of falling (Figure 17).

Often, such rocks are not removed from sloping ground because of difficulties of access or because they may release considerable material above them. Small buttresses can be made of concrete and faced with the local rock not only to prop individual blocks of rock liable to roll but also to avoid obstruction on the local landscape.

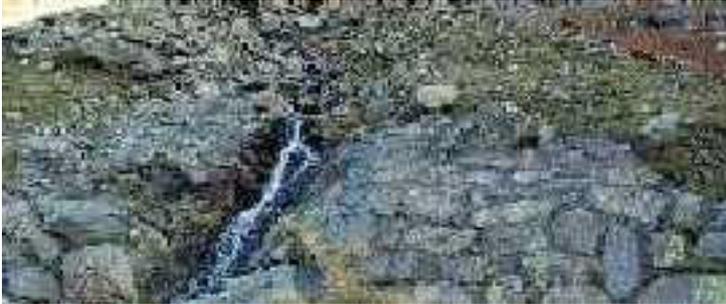
Figure 18. Trained watercourse alongside road through Nant Ffrancon

occurring events in a given area. Mitigation works may include ditch deepening, reshaping and lining (Figure 18) and construction of large culverts.
