# Environmental impacts of a large catastrophic landslide, in Sivas northeast of Turkey

CANDAN GOKCEOGLU<sup>1</sup>, TAMER Y. DUMAN<sup>2</sup>, HARUN SONMEZ<sup>3</sup> & HAKAN A. NEFESLIOGLU<sup>4</sup>, TOLGA CAN<sup>5</sup>

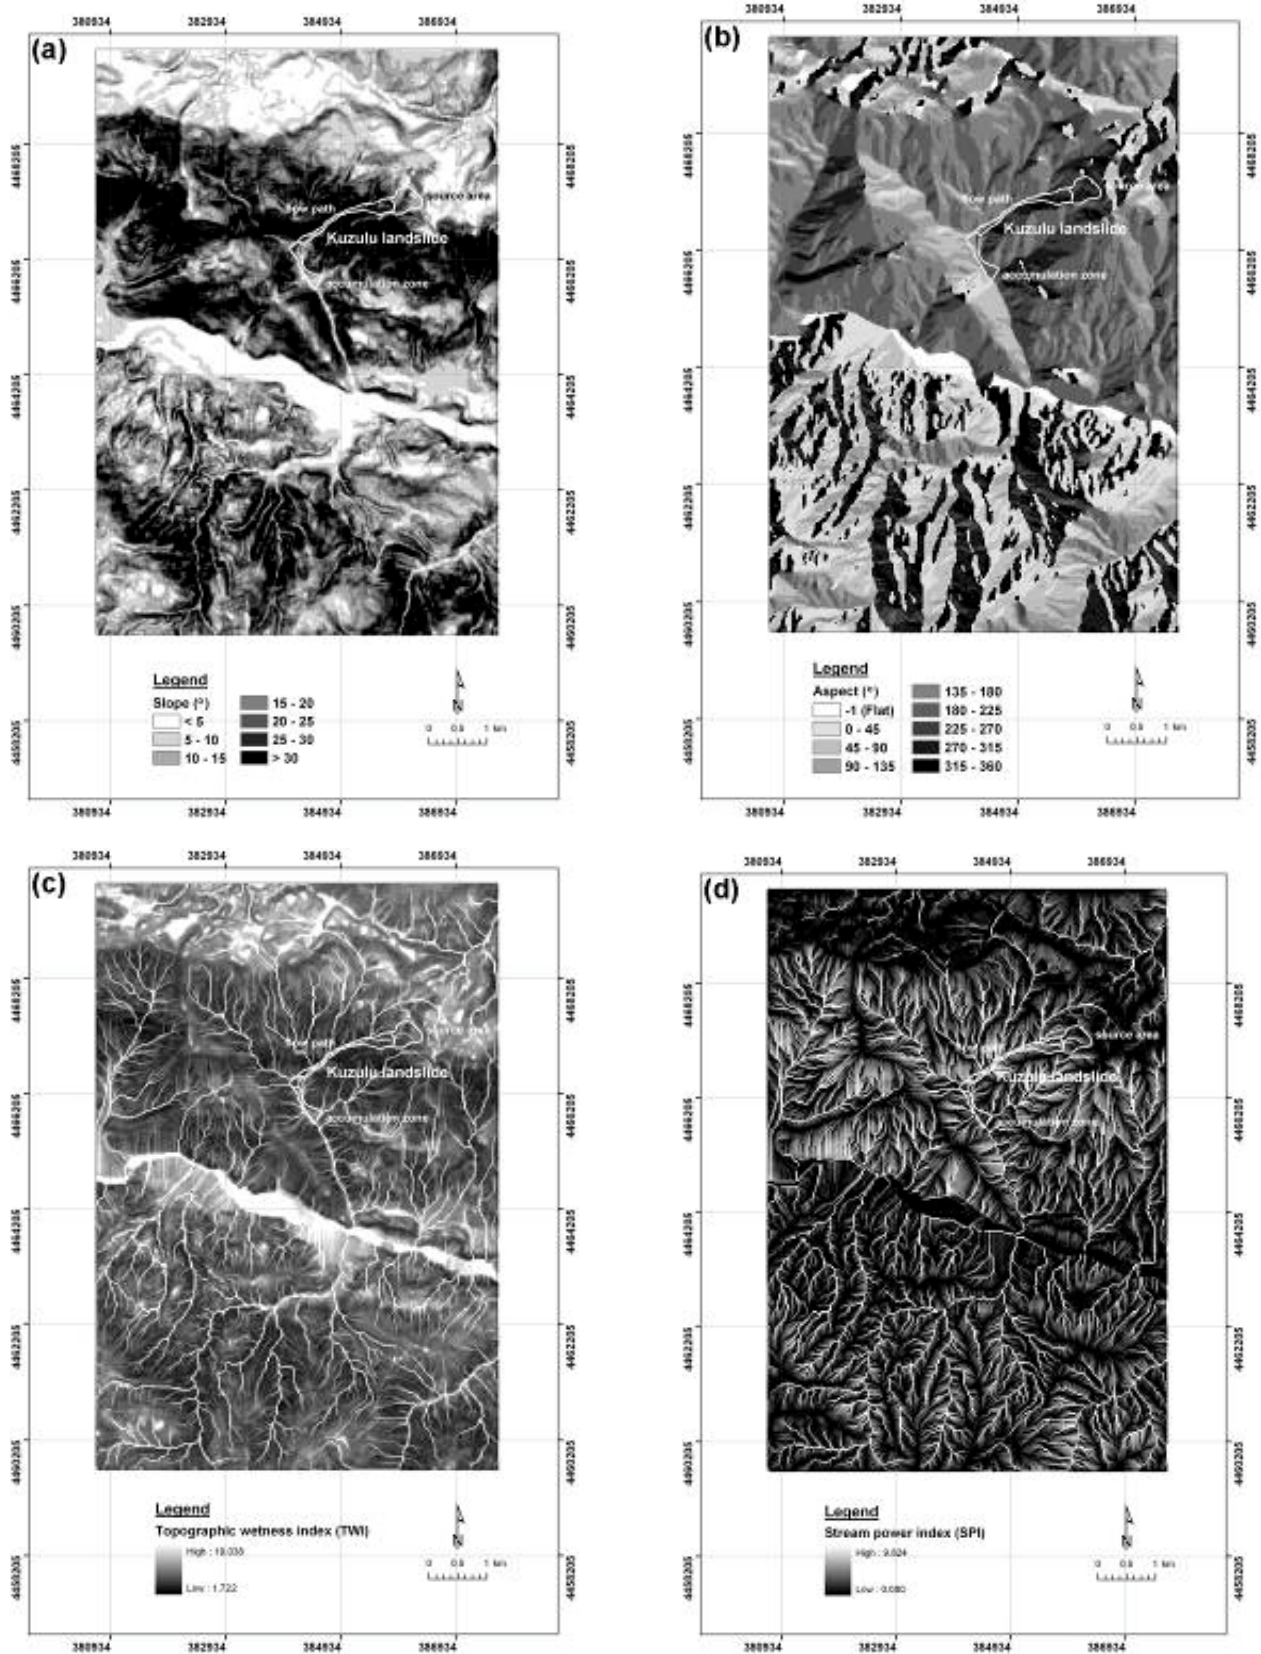
Some thematic DEM derivative maps such as slope, aspect, topographic-wetness index and stream-power index maps have been produced for evaluation of the morphological characteristics of the landslide area. In the area, the surface elevation varies between 580 and 1830 m. Depending on the high variation in the elevations, the slope values are also high (Figure 2a). In the area, the slope ranges from between 0-64 degrees. However, in the zone of paleolandslides where the Kuzulu landslide occurred, the slope are about 20 degrees, while that of the transportation channel is extremely high, over 35 degrees. Depending on the North Anatolian Fault Zone, the main physiographic trend of the area is approximately east-west (Figure 2b). However, the aspect of the slope with the Kuzulu landslide varies from northwest to southwest.

Primary topographical attributes such as slope and aspect are calculated from the directional derivatives of a topographic surface (Wilson and Gallant, 2000). The secondary topographical attributes are computed from two or more primary attributes. According to Wilson and Gallant (2000), the majority of these secondary attributes comes from describing patterns as a function of process. In this study, two well-known secondary topographical attributes are considered. One of them that is topographic-wetness index (TWI) (Moore et al., 1991) has been used extensively to describe the effect of topography on the location and size of saturated source areas of runoff generation. The topographic-wetness index map of the landslide area is produced in Figure 2c. When observing Figure 2c, the topographic-wetness index values are higher around the Kelkit River bed and the paleolandslide area than in other parts of the area. This is based on the fact that the paleolandslide area, located in the northern part of the study area, includes numerous surface depressions, and these depressions prevent surface runoff, allowing infiltration of surface water from various sources, such as rainfall and snowmelt. This finding is supported by field observations. Especially, many springs exist at lower elevations. Infiltration of water to slope-forming material results in increased pore-water pressure in the material and to decrease in its shear strength. The other topographical index parameter, stream power index (SPI) is important because the earth-flow part of the Kuzulu landslide run out more than 1800 m. This long run out distance can be explained two ways: viscosity of the material and steepness of the topography. The stream-power index map of the study area is given in Figure 2d. The stream-power index values for the secondary channels of Agnus Creek are very high, approximately 9. This shows that these channels have a high potential for earth-flows with high velocities.

**Figure 2.** Slope map (a), aspect map (b), topographic wetness index (TWI) map (c), and stream power index (SPI) map (d) of the study area.

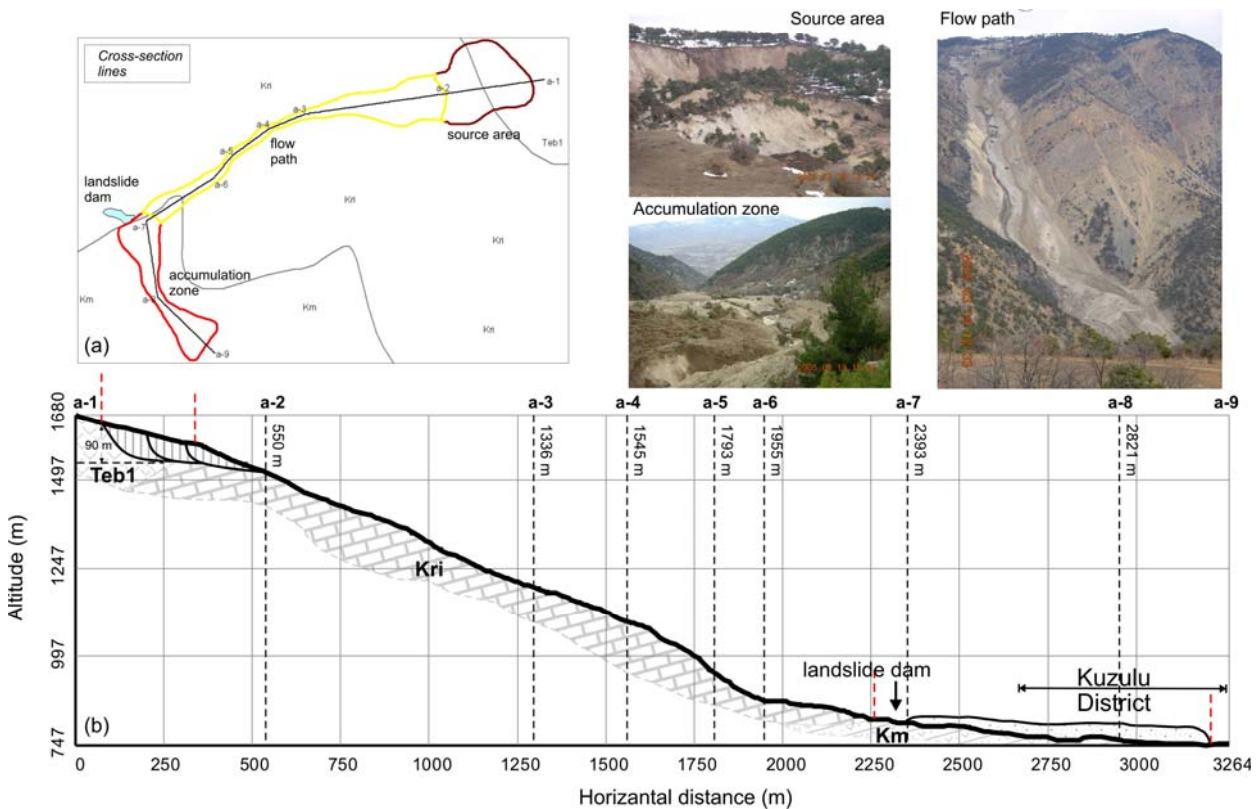
On March 17, 2005, the Kuzulu landslide, in the thick regolith zone of the volcanic units, was triggered by snowmelt without any precursor. The initial failure of the Kuzulu landslide was rotational. Following the rotational failure, the earth material in the zone of accumulation was transformed into an extremely rapid flow caused by steep

topography and high water content. The Agnus Creek valley, where Kuzulu village is located, was filled by the earth-flow and a landslide dam having a surface area of 6900 m<sup>2</sup> and a depth of 30 m was formed on the headwater of Agnus Creek (Figure 3). The distance from the toe of the rotational failure down to the toe of the earth flow was more than 1800 m, with about 12.5 million m<sup>3</sup> of displaced earth material. The velocity of the earth-flow part of the Kuzulu landslide was extremely fast, approximately 6 m/sec. Fifteen villagers were buried under the displaced material, because of its extremely high velocity. This was the most important impact of the Kuzulu landslide. In addition, thirty-four houses (Figure 4) and a mosque were demolished, and an important agricultural area was destroyed. As mentioned above, the main failure was located in a large paleolandslide area and in the regolith zone of the volcanic units. Because of the geology, the depth of maximum failure surface was about 100 m (see Figure 3). For this reason, the forest cover did not have a positive effect on the stability. Due to the landslide, an important forest cover having an area of 4.7 ha was completely destroyed. Agnus Creek discharges into Kelkit River, one of the more important rivers of Turkey. During a 4 day period, approximately 5 million m<sup>3</sup> of earth material was transported to the Kelkit River by Agnus Creek. This material caused a decrease in water quality of the Kelkit River and an increase in its sediment load. Considering the field observations, retrogressive landslide activity is expected; thus, other parts of Kuzulu village are under threat of future landslide activity. Although the distance between the main failure and Kuzulu village was approximately 2 km, the earth-flow reached the village. In fact, prediction of runout distances of earth-flows is very difficult, although many hypotheses have been presented to predict runout. Some detailed empirical calculation on runout distance of the Kuzulu landslide was given by Gokceoglu et al. (2005a and 2005b).

**Figure 3.** Plan view (a) and cross-section (b) showing the mechanism of the landslide, and photos (c) from source area, flow path and accumulation zone of Kuzulu landslide (Gokceoglu et al., 2005a).

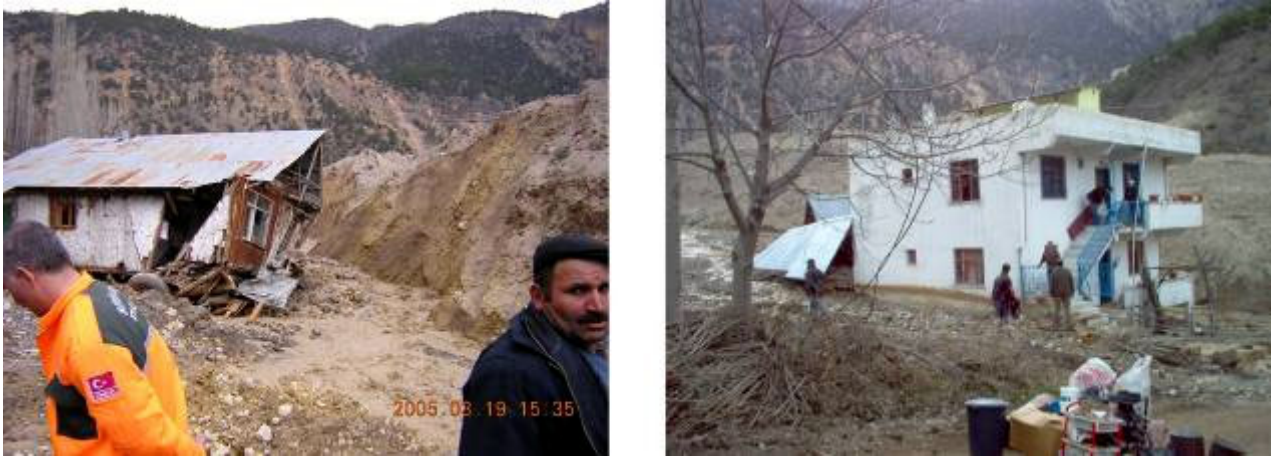
Figure 4. Damaged houses.

During the Kuzulu landslide, all negative impacts of landslides on the environment occurred. 15 people (villagers) were buried under the displaced material, because of extremely speed velocity, approximately 6 m/s. This is the most important impact of the Kuzulu landslide. A total of 34 houses and 1 mosque were demolished, completely, and an important farming area was destroyed. Due to the landslide, an important forest cover an area of 47000 m<sup>2</sup> was completely destroyed.
