# Flooding of the Prague metro during the August 2002 floods

SVATOSLAV CHAMRA<sup>1</sup>

**Abstract:** In August 2002, Southern Bohemia was affected by extremely heavy rainfall, which lasted for two weeks. Because of two flood tides, the storage capacity of the drainage area and the capacity of the system of the dams were exceeded.

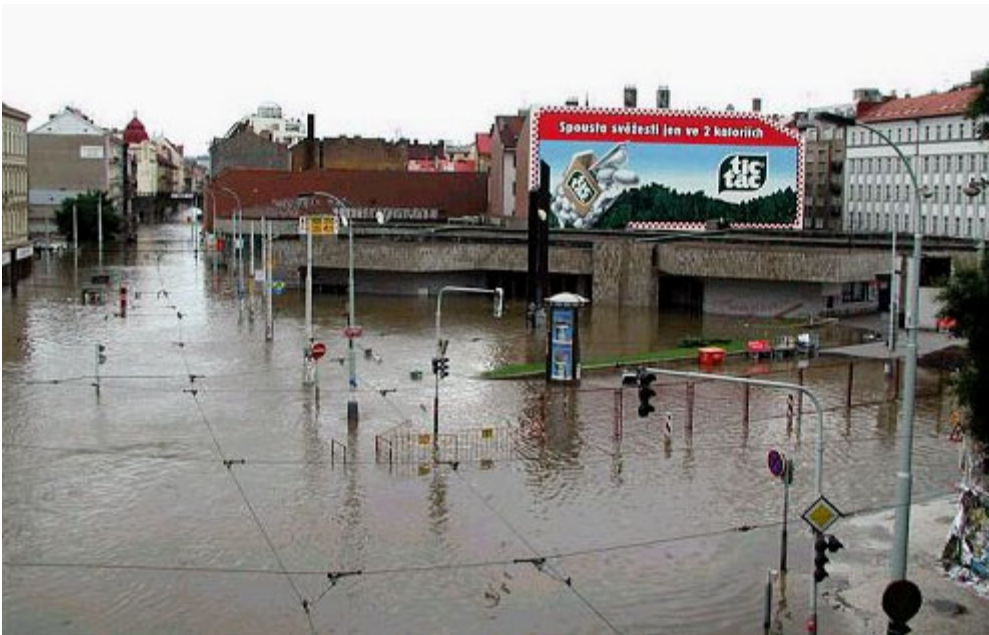
At that time, the Metro had 53 stations in all, of which 19 were completely flooded (Figures 7, 8, 9). The total volume of water in the stations and tunnels was estimated at about 1.2 mil. m<sup>3</sup>.

**Figure 7.** Flooded Florenc Metro Station

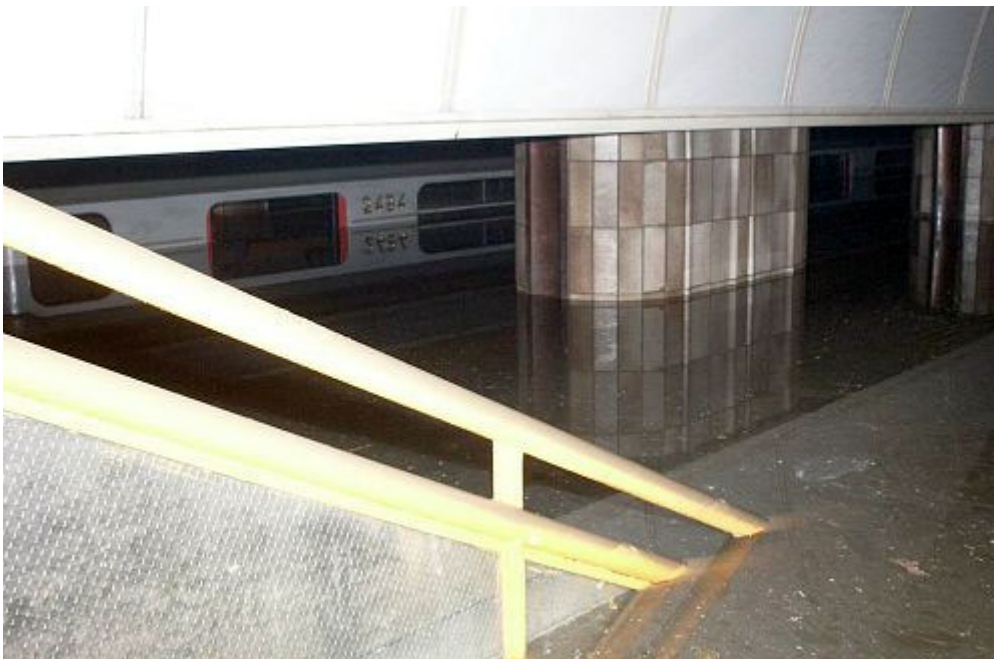
**Figure 8.** Submerged metro train in Florenc Station

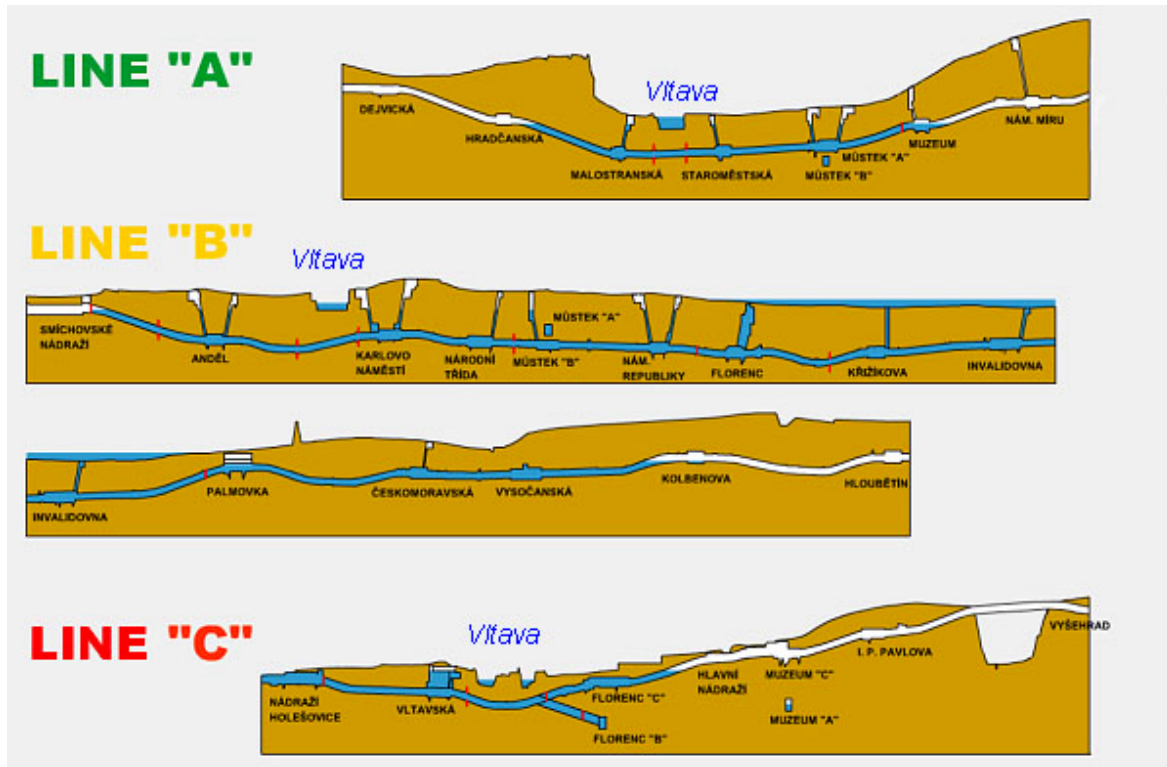
Figure 9. Flooded stations and tunnels of Prague metro

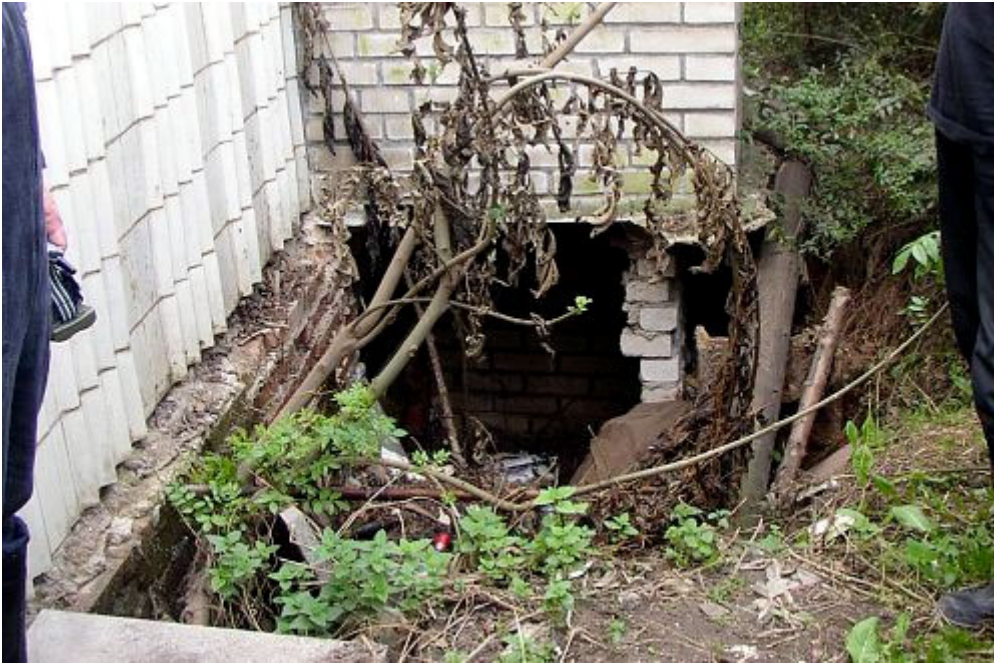
**Figure 10.** Damaged ventilation shaft near Invalidovna Station

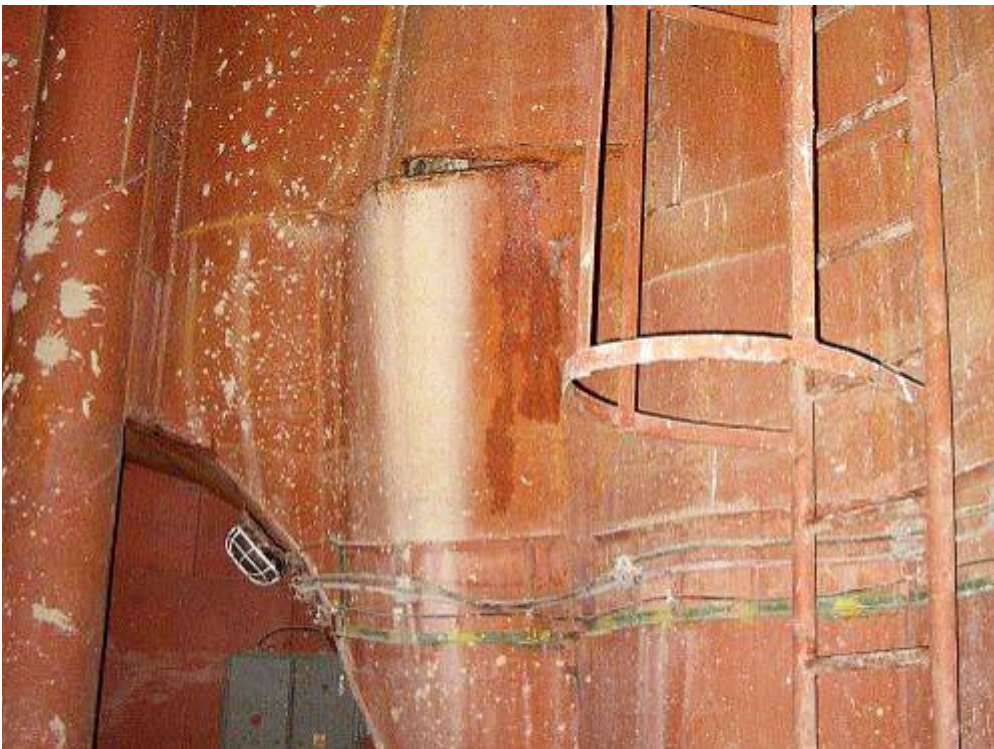
- **a minor point of water penetration** into line tunnels was faulty steel insulation of ventilation shafts in Křižíkova and Štvanice Stations (Figure 11).

**Figure 11.** Faulty steel insulation of ventilation shaft in Štvanice

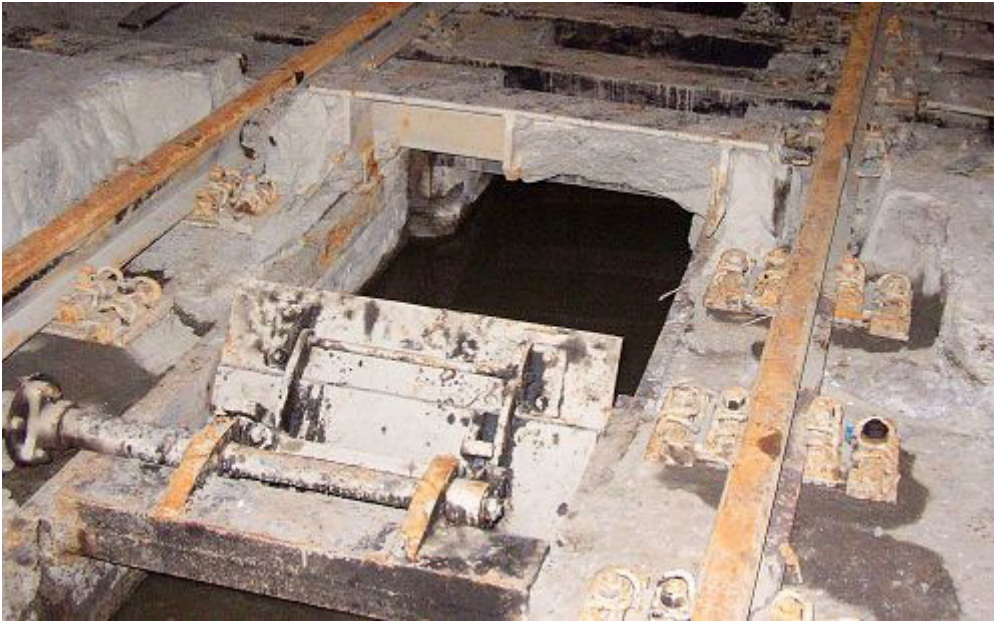
- destruction of a pressure plug of the air-conditioning chamber between line tunnels in Invalidovna Station, which showed workmanship defects
- pulled out concrete block in the pressure divide between Florenc B – Národní Republiky Stations (Figure 12), damaged (lifted) concrete sills in pressure divides of both tunnels between stations Florenc C – Vltavská Stations

All these defects were caused by a serious lack of performance discipline, and their poor workmanship quality is in contradiction with both the project drawings and the set of record drawings.

Figure 12. Pulled out concrete block in pressure divide

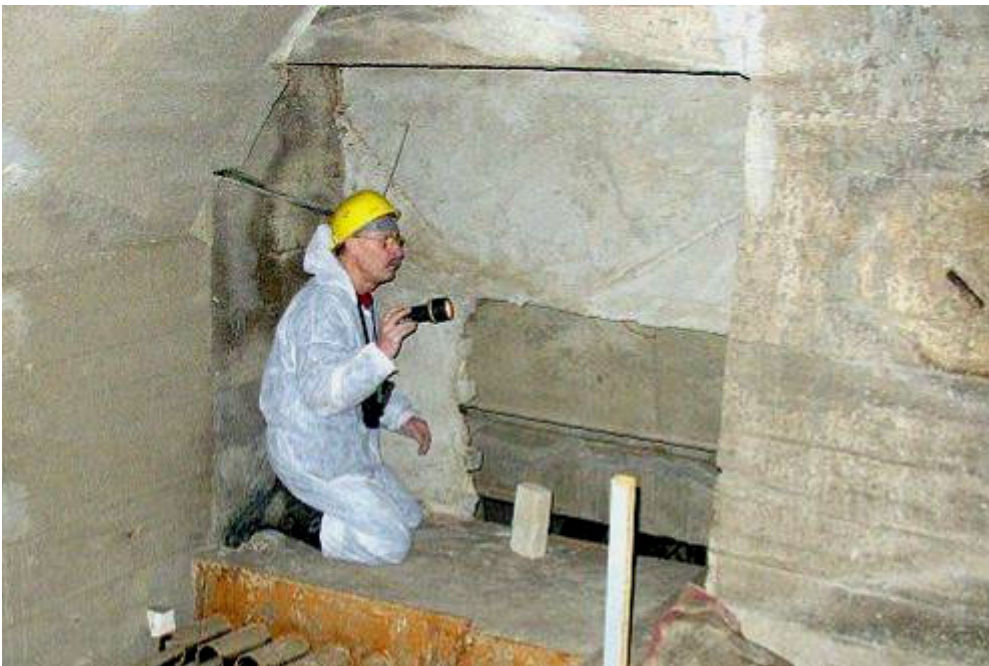
- broken cross member in the cable gallery between line B and A in M stek Station (Figure 13). According to the project there should have been a reinforced concrete pressure divide instead.

Figure 13. Cable gallery between lines B and A in Mustek Station

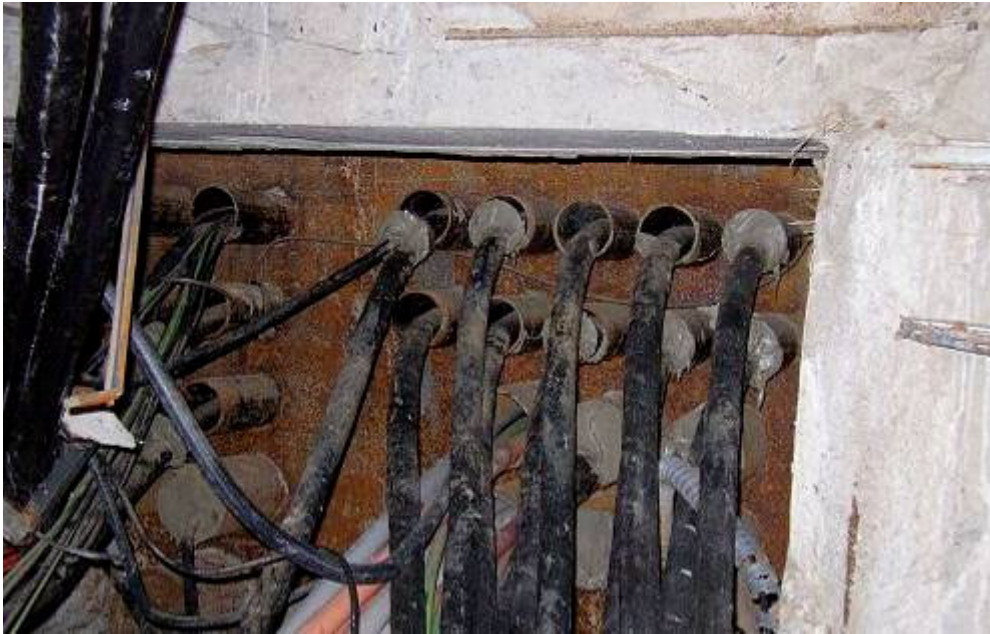
- unsealed cable grommets (Figure 14) were the major cause of flood wave propagation in the underground – its share in flooding the Metro system was estimated at more than 44 % .

The significance of watertight sealing in cable grommets may be best understood by the following example: the amount of water passing through one unsealed (empty) cable grommet with a diameter of 100 mm under a given hydrostatic pressure (20-30 m of water head) equals approximately **125 – 150 l/sec**, so that this single grommet could fill up the volume of 1 linear metre of a line tunnel (ø 5.10 m) **in approximately 2.2 to 2.7 minutes!**

**Figure 14.** Unsealed cable grommets
