Engineering geological mapping in Pietermaritzburg, South Africa: Constraints on development

NICK P. RICHARDS¹, G.A. BOTHA¹, P. SCHOEMAN, B.M. CLARKE,
M.W. KOTA & F.N. NGCOBO

¹ Council for Geoscience, South Africa. (e-mail: gabotha@mweb.co.za)

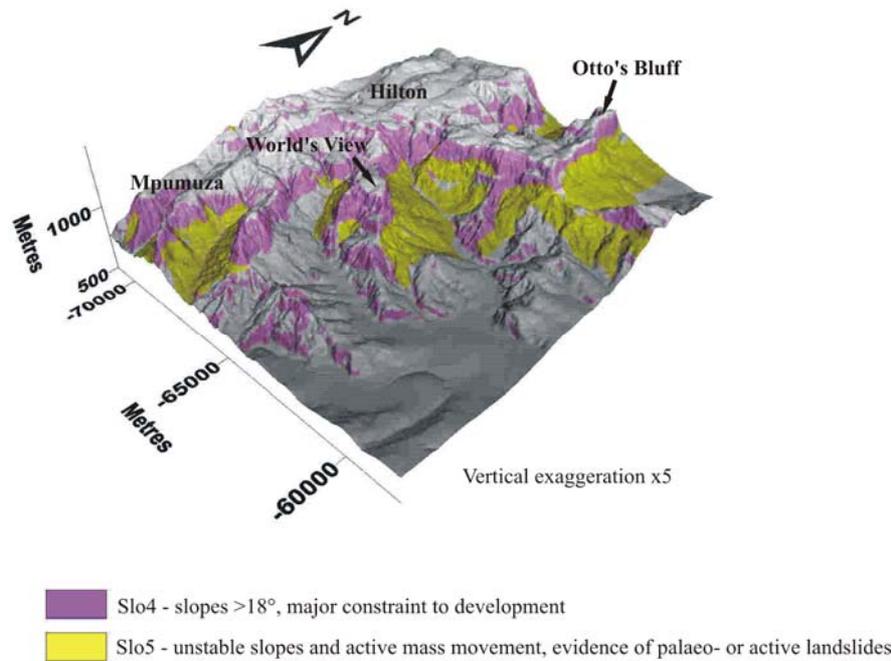
The hummocky topography around the World's View to Otto's Bluff escarpments and the Mpumuza area is underlain by ancient landslide debris which is potentially erodible and unstable (Figure 3). There are many instability features associated with the colluvial hill slope deposits. Donga erosion has reached an advanced stage in many areas and head-cut, donga extension has incised colluvial hollows concealed beneath the land surface. A noticeable feature of many of the colluvium-mantled slopes beneath the Vryheid Formation escarpments in the north and northwest portions of the mapping area is the hummocky surface topography and micro-relief. As equilibrium conditions within hill slopes change as a result of incision by gullies, climatic change or human disturbance, mass wasting adjustments occur in the form of creep movements, debris slides and slumps.

Figure 3. Digital elevation model (DEM) of the northwest portion of the Pietermaritzburg area showing areas mapped as Slo4 and Slo5.

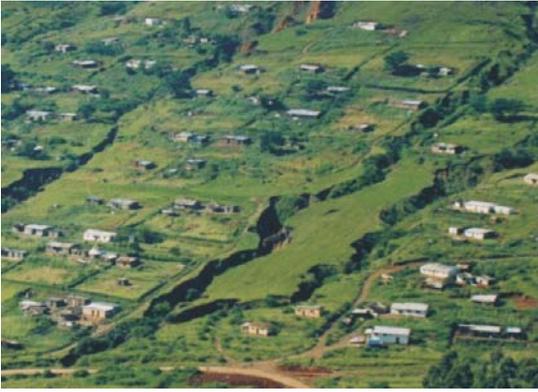
The thick colluvial deposits found on slopes underlain by shale and dolerite bedrock in areas southwest of Pietermaritzburg, including Edendale and Sinathing are particularly erodible where rapid donga expansion and headward cutting is compounded by sidewall failure (Figure 4). Lateral growth of the donga is limited by the rising bedrock sidewalls, which define the palaeo-bedrock hollows which were infilled by erodible colluvium. Although the cohesive, reddish-brown soil formed within dolerite-derived colluvium commonly has a moderate blocky structure and is not particularly erodible, loss of material through sidewall failure results in movement of material. Where active soils are present in areas that surround a donga, the likelihood of donga advance is increased due to the higher erosive potential in the structured soils. By contrast, grey stratified colluvium exposed in some dongas is potentially dispersive as well as highly erodible. Over much of the Edendale area donga erosion is triggered by storm water discharge from roads. Erosion is often exacerbated with the introduction of piped culverts. Erosion of structured soils and fill material around culverts is locally common in the Edendale area.

Figure 4. Deep donga incision (up to 18m deep) of colluvial slopes in the Sinathing area and close proximity of informal houses to collapsing donga sidewalls.
