Implications of urban development on escarpment instability

B I THOMAS¹, H T BROCKLEBANK² & C POWER³

Abstract: The town of Penarth, South Wales, owes its development to major industrial expansion experienced during the 19th Century. Penarth Dock was constructed at the foot of a 30m high escarpment between 1859 and 1865 primarily to assist Cardiff in receiving coal mined in South Wales via railway for transshipment abroad for export. In addition to this, quarrying of limestone from the escarpment for use in cement manufacture was also commonplace. During the late twentieth century, and after many years of neglect, redevelopment work commenced at Penarth Dock. The docks area was partially infilled and the rail tracks and sidings removed. A marina with high quality residential and commercial buildings was constructed in its place. This redevelopment has brought about the need for car parking and a boatyard in close proximity to cliffs of marginal stability in areas of enhanced public access. The escarpment, which comprises sediments of the Mercia Mudstone Group overlain by deposits of the Penarth Group, has suffered a number of slope failures and rockfalls over recent years; the mos

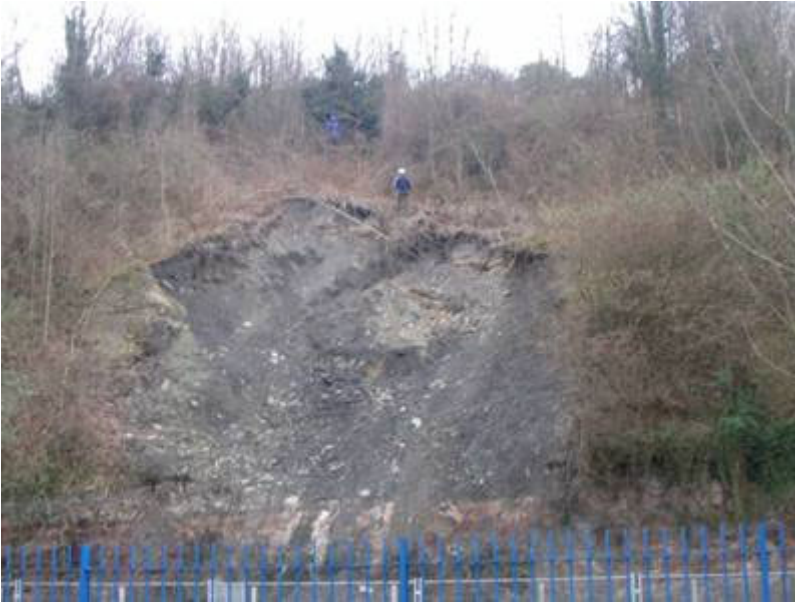
Figure 1. 2004 Slope Failure at Penarth Escarpment

Following the 2004 failure, fallen slope debris material collected behind an existing chain-link fence located along the length of the car park/boat yard. During investigation of the slope failure, water was observed discharging from the base of the failure plane and the slope toe drain was seen to be intermittently blocked with debris. Scouring of the slope failure scar from surface water was also evident.

At the location of the 2004 slope failure a distinct change in the colour of the beds of the exposed sediments was evident. The extent of the slope failure can be seen in Figure 1.

At the base of the escarpment there are alternating red and greenish-blue beds of the Blue Anchor Formation exposed in a near vertical face approximately 6m high from car park level. Above this horizon the shales of the Westbury Formation are exposed in a slope of approximately 50° to the horizontal. Thus the change in colour and slope angle is coincident with the stratigraphic change from the Blue Anchor Formation to the Westbury Formation and correlates precisely with the results of published mapping. At the crest of the escarpment it is believed that limestones of the St Mary's Well Bay Formation (Lower Lias Group) are present. It is known that this limestone was extensively quarried at the end of the 19th Century and the early part of the 20th Century for use in cement manufacture (Lawrence & Waters, 1987) and thus exposures would be difficult to examine due to disturbance by man's activity.

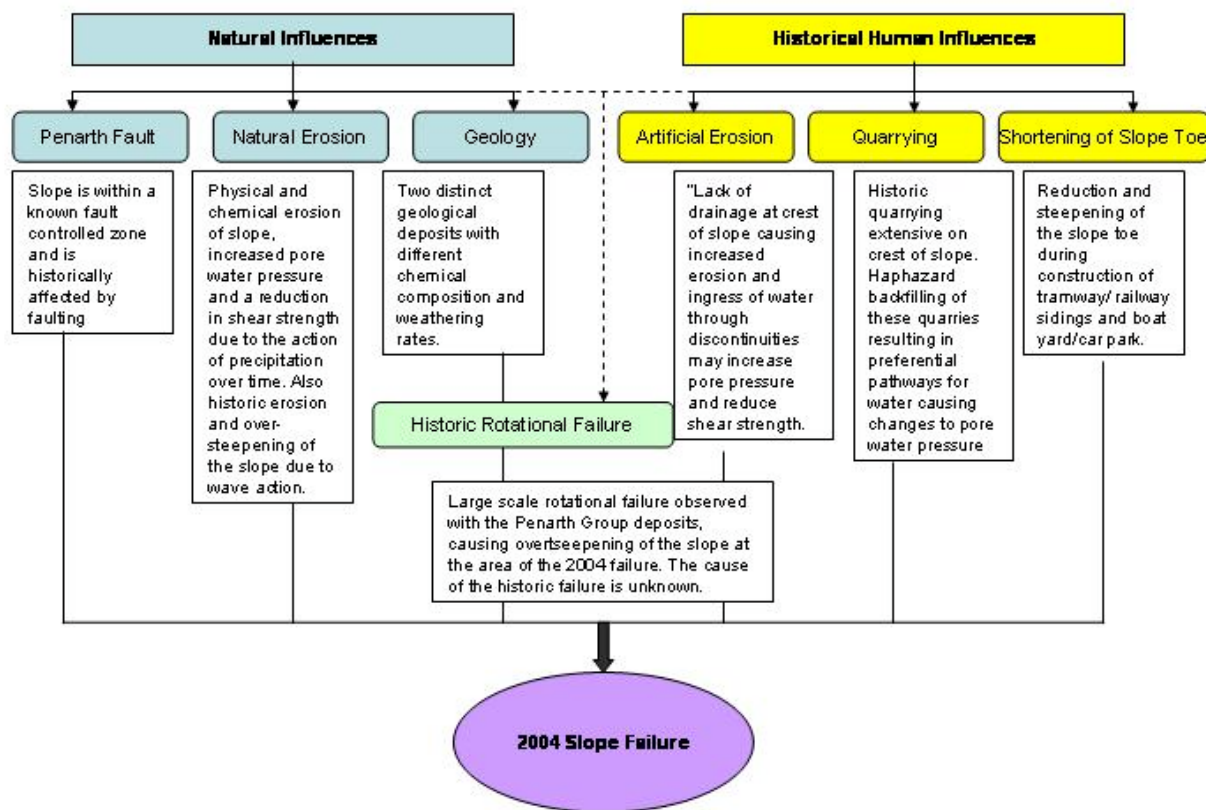
Figure 2. Factors Influencing the 2004 Slope Failure on Penarth Escarpment

- differing rates of weathering for differing lithological units within the Westbury Formation resulting in the exposure of thin competent beds of mudstone,
- structural influences originating from the east-to-west-trending wrench fault (Penarth Fault),
- sea erosion processes,
- natural surface erosion from precipitation and surface water runoff,
- changes in pore pressures associated with complex groundwater conditions.

The artificial steepening of the escarpment was especially likely to have occurred at the slope toe for the construction of the rail sidings used to serve the Penarth Docks. This would have undercut the escarpment resulting in a steepened slope gradient. Haphazard infill of former quarries at the crest of the slope, as observed during the ground investigation, may have raised the natural ground surface profile at the crest of the escarpment. Both influences tend to destabilise the slope. Backfilling of disused quarries could have altered the groundwater regime at the crest, as suggested by the perched groundwater noted at this level. Surface water ponding and runoff across the escarpment, possibly associated with the location of the backfilled quarries, could result in water ingress along preferential pathways, increasing pore water pressures within the slope.

A combination of natural and historical human influences affecting Penarth Escarpment has contributed to the 2004 slope failure. However, the historical rotational failure, the back scarp of which was noted immediately upslope of the 2004 failure, has undoubtedly influenced the stability of the escarpment in this area, and is very likely to have had a significant influence on the 2004 slope failure. The position of this older failure may be related to geological faulting (the Penarth Fault) and its occurrence may also have been affected by human activities such as changes in slope geometry from steepening of the slope during the construction of the rail sidings at the toe of the slope. Rotated blocks and beds of the subordinate competent mudstone observed within the 2004 failure scar during the roped access surveys, confirm that the recent failure is simply a small section of a much larger historic failure. Figure 2 summarises the main factors influencing the failure.

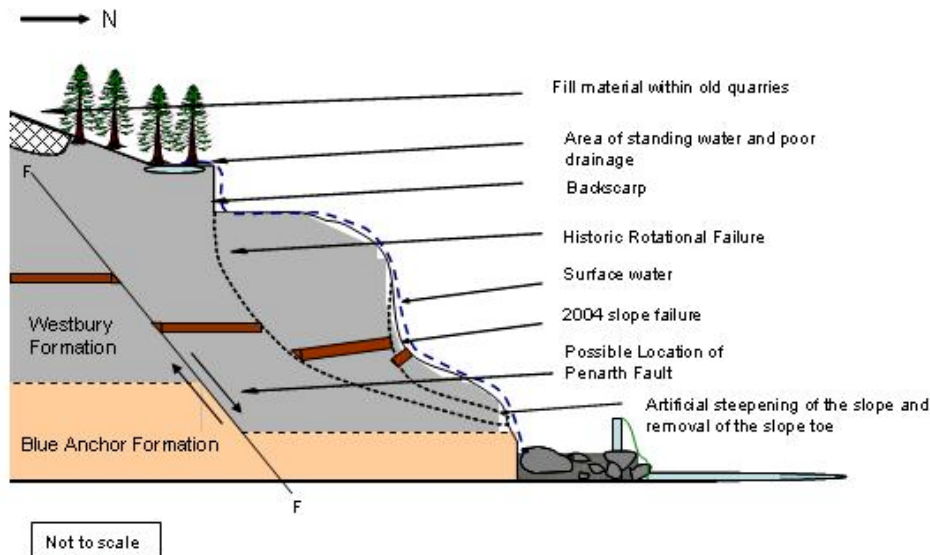
Figure 3. Simplified Explanation of the 2004 Slope Failure

A simplified sketch explanation of the slope failure is given in Figure 3 and clearly shows that the 2004 slope failure at Penarth Escarpment resulted from a combination of natural influence and human influence, as well as the position of an older, pre-existing slope failure.
