A study of monitoring, early warning and control engineering for the Danba landslide, China

Abstract: The Danba landslide is located at the rear of Danba town in Sichuan. It is approximately 270 m long and 200 m wide. The average thickness of the slide body is about 30 m. Its capacity is about 2 million m³. The slide originated from an ancient giant one, which was reactivated by excavation for the construction of the town at the foot of the slide. From October 2004, apparent deforming phenomena of the slide occurred. The monitoring results indicated that the deformation had speeded up since the middle of February 2005; the average displacement was about 2-3cm per day and the maximum was near to 5 cm. At the same time the sharp deformation made a long pulled fissure, about 1 m wide, which appeared at the rear of the slide, while the bilateral sheared fissures and the swelled ones in front were becoming apparent. Fissures on the surface almost connected with each other and had the trend to glide entirely. If the landslide moved forward as a whole, more than half of the Danba town would become a dangerous area. About 4600 civilians had been forced to retreat from the unsafe area.

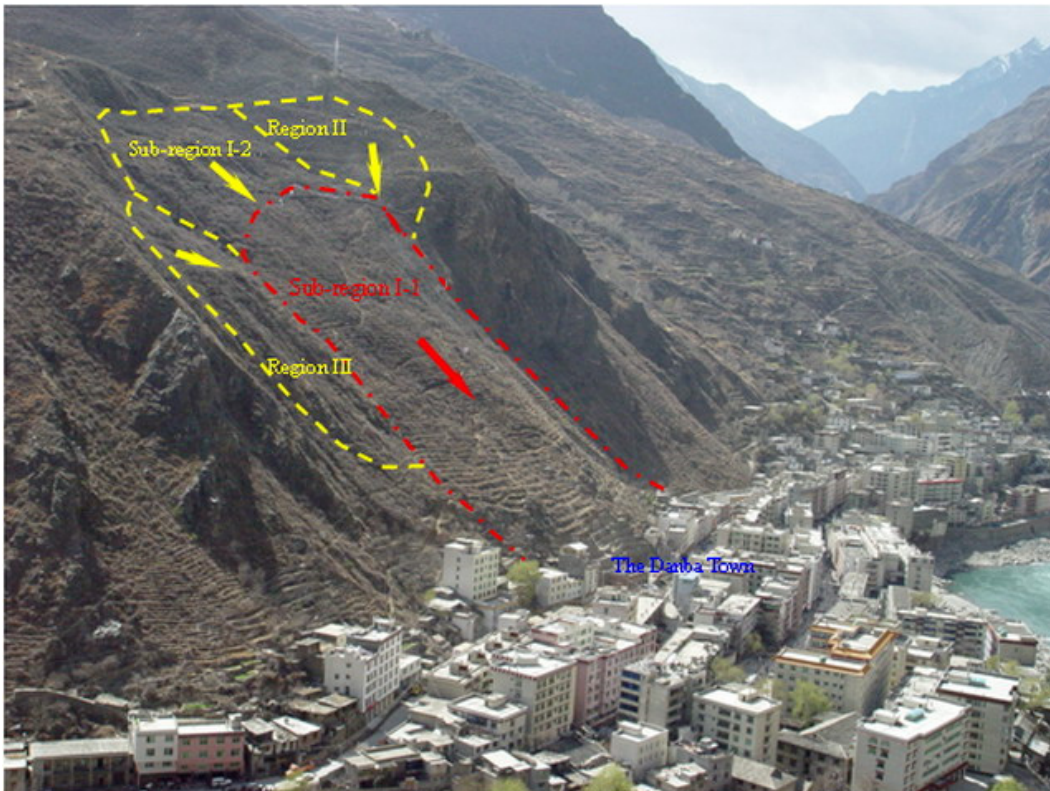
The plan view of the landslide is collar chair-like. Its altitude varies from 1881m to 2110m and the difference in elevation between the front and the rear is 223m. The rear of landslide lies in the front of the second terrace of Baiga Mountain. The toe of the landslide is next to the Jianshe Street. The border of the landslide is extremely obvious. After the foot of the landslide was excavated, a 6m-28m high dry rubble retaining wall was built in the front of the slide. The slope angle of the wall is 56° - 65° . The slope of the rear landslide is gentle, in the order of about 10° . The average slope angle of the middle is 31° . The landslide is a catastrophic accumulation formation slide. It is 200-250m wide, 290m long and about 30m thick. The area and the volume are approximately 0.08 km^2 and 2.2 million m^3 , respectively. (Figure 1)

Figure 1. The Danba town and the Danba landslide

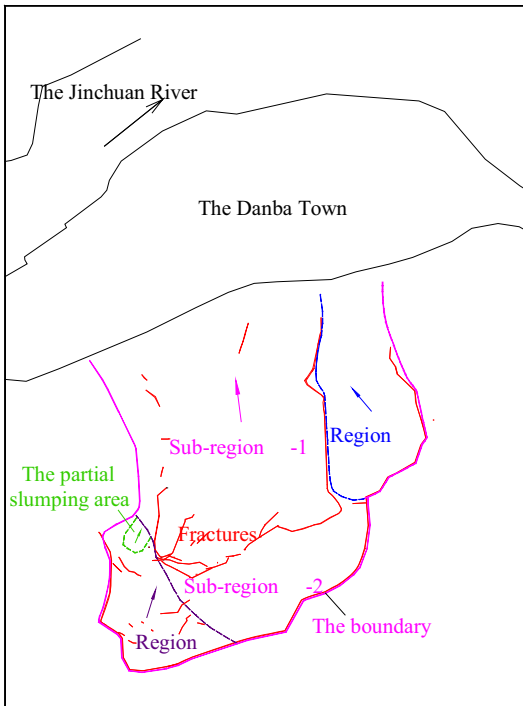
According to the developing process of the landslide deformation, the mechanism of formation and the character of the displacement, the landslide can be divided into three regions: the main body (Region I), the drag region in the left rear (Region II) and the one in the right rear (Region III), which are shown in Figure 1 and Figure2.

Figure 2. The Region-divided plane graph and fracture pattern

Because both sides of the slope in the rear of sub-region I-1 are relative steep, since early March the left rear (region II) and the right rear (region III) began to move integrally by the draw of region I-1, while many fractures came out and connected. By the influence of landform, the glide orientations of the region II and III were drawn towards region I (Figure 1).

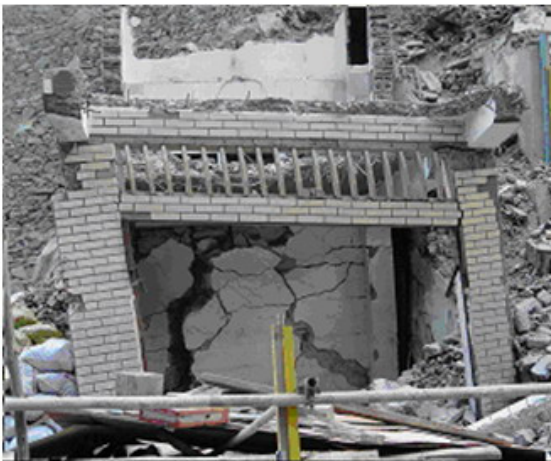
Figure 3. The destroyed houses in the leading edge of the landslide

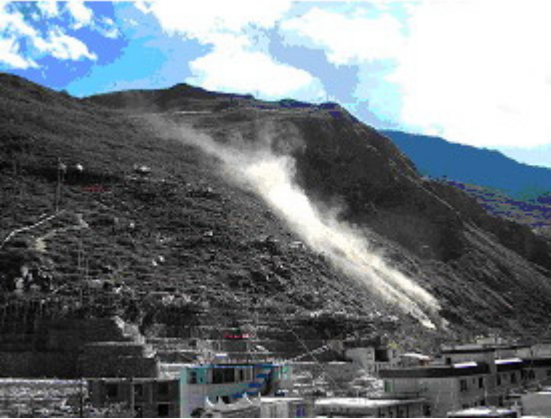
According to the geological survey and the exploration results, the shape of region II is an irregular hemicycle in plan. Its area is about 6000 m², thickness is approximately 15-20m and the volume is about 150,000 m³. The posterior edge of region II had a large number of tensile fractures and faulted terraces. In addition, influenced by the steep landform (the slope angle is 50°-80°), small scale slumps often happened in the left front of region II. For example, the total volume of slumps happened on 9 and 14 March totalled 100m³. At 2:00 pm 14 March, about 600m³ soil and stones fell and rolled down rapidly (Figure 4). A boulder greater than 1m³ fell down from over 200m height. The pre-stressed anchor rope machines and houses at the foot of the slope were destroyed seriously by the rockfall (Figure 5). Fortunately, the constant monitoring forecast the accident in time, so it caused no casualties. But after the accident, a huge boulder, approximately 5m height, was found in the slumping area, which seems like a sword of Damocles hung over the Danba city. The lives and assets of the Danba civilians were in a great danger. It was moved by blasting, and any danger was alleviated.

Figure 4. The partial slump in Region II on 14 March 2005

In the process of the engineering work, the displacement of region II was always large. Slumps in the left front of region II were serious as narrated before. In order to make the region II stable as soon as possible and allow the people in dangerous areas remove back to their houses, 2 rows with 40 bundles of anchor ropes were constructed in the centre and upper part of region II. After soil and stones in the slumping area were cleared, anchor rods and concrete injection engineering were constructed to reinforce region II.

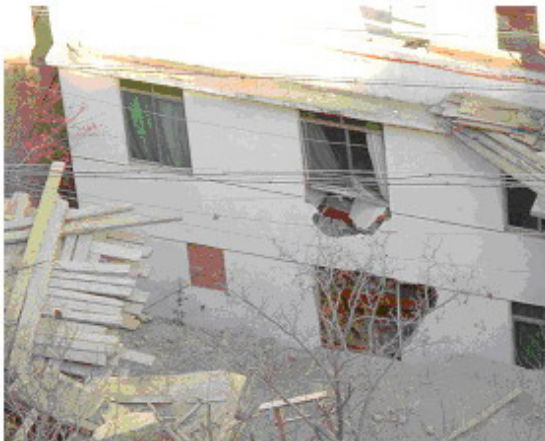
Figure 5. The houses destroyed by the partial slumps in Region II at the foot of the landslide

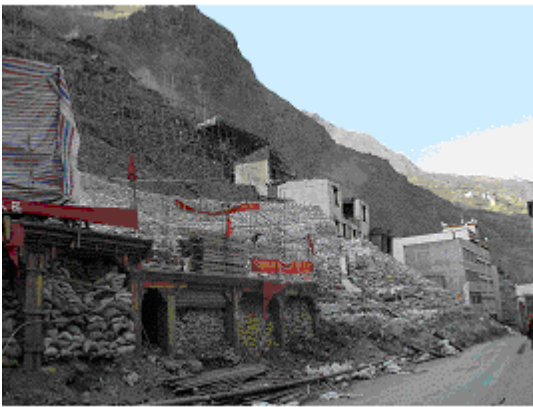
Figure 6. The sand bags piling engineering in the leading edge of the landslide

- The aim of the remedial engineering is to stop the movement of the landslide. According to experts' advice, the engineering work could be divided into two parts: firstly, in order to reduce the sliding velocity, sand bags were piled up in the leading edge of the landslide. With this mission, we can save time for the construction of active reinforcement project (the construction of the pre-stressed anchor rope); secondly, the pre-stressed anchor ropes were constructed to reinforce the landslide actively in the centre and anterior part of the landslide. 300 army soldiers and 1000 militiamen and citizens began to pile sand bags in turns by round-the-clock work from 20th February to the end of February. Finally the capacity of the sand bags had reached to 7170m³(Figure 6). 6 rows with 244 bundles of pre-stressed anchor ropes were arranged in the centre and anterior part of the main body (sub-region I-1). The average depth of the rope holes is 40- 50m and the level interval is 4m. These pre-stressed anchor ropes were connected by cross beams. One pre-stressed anchor rope was made of 9 non-cohesive steel strands whose diameter is 15.24mm. The designed pre-stressing force applied to the anchor ropes is 1300KN. The first anchor rope in region I was stressed on 15 March. At the end of April, the construction of pre-stressed anchor ropes in region I was accomplished.

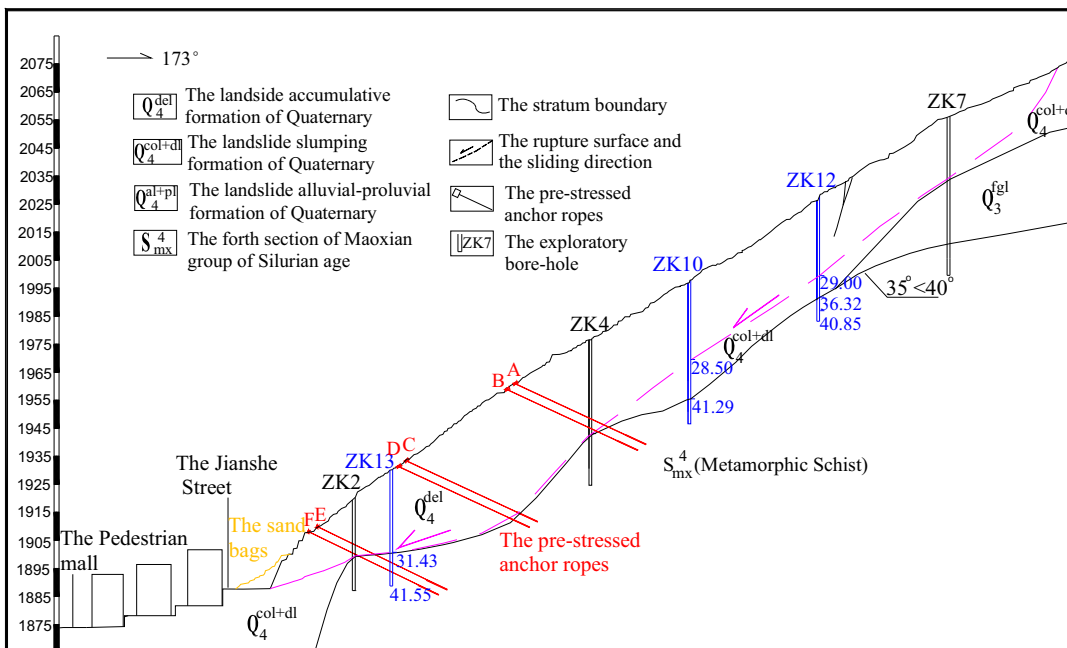
In order to grasp dynamic development of the landslide deformation, at the same time to help to make decisions to guide people to evacuate as well as to guide the urgently wrecking engineering, the pre-warning of the slide was carried out by round-the-clock monitoring. Since 21 January 2005, 46 professional monitoring points and 26 artificial monitoring points were placed in the landslide to monitor the deformation. Meanwhile there were certain patrol people to investigate the fractures on the landslide. In addition, in order to grasp the deep deformations of the slide and to find out the definitive embedded depth of the rupture surface, 3 deep deformation monitoring holes were set following the axle wire of the main body in the middle and later periods of the engineering work (ZK13•ZK10 and ZK13 in Figure 7). A clinograph was adopted to monitor the deep deformation.

Figure 7. The sectional arrangement plan of the urgently wrecking engineering

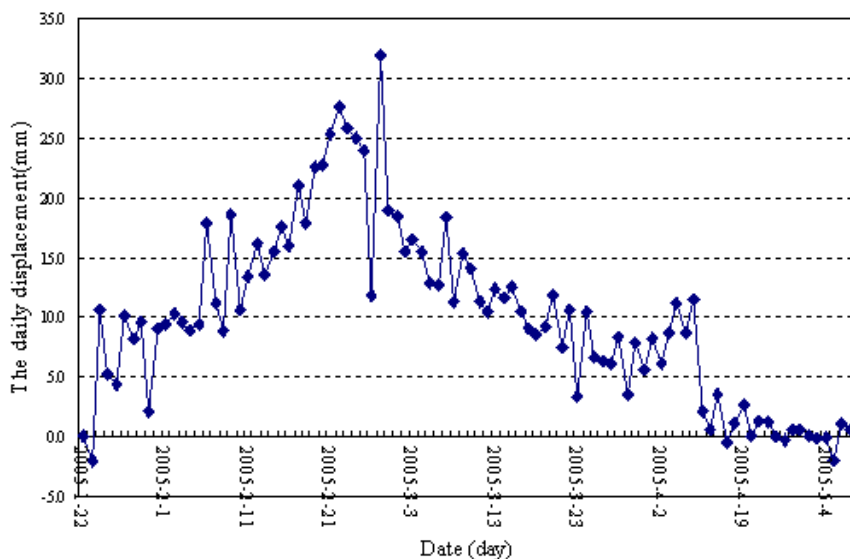
Figure 8 and Figure 9 show the deforming velocity curve of the 2# monitoring point in the front of the principal section and the 9# point in the rear of it, respectively. The accumulating displacement curve of 9# point is shown in Figure 10. It can be seen from Figure 8 that from 6 February 2005, the front of the main body appeared to show the tendency of accelerative deformation and on 22 February the maximum deformation per day had reached 27.6mm. Once sand bags were piled form 22 February, the deformation per day tended to reduce (due to the disturbance of piling sand bags, sharp fluctuations happened on 26 February and 27 February). Figure 9 indicates that the rear of the

Figure 8. The deforming velocity curve of the 2# monitoring point in the front of the principal section in region I

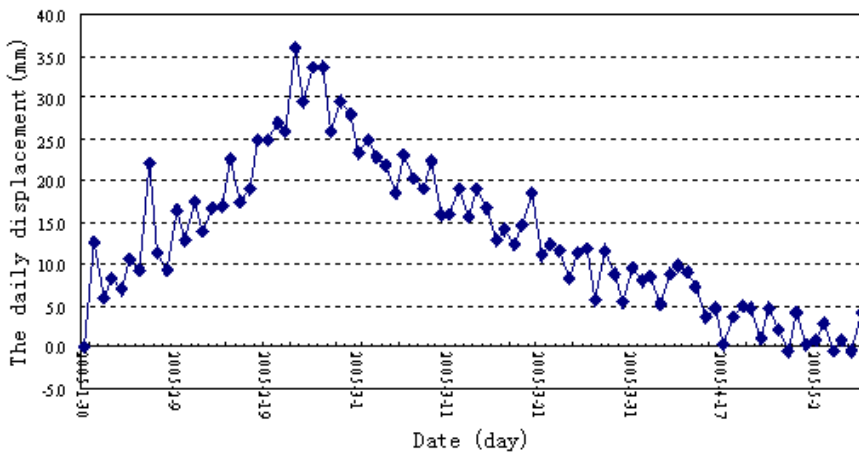
main slide body also had the accelerative deforming tendency, beginning from 6 February. The maximum deformation on 22 February came up to 30.3mm, then the deformation velocity began to reduce gradually. As seen from Figure 8 to Figure 10, the sand bags piling engineering had a very obvious effect on reducing the deforming velocity so it earned enough time to construct the pre-stressed anchor ropes.

Figure 9. The deforming velocity curve of the 9# monitoring point in the rear of the principal section in region I

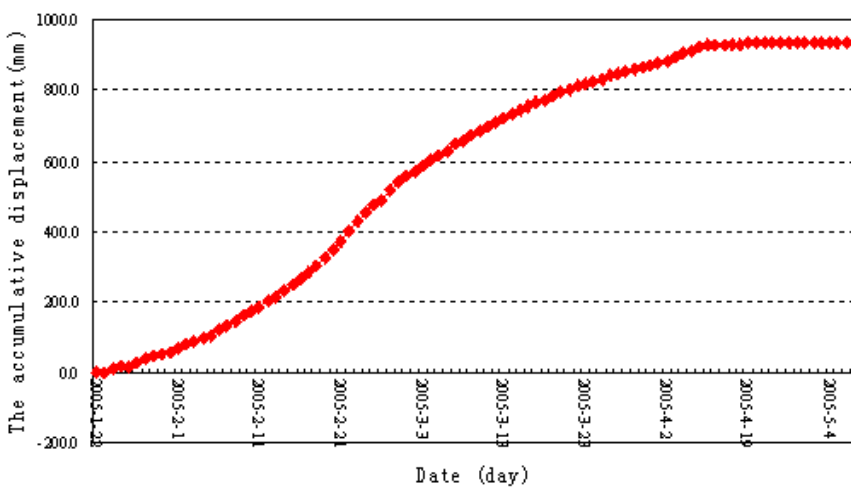
Figure 10. The accumulative displacement curve of the 9# monitoring point in the rear of the principal section in region I

The accumulating displacement curve of the posterior part of region I (the main body) is shown in Figure 10. From this picture we can obviously see the whole process that the deformation of the landslide began to accelerate from the beginning of February, and to decelerate after 22 February, and became stable gradually after the middle of April. The remarkable effects of the engineering work can be seen obviously in Figure 10. In addition, it still shows that the biggest accumulating displacement monitored by 9# monitoring point had approached 1.2m (The accumulating displacement monitored by 11# monitoring point near to I-1 region approached 1.5m. This monitoring point was damaged by construction). The monitoring results indicate that the total deformation of the landslide had already been big enough.

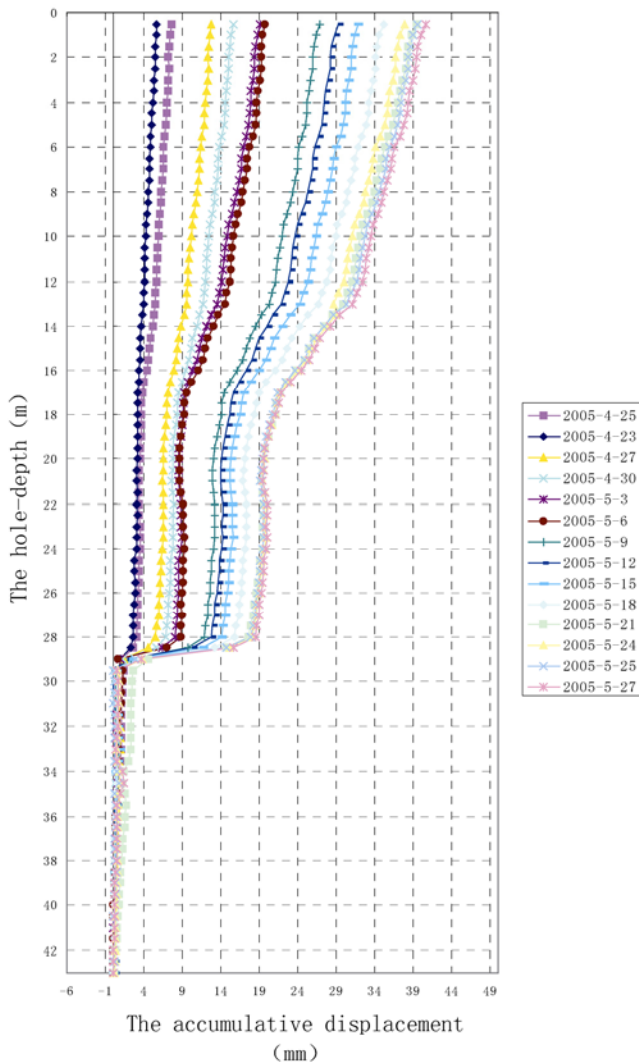
Figure 11 shows the monitoring results of the deep displacement of ZK12 (Figure 7) in the centre and posterior part of the main body. As clearly shown in Figure 11, the rupture surface was embedded in the 29m below the ground surface. During exploration, it was considered that the rupture surface was the contact surface between the unconsolidated debris of Quaternary sediments and the underlying bedrock. But the results of deep displacement monitoring showed that the previous thought was wrong. The Danba landslide didn't glide completely along the contact surface, many segments cropped out from the unconsolidated debris. For example, the depths of the contact surface monitored by ZK12 and ZK10 were 36.2m and 41.29, but the depths of the real rupture surface were 29m and 28.5m, respectively. The depth of the rupture surface and the contact surface monitored by ZK13 were almost the same, which is 31.43m (Figure 7). Through deep displacement monitoring, we cannot only make sure the exact position of the rupture surface, but also can grasp the evolution of the space deformation of the landslide. The landslide not only crept down entirely, but also had the character that the deformation declined gradually from the deep to the surface, which can be seen from Figure 11. As time goes by, the deformation of the landslide is on a downtrend (Figure 11). Until August 2005, the daily deformation is less than 1mm per day. Affected by rain and other factors, the deformation of the landslide might increase suddenly (9 May, 10 July), but returns back to normal soon after.

Both the surface displacement monitoring (Figure 8 & Figure 9) and the deep displacement monitoring results (Figure 11), all indicate that the deformation velocity of the landslide has decreased sharply by carrying out the remedial engineering and now the possibility of gliding entirely is very small. But the deformation didn't completely cease. Nowadays, the slope is gliding at a 1mm per day deforming rate. To stop the deformation completely and keep

Figure 11. The deep displacement monitoring results of ZK12

Danba landslide in a long-term stable condition, as well as to ensure the Danba people live and work safely and happily, comprehensive measures are carried out now. The measures are using friction piles in place of the sand bags piled during the emergency period, at the same time adding 3 rows of pre-stressed anchor ropes in centre and posterior part of sub-region I-1. Finally, the Danba landslide will be cured drastically.
