# A case study of a translational landslide along Pennsylvania Turnpike, USA

ABDUL SHAKOOR<sup>1</sup> & RYAN TINSLEY<sup>2</sup>

**Abstract:** A major landslide in Somerset County, Pennsylvania, USA, known as the New Baltimore landslide, has been problematic for Pennsylvania Turnpike (I-76) since its construction in 1940. The landslide extends approximately 2000 ft (606 m) upslope and 1000 ft (303 m) laterally, and moves toward the east-bound lane of I-76 at a rate of 3.5-5 in/yr (9-13 cm/yr). Overall, the landslide can be classified as a translational failure with localized rotational slides, rock falls, and flows. The geology at the site consists of the Upper Devonian Catskill Formation that includes sandstone, siltstone, mudstone, and shale units.

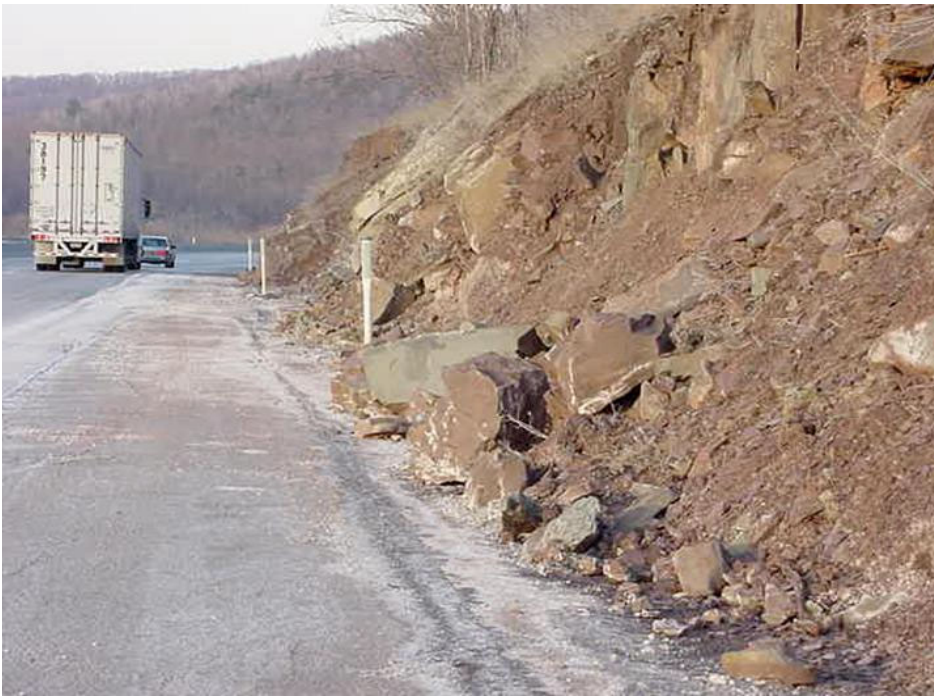
The New Baltimore Landslide is located at milepost 128 along the east-bound lane of the Pennsylvania Turnpike (I-76) in Somerset County, Pennsylvania (Figure 1). It is an old (pre-1883) landslide that is approximately 1000 ft (305 m) wide and extends 2000 ft (610 m) upslope. Overall, the landslide can be classified as a translational movement with localized rock falls, rotational slides, and flows. The landslide has several distinguishing features that indicate various episodes of movement inside the mobilized mass, the most prominent being the repetitious series of scarps and slumps within the hummocky terrain that extends from the toe to the crest of the slope. The landslide has posed a problem to the Pennsylvania Turnpike ever since the completion of its construction in 1940. It continues to move toward the Interstate 76 at a rate of 3.5 to 5 inches (9 to 13 cm) per year. The active nature of the landslide has led to a relatively large unstable rock mass at the toe of the slope and heaving of the east-bound lane shoulder as

**Figure 2.** Overview of unstable rock mass at the toe of the landslide along I-76.

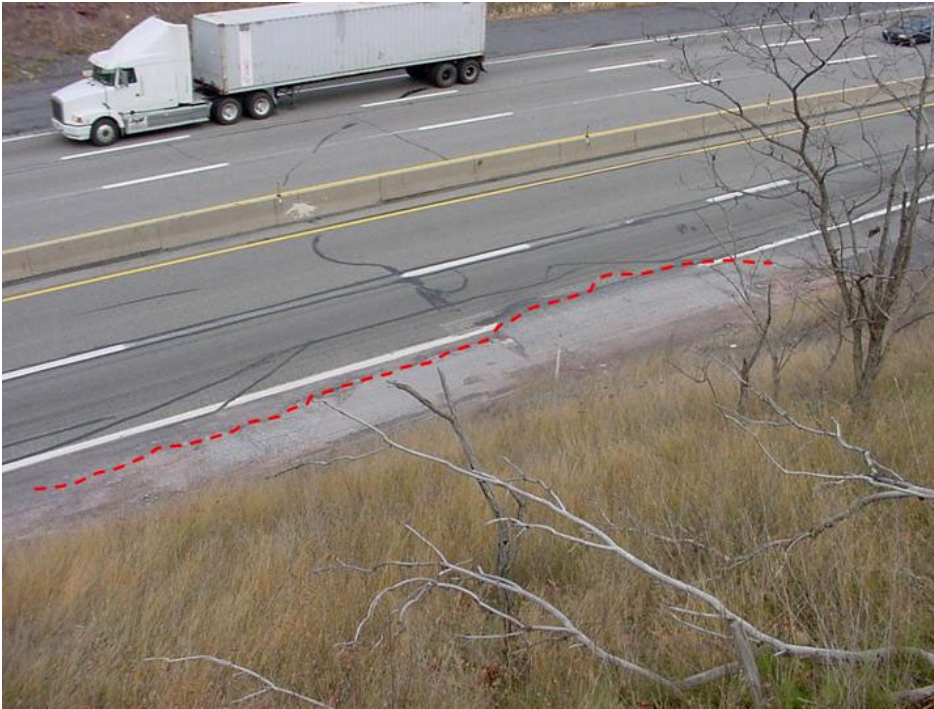
shown in Figures 2 and 3, respectively. There have been numerous rock falls along the east-bound lane of I-76, like the one shown in Figure 4, that pose a constant threat to turnpike traffic.

**Figure 3.** An overview of pavement heaving of eastbound lane of I-76.

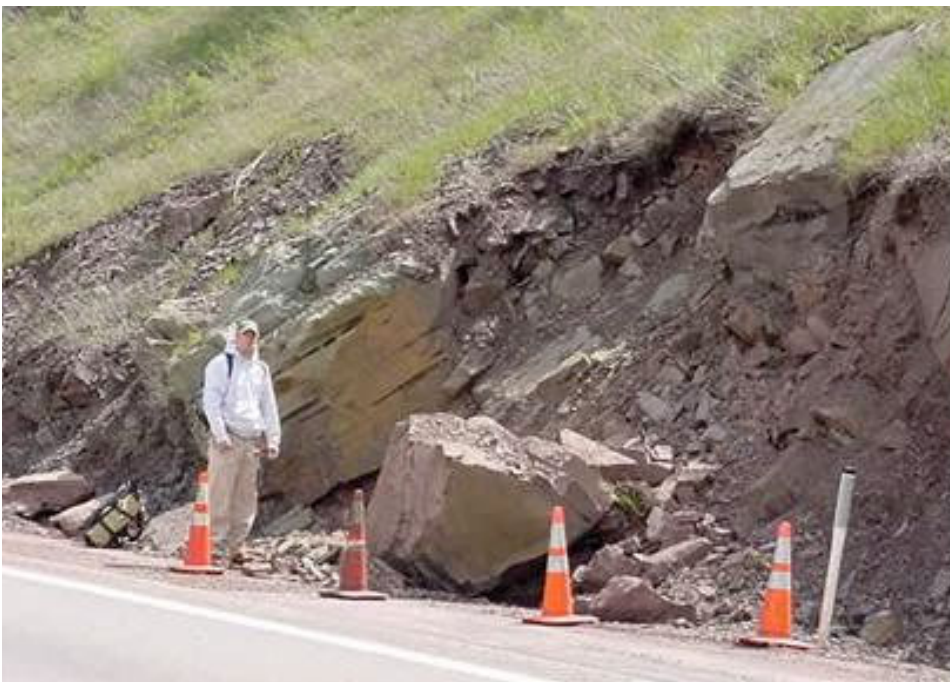
**Figure 4.** A major rockfall within the toe area of New Baltimore Landslide along I-76 in July of 2001.

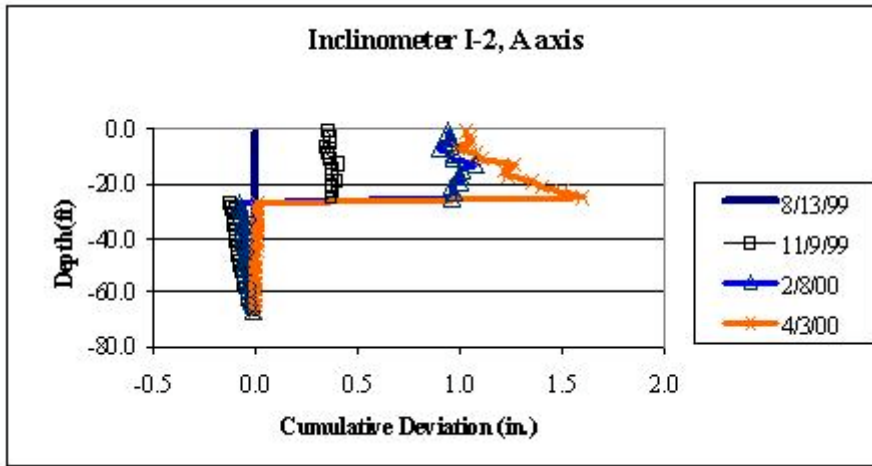
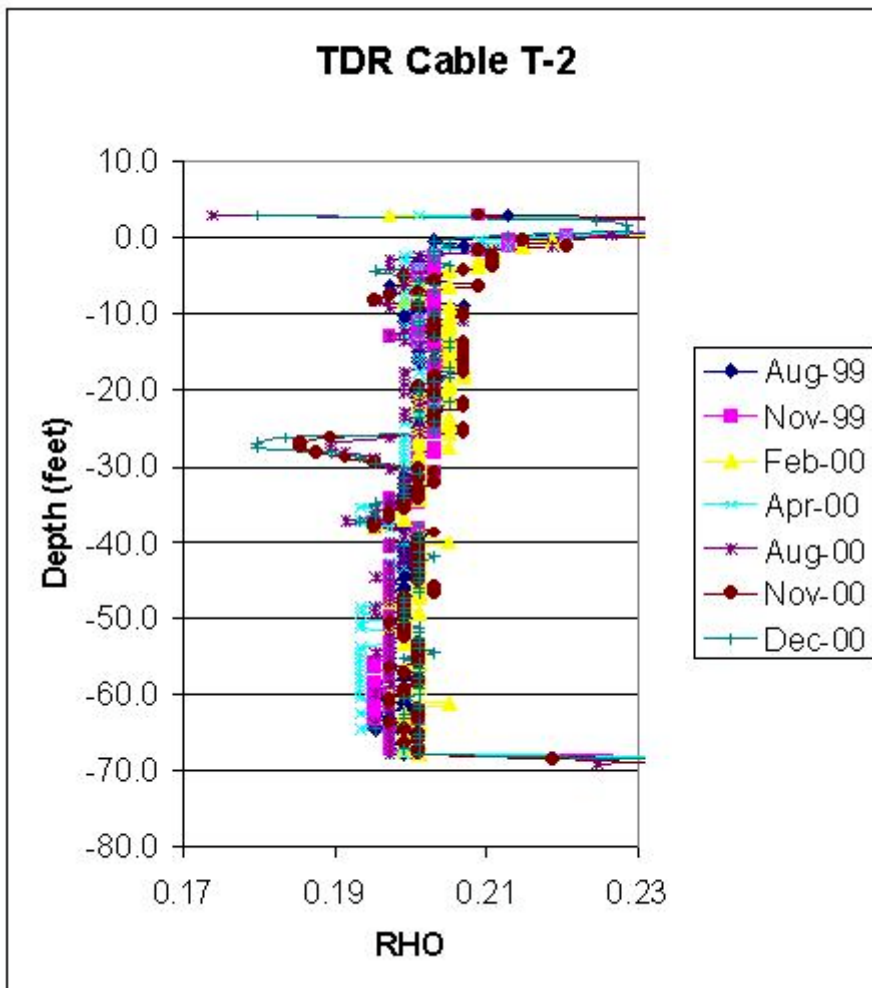
**Figure 6.** Slope inclinometer (top) and TDR Cable (bottom) graphs indicating similar depth of the primary failure plane in test boring T-2. Note: 1 foot = 0.303m., 1 inch = 25.4mm

TDR Cable	Depth of Failure Plane Below Ground Surface
T-2	26-29 ft / 7.92-8.84 m
T-3	72-75 ft / 21.95-22.86 m
T-6	43-46 ft / 13.10-14.02 m
T-8	19-22 ft / 5.79-6.71 m
T-9	9-13 ft / 2.74-3.96 m
T-10	34-38 ft / 10.36-11.58 m
