Instability of slopes along the Nymphopetra to Strymonas section of the Egnatia Highway in N Greece

MARIA CHATZIANGELOU¹ & BASILE CHRISTARAS²

Abstract: The Nymphopetra to Strymonas section of the Engatia Highway is about 60km long, and is located in northern Greece, to the North-East of Thessaloniki. It is divided into two parts: i) Nymphopetra-Asprovalta, about 40km long and ii) Asprovalta-Strymonas, about 20km long. The Asprovalta-Strymonas section has already been constructed while the Nymphopetra-Asprovalta section is under construction.

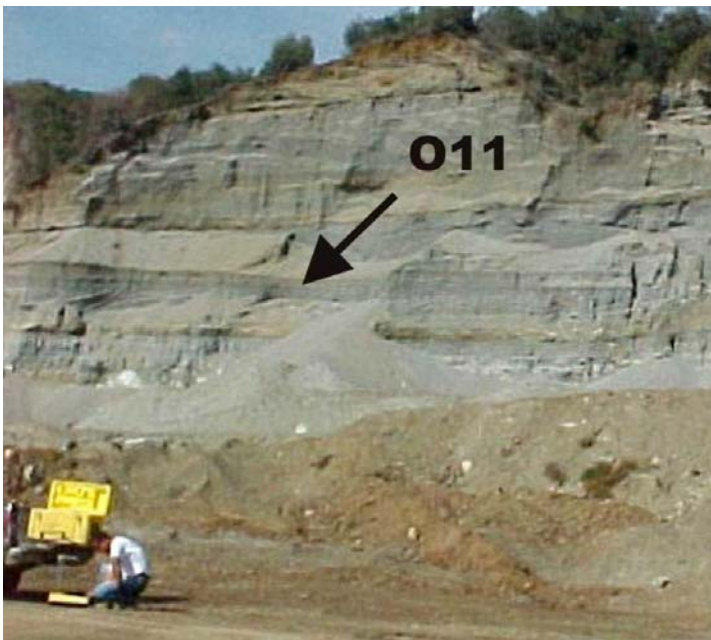
The slope “O11”, which is located between ch.20+500 and ch.20+800, consists of lake deposits (Figure 3). A fault of 255/46 cuts these deposits; the bedding is 162/39 and the main joint set is directed to 101/84.

Figure 3. Unstable slope O11, between ch.20+500 and ch.20+800

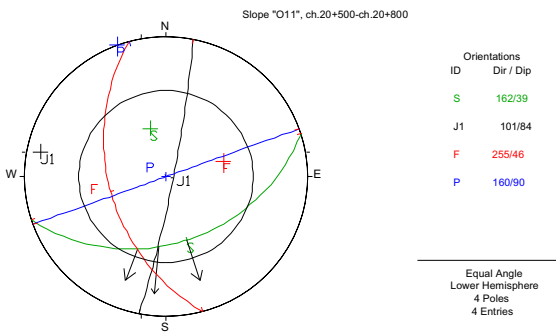
The lake deposits on “O11” slope may slide along the direction of the bedding 162/39. Two potential wedges are formed by; i) bedding 162/39 and fault 255/46 and ii) joints 101/84 and bedding 162/39. The sliding takes place at SSW direction (Figure 4). Also, the critical slip circle was estimated using slope geometry of 15m high and slope inclination of 90°. The radius of the critical circle is estimated 15m and the safety factor for saturated conditions is calculated 3 (Figure 16).

Figure 4. Major discontinuities' planes at slope “O11”

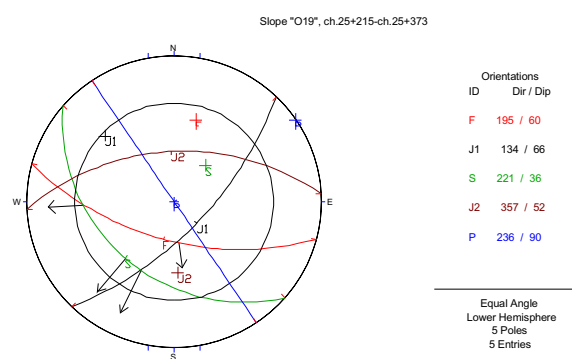
Studying the stability of “O19” slope, the slope may slide along the planes of: i) the gneiss schistosity 221/36, and ii) the fault 195/60. Three potential wedges are formed by; i) joints 134/66 and the fault 195/60 (sliding at south direction), ii) the joint 134/66 and schistosity 221/36 (sliding at SW direction), iii) fault 195/60 and schistosity 221/36 (sliding at west direction) (Figure 5). Gneiss rock mass is easily eroded and weathered by air or water. So, it becomes quickly uncohesive behaving like soil material. For this reason, the critical slip circle was estimated using slope geometry. The safety factor for saturated and unsaturated conditions was also calculated. The slope stability analysis took place using unit weight of gneiss equal to 2,65gr/m³, friction angle equal to 22° and no cohesion. Two benches

Figure 5. Major discontinuities' planes at slope “O19”

The landslide of the slope “O19” was activated by the excavation performed for the construction of an embankment. The unfavourable orientation of schistosity 221/36 affects the slope stability causing failure (Figure 5).

Referring to the slope "O19", the unfavourable orientation of schistosity and the presence of potential wedges affect the stability causing failure. Taking into account that using a slope inclination less than 34°, the size of slope will be reduced very much and the morphology relief will be changed significantly. Using an average inclination equal to 34° (2:3), the slope will be moderately stable and sliding of rock pieces will occur. Wire mesh investment is proposed for highway protection from falling rock. The proposed geometry consists of two benches 10m high being inclined to 34°. Low vertical benches, having width equal to 5m and height 2.5m – 3.25m, are proposed at the site of embankment. The safety factor on unsaturated conditions was estimated as 2 and under saturated conditions was estimated as 1 (Figures 15-18). The stability will be achieved if the resistance force of the embankment is higher than the shear strength, which causes the sliding. Wire mesh is enough to protect absolutely weathered rock pieces from falling on the road.

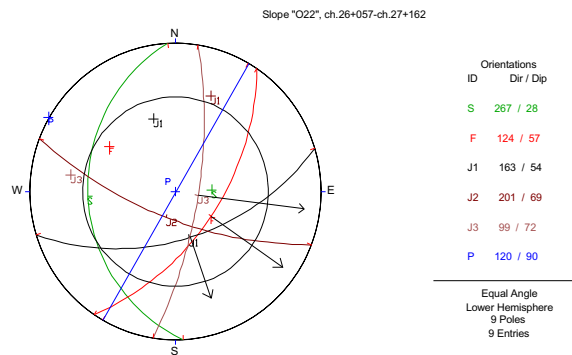
Studying the stability of “O22” slope, the gneiss rock mass may slip along; i) the fault 124/57 and ii) the joints of 99/72. Potential wedges are also formed by joints 201/69, 99/72 and joints 124/57 parallel to fault. Sliding may occur at SSE direction (Figure 6).

Figure 6. Major discontinuities' planes at slope “O22”

Terraces inclined at 45° are proposed to form the “O22” slope in order to be protected from planar sliding. The maximum height of the slope is about 50m. Taking into account that the slope consists of absolutely weathered gneiss ($\gamma=2,65\text{gr/cm}^3$, $\phi=26^\circ$, $c=0$), there is a potential cycled sliding. But according to slope stability analysis in saturated conditions, the slope is stable as the calculated safety factor of the critic circle is 7 (Figure 21).

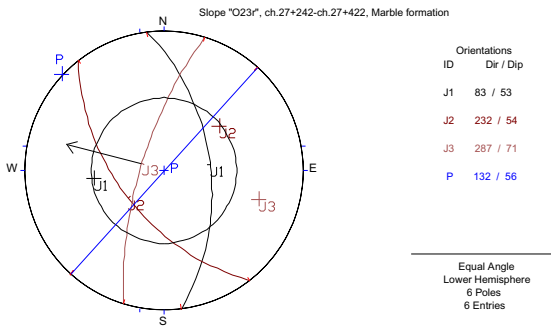
According to stability analysis of the “O23₁” slope, the type of probable sliding is; i) a planar sliding of gneiss rock mass along the joints directed to 279/43 and ii) a potential wedge sliding at west direction. The planes of joints 212/58 and 279/43 form the wedge (Figure 7). The marble rock mass may slide along the joints of 287/71. As the rock mass is slightly weathered, there is no possibility of circled sliding (Figure 8).

Figure 8. Major discontinuities' planes of marble at slope "O23_r"

The GSI of marble formation of the slope “O23” is estimated between 60 and 63. So, the friction angle the rock mass is 35° (Marinos *et al.*, 2005). In addition to this, the GSI of gneiss formation of the same slope is estimated between 53 and 57, the friction angle of the rock mass is 43°. In order to protect the slope from rock mass sliding, an inclination of slope equal to 45° is proposed.

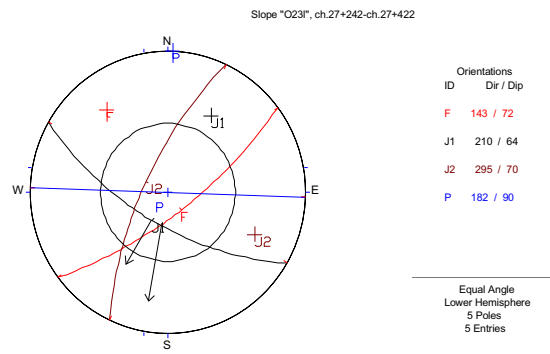
The gneiss rock mass of the “O23₁” slope may also slide along the planes of joints 210/64. A potential wedge, being formed by the joints of 210/64 and joints parallel to fault 143/72, may slide at South direction. As the rock mass is slightly weathered there is no possibility of circled sliding (Figure 9).

Figure 9. Major discontinuities' planes at slope "O23_l"

The GSI of gneiss formation of the slope “O23” is estimated between 33 and 37. So, the friction angle of the rock mass is 38°. In order to protect the slope from rock mass sliding, an inclination of slope equal to 45° is proposed.

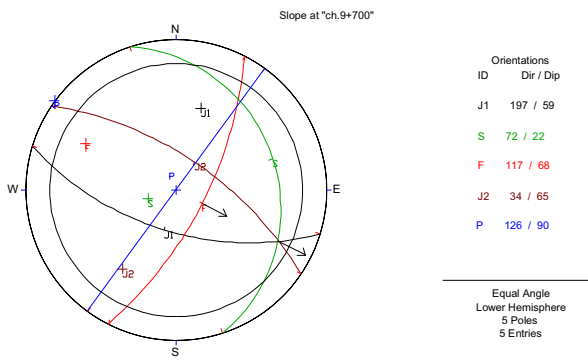
Five benches, with inclination of 45° for their sub-slopes, form the slope at “ch.9+700”. The slope is 60m high. As the rock mass is absolutely weathered, the critical slip circle was estimated. The critical circle, in saturated conditions caused by rainfall, is 50m deep and the safety factor is estimated 1.16 (Figure 22, Figure 23). So, the stability is ultimate in saturated conditions. Taking into account the orientation of discontinuities sets, the slope may slide along the fault 117/68. The joints of 197/59, 34/65 and the schistosity 72/22 form potential wedges, which they may slide at SE direction (Figure 10).

Figure 10. Major discontinuities' planes at slope at "ch.9+700"

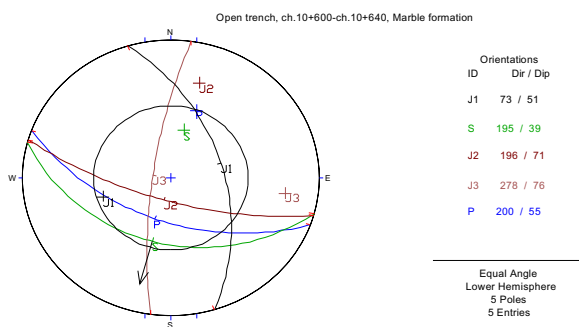
Taking into account that the friction angle of the rock mass is about 35°, gneiss formation, being placed between ch.10+505 and ch.10+556 of the third bench of the open trench, may slide along the direction of schistosity 213/35 (Figure 11, Figure 12). The same formation, being placed between ch.10+510 and ch.10+520 of the 2nd bench, may slide along the direction of schistosity 246/42 (Figure 13). There is a part of completely weathered gneiss, being placed between ch.10+670 and ch.10+680 of the 2nd bench, which may slide along the direction of the section being formed by schistosity 229/48 and joints 169/53 or 125/85 (Figure 15). Marble formation, being placed between ch.10+600 and ch.10+640 of the 2nd bench, may slide along the direction of the section being formed by schistosity 195/39 and joints 278/76 (Figure 14).

Figure 14. Major discontinuities' planes at the open trench

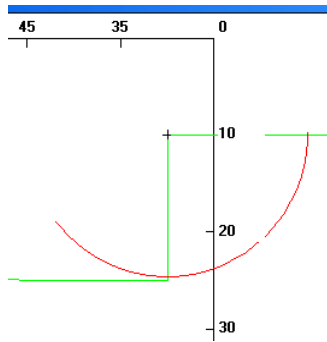
Figure 16. Critical slip circle and safety factor of slope "O11", in saturated conditions

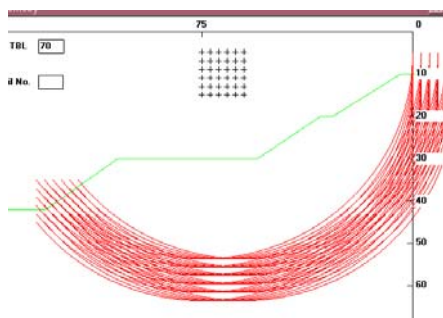
10m high from the slope geometry, inclined to 34° (2:3). Low vertical benches, having width equal to 5m and height of 2,5m – 3,25m, designed to be created at the site of the embankment, so as the friction between the embankment and the slope to be increased. Using the geometry above, the slope in study is stable on unsaturated conditions (S.F. = 2) and it is unstable on saturated conditions (S.F.=1) (Figure 17, Figure 18). After the construction of the embankment, the safety factor, on unsaturated conditions, was estimated equal to 2 and the safety factor, on saturated conditions, was estimated equal to 1 (instability) (Figure 19, Figure 20).

Figure 19. Circle sliding analysis and safety factor of slope "O19" after the embankment's construction, in unsaturated conditions

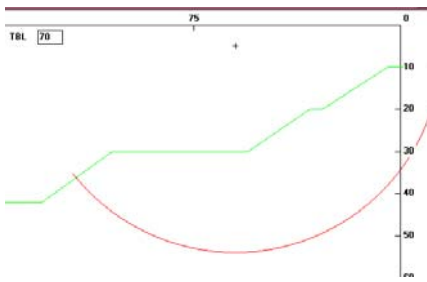
Figure 20. Critical slip circle and safety factor of slope “O19” after the embankment’s construction , in saturated conditions

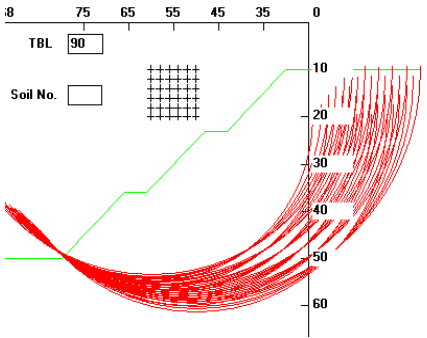
Figure21. Circle sliding analysis and safety factor of slope “O22” , in saturated conditions

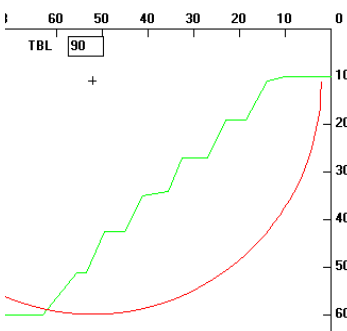
Figure 23. Critical slip circle and safety factor of slope at “ch.9+700” using the begging geometry in saturated conditions

A short rainfall, which has taken place on March 2002, created a landslide of the half part of the slope at “ch.9+700”, which was just excavated using a beginning geometry. The slope consists of small rock blocks. A cyclical sliding of loose material is bounded at east side of slope, where is the fault surface (115/65) and at west side of slope, where is a long sliding surface (120/76). Rainfall is the main cause of landslide as the safety factor (1.16) in saturated conditions is ultimate (Figure 23).

Studying the stability problem of the slope at “ch.9+700” a new geometry of slope is proposed for landslide’s restoration. For this reason, dips of downstairs are proposed to be smaller (height/width=1/1.5, and 1/1) than dips of upstairs (height/width=2/1). Using this new geometry, the safety factor is 25% higher (SF=2.08) in unsaturated and 35% higher (SF=1.57) in saturated conditions than using the beginning geometry. The benches of the slope are designed about the same length so as the length does not affect the safety factor and pore pressure (Figures 25-26). Thus, safety factor depends only on inclination of benches. According to the new geometry, big dips are formed downstairs and small ones are formed upstairs. When the height is also increased, restrained powers are increased and sliding powers are decreased. So, the safety factor of every part is progressively increased downstairs to upstairs making slope stable according to Chatziangelou & Christaras (2005a & 2005b).

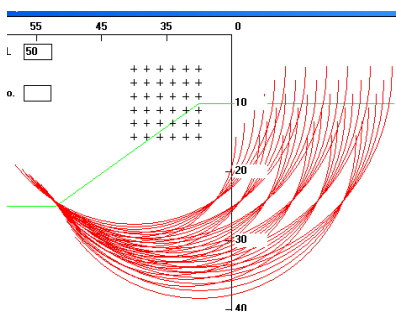
Figure 24. Circle sliding analysis of slope "O11" using the proposed geometry in saturated conditions. Critical circle;(x,y):(5,5)

In order to protect the slope "O11" against sliding, a slope inclination of 34° is proposed. Using the proposed inclination, the radius of the critical circle is estimated at 29m and the safety factor is calculated 5 in saturated conditions (Figure 24).
