# Stability analysis and safety assessment of high cut slopes in new towns for the Three Gorges Project population migration, China

R. Q. HUANG, X. J. PEI

*National Laboratory of Geohazards Prevention. (E-mail: hrq@cdu.edu.cn)*

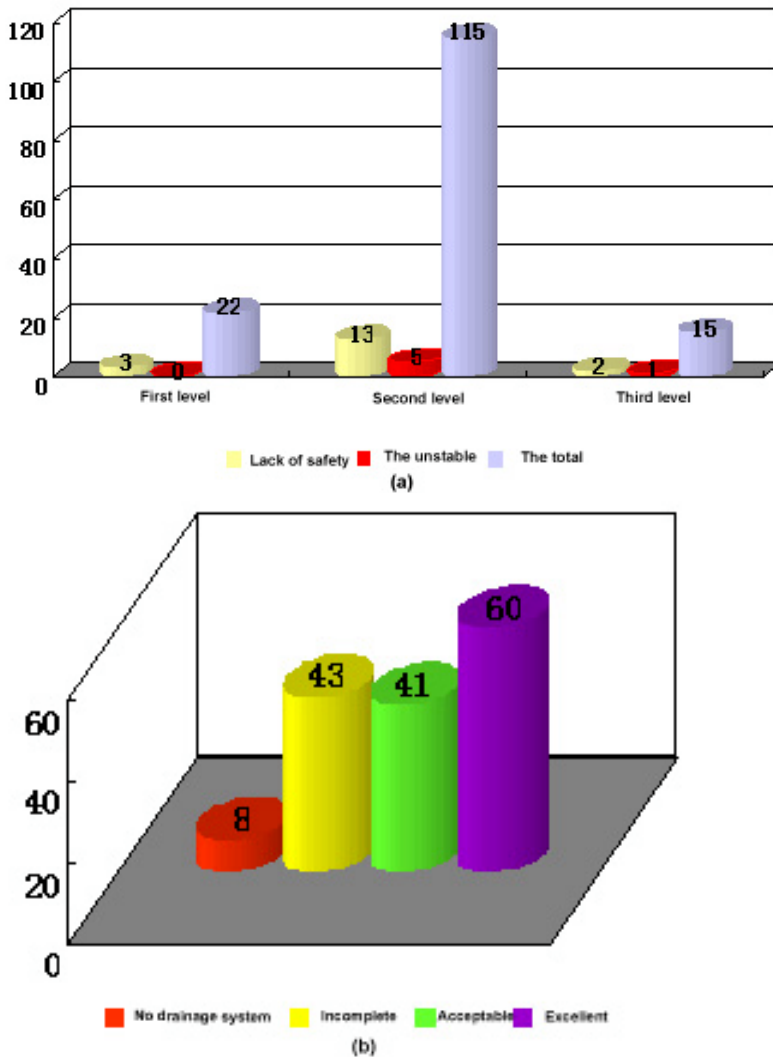
The Evaluation Team undertook in situ investigation and data collection for 152 high cut slopes for 40 days and analysis and collation of the data for a further 30 days. There were 10 rock slopes, 19 rock and soil slopes and 123 earth slopes investigated. 148 of all the high cut slopes had been treated, and included 95 gravity retaining walls, 3 anti-slide piles, 3 pile sheet retaining walls, 33 ribbed plates, lattices and anchors, and 14 multiple retaining walls. In the appraisal report there were 16 slopes that were considered unsafe and 6 slopes that were at the point of failure. Different grade distributions can be seen in Figure 5.

- 1) An evaluation of the stability of 152 high cut slopes related to immigration in Fengjie County led to three categories of slopes according to slope type, height and failure mechanisms. 130 (85%) slopes were found to be safe, 16 (11%) slopes were found to be just safe and 6 (4%) slopes to be unsafe. Most slope treatment measures for high cut slopes were found to be reliable. Stabilisation of the high cut slope contributed to the fact that the new towns could be built and the reservoir filled on time.
- 2) Main geological issues induced by engineering construction or failure included inadequate drainage systems for the slopes or the retaining walls, incomplete rain and flood hazard prevention and mitigation systems, and not assessing the affect of building on retaining walls and cut slopes. Engineering construction and monitoring needs to be coordinated.

**Figure 5.** Safety appraisal results of high cut slopes in Fengjie New Towns: (a) appraisal results of different safety grades for high cut slopes; (b) investigation results of drainage systems of slope engineering

- 1) Perfection and maintenance of drainage systems including the surface water drainage systems, the sub surface drainage systems and the city sewage systems.
- 2) Complete slope monitoring system should exert an influence on treatment of the slopes.
- 3) Further checking of the stability of the slope with different scenarios to take into account changes in plans should result in guidelines for additional stability mitigation measures.
- 4) Rock retaining walls, rockfall trenches and protection nets used where necessary.
- 5) Vegetation protection measures reinforcing the slopes should be taken.
