# Research into the characteristics of the Jin Jiguan Tunnel's geohazards and their control

**Abstract:** The Jin Jiguan Tunnels on the Chuan-Zang Highway at Ya-an town were opened to traffic in January 1995. However, in 2001 the twin tunnels were found to be suffering from water penetration and deformation phenomena to varying degrees with heave and rock fracturing evident at several places within the tunnels. This had some detrimental effects on the normal use of the tunnels. Based on field investigation and other studies by the authors, it was concluded that three main factors contributed to the geohazards appearing in the tunnels. The first involved expansive soils present in the Guan-kou lithostratigraphical unit that expanded when they came into contact with water and caused arching and deformation of the road surface. The second factor stemmed from a combination of poor practice, inadequate equipment and uncontrolled working conditions during construction that caused fractures and construction crevices within the tunnel linings. Gypsum in the Guan-kou formation was dissolved by groundwater that seeped towards the tunnels and then recrystallized along the fractures and crevi

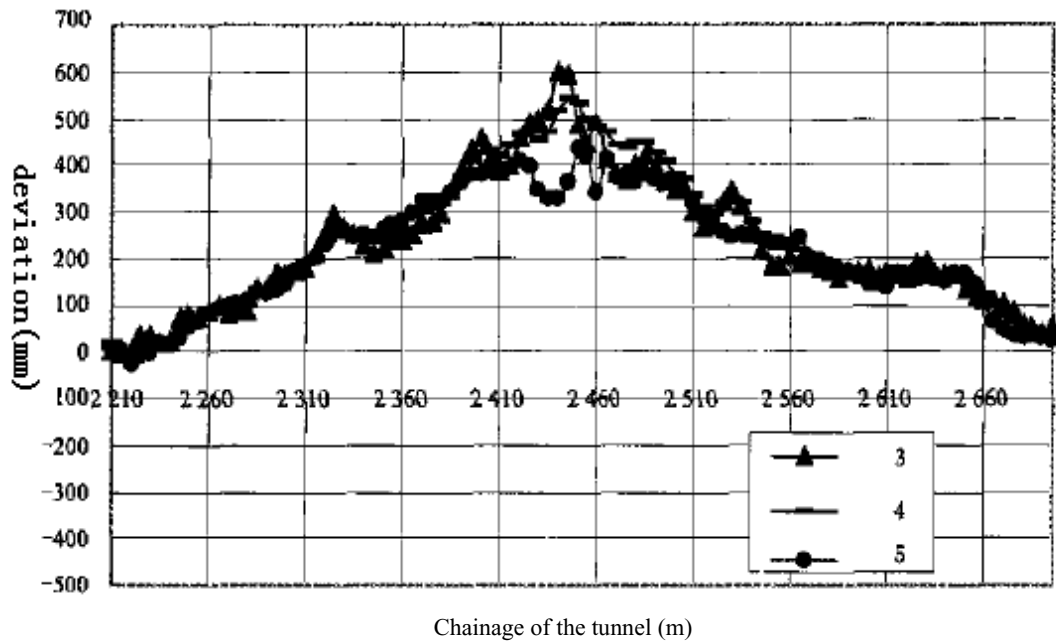
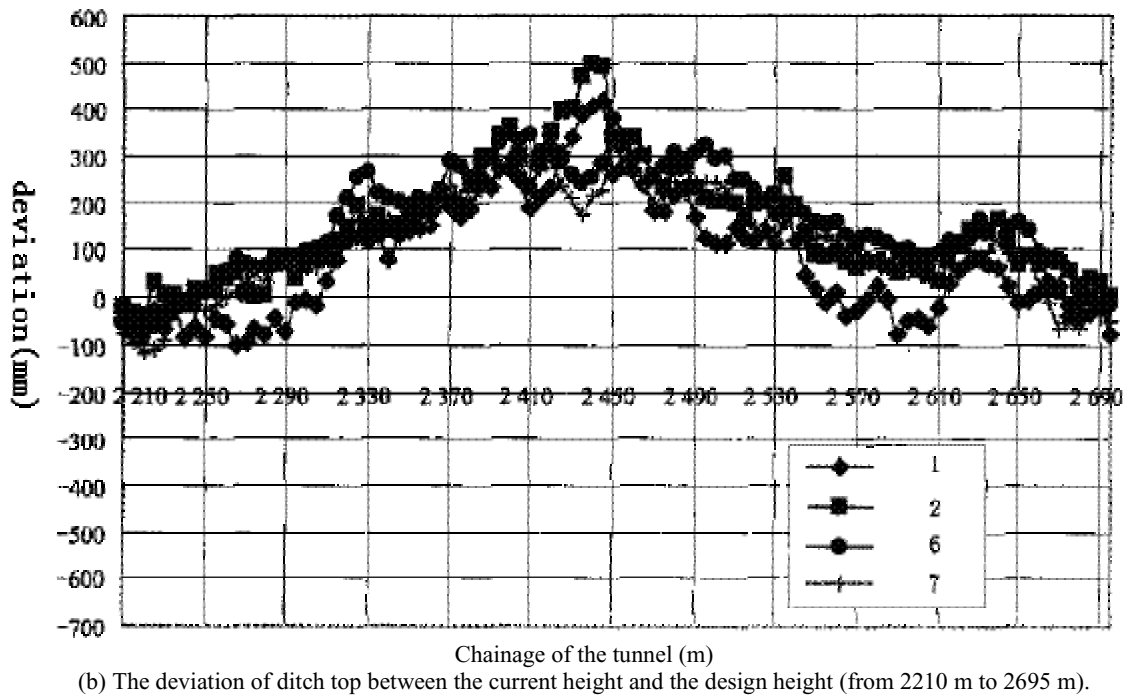
**Figure 3.** The deviation between the current and designed heights at Jin Jiguan No 1 Tunnel.

Geological surveys of the tunnels identified the principal sections where the current height of 3 ground baselines deviates from the original design height. These are from chainages 2310 m to 2650 m along No 1 Tunnel and from 2285 m to 2485 m at No 2 Tunnel (see Figures 3 (a) & 4(a)). The deviation increases from the ends towards the middle of the tunnels with the maximum deviations from 2440 m to 2450 m at No 1 Tunnel and from 2385 m to 2465 m at No 2 Tunnel.

The surveys also identified the sections where the current height of 4 ground baselines on the top of ditches deviates from the design height. These are from chainages 2230 m to 2530 m along No 1 Tunnel and from 2265 m to 2465 m at No 2 Tunnel (see Figures 3(b) and 4(b)). Once again, the deviation increases from the ends towards the middle of the tunnels with the maximum deviations from 2440 m to 2450 m at No 1 Tunnel and from 2385 m to 2465 m at No 2 Tunnel.
