Disease of bridge on the highway road 108 in the west of China (Guangyuan) and its reinforcement measures

YUN-JIE WEI¹ MO XU² & DE-MIN XU³

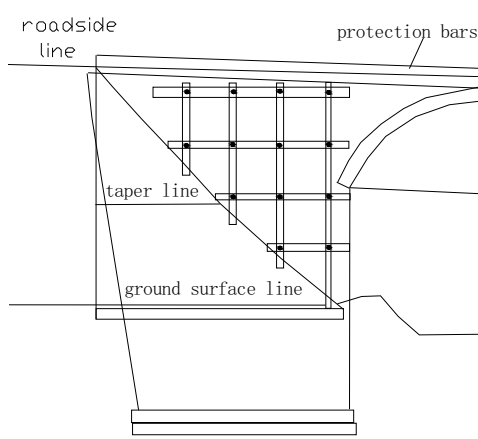
Songjiagou Bridge is located in the town of Zhongzi, it has a length of 45m, width of 13.5 m, arch height of 21m and arch span of 16m. The bridge is of masonry construction and backfilled with soil. During trial, deformation occurred in the bridge abutment and cone slope. The sidewall was found to have displaced 4 m and the cone slope cracked. Several cracks 1 to 20 mm wide were apparent in the bridge abutment protection bars (parapet) and the arch wall. The length of the slant spread is 8 to 10 m indicating a trend of gradual deterioration.

The cause to the cracking is thought to be due to the poorly compacted backfill, which has a loose structure and high void ratio. Water penetrating the structure has caused the backfill to swell reducing its strength and lowering its bearing capacity. Subsidence due to traffic load has subsequently occurred. Lateral compression of the backfill has resulted in deformation of the sidewalls and cone slope.

Grouting was performed to prevent further road subsidence. Unfortunately, sidewall displacement and cracking in the arch wall continued. The depth of grouting is limited (4 to 8 m) and it is thought that the cause of the cracking is due to backfill material below this level. Consequently, structural reinforcement using anchors/ties has been adopted to reinforce the bridge structure.

Figure 1. Layout of structural reinforcement using anchors/ties, Songjiagou Great Bridge

1. Twenty-six (26) 130 mm diameter anchor boreholes were drilled horizontally on a 3 m x 3 m grid pattern into the bridge abutment sidewalls. The holes were arranged in four horizontal rows; with four holes in the first two rows, three holes in the third row and two holes in the fourth row (Figure 1).
2. Horizontal and vertical beams are used to span the holes in each sidewall. Holes have been preformed in the centre of each beam, with sufficient space to allow for adjustment on site. The upper anchor beam is 600 mm wide and 300 mm thick and the other anchor beams 400 mm wide and 300 mm thick. The length of the beam depends on the geometry of the sidewall.
