Study of the formation mechanism for the Dongxi slope in the three gorges reservoir area of China

JI-LIANG ZHU¹, SHI-YUAN ZHANG², QIANG CHEN³, YUN-JIE WEI³ & XIANG-TAO XU³

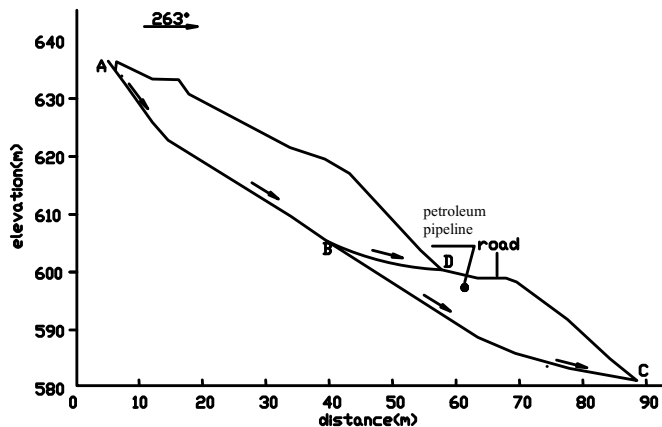
Figure 2. Cross Section of Dongxi slope

A representative section was selected (Figure 2) and stability coefficients of the ABC section and ABD section were calculated one by one under different engineering conditions. The parameters for the calculation and the stability coefficients are as follows:

The calculated factors of safety show that the ABC part and ABD parts of the slope are stable or relatively stable under natural or earthquake conditions. Its factor of safety will quickly decrease and the slope will suffer either creep deformation or mass instability under storm or storm and earthquake conditions. The calculated factor of safety of the ABD section is less than the one of ABC section, so the ABD section is more likely to fail under the same condition. The calculated result is in accordance with observations.
