Safety assessment and land planning development of abandoned quarries in urban areas – A case study from the city of Athens, Greece

CONSTANTINOS LOUPASAKIS¹ & JOHN KARFAKIS²

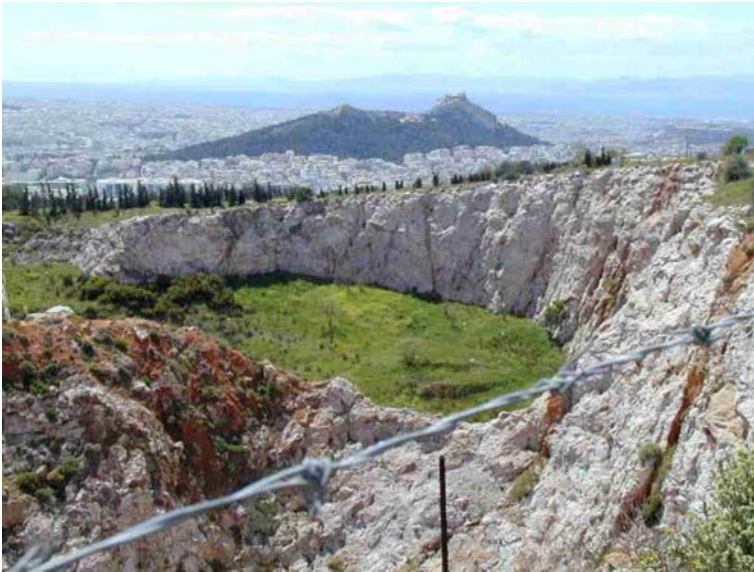
Most of the faults exhibit intensive karstic weathering, turning them in wide karstic fissures. Those voids are 0.5m to 2m wide and are filled with clay or stalagmitic materials (Figure 3). When the karstic fissures intersect, the voids can become extremely wide (Figures 4 and 5)

Figure 3. The brown and the dark grey zones intersecting the slopes are the wide karstic fissures which are filled with clay or stalagmitic - calcitic materials.

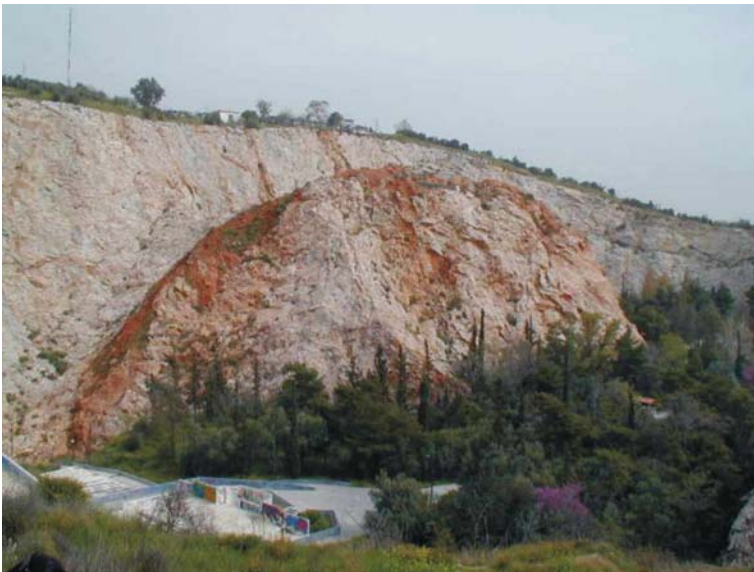
Figure 4. Extremely wide karstic fissure (up to 15 m) filled with clay materials. The material has enclosed blocks of the Turkovounia limestone. During the excavation the surrounding limestone was untouched in order to avoid moving the enclosed materials.

As previously mentioned the wide karstic fissures are filled with clay or stalagmitic material, which encases blocks of the limestone (Figure 4) or the blocks are trapped in a stalagmitic net. The gradual erosion of the surrounding material leads to the releasing of the blocks which fall down slope and accumulate at the base (Figure 5).

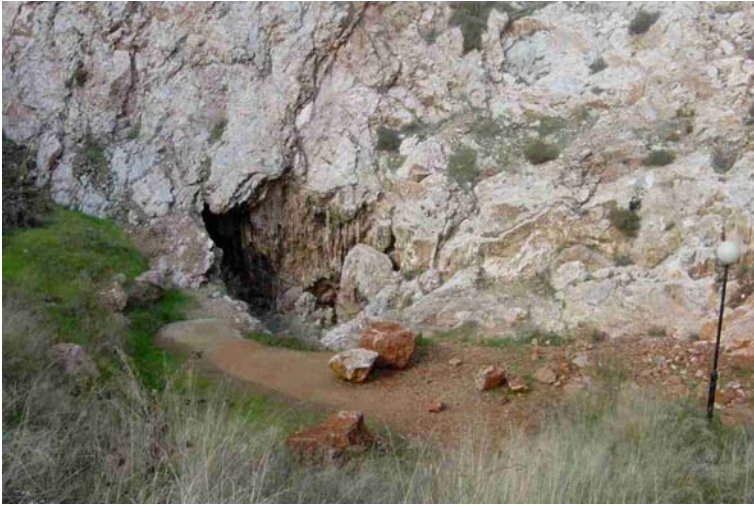
Figure 5. Extremely wide karstic void (up to 10 m) forming a small cave. This cave is formed on the extension of the zone presented in figure 4. The blocks located next to the cave are coming from the zone mentioned above which is filled with clay materials.

The flat area surrounding the cave was defined by the land-planning engineers as a sightseeing location. The slopes surrounding the cave are 50m high and, as presented in Figure 5, comprise large limestone blocks. These blocks are the remains of the excavation procedure, which over hang the slopes, and blocks stack into the clay filling materials of the nearby karstic fissure. The extreme height of the slopes and the continuous erosion of the clay filling materials make support measures difficult and expensive. Also, the poor decoration of this small cave makes the application of expensive support measures unreasonable.

- Application of spot rock bolts for the stabilization of the large wedges of the small slope section presented in Figures 7 and 8.
- Restriction of access to the area surrounding the cave. The construction of an observation post on a higher level is recommended, in order to satisfy the plans of the land-planning engineers.
- Installation of a safety fence or a wide hedgerow around the theatre in order to prevent the access to the base of the slopes. The post quarrying material deposited on the base of the slopes extending over theatre (besides the section with the large wedges) forms a wide plain area, sufficient for stopping the rock blocks from rolling into the facilities (Figures 1 & 3). However, it is obvious that the access to the area would be dangerous, because of the continuous rockfalls.

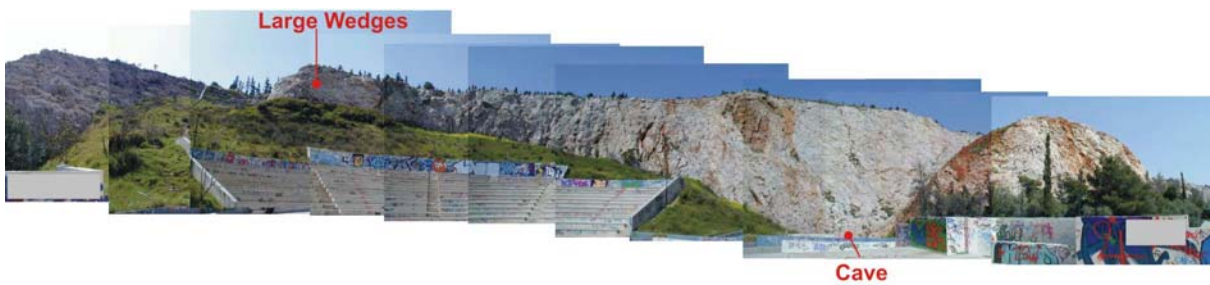
The infill material deposited post quarrying, at the base of the section with the large wedges, has formed an inclined surface reaching the top of the theatre (Figures 7 and 8). This morphology, in case of rock fall or sliding, enables the immediate rolling of the blocks into the theatre facilities. It is obvious that if an incident like this occurs during a performance it can cause serious human casualties.

Figure 7. Panoramic picture of the slopes surrounding theatre. The notes point out the section of the slope with the large wedges and the location of the cave presented in Figure 5.

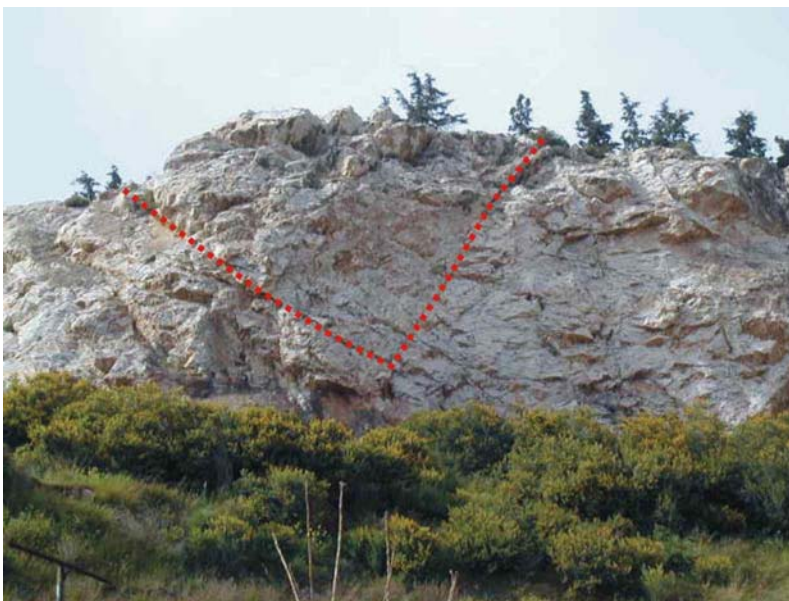
Figure 8. Large wedge formed in a small section of the slope surrounding theatre. The height of the slope is 20m. As presented in Figure 9, the rubble materials deposited on the base of the slope, form an inclined surface ending up on the top of the theatre.

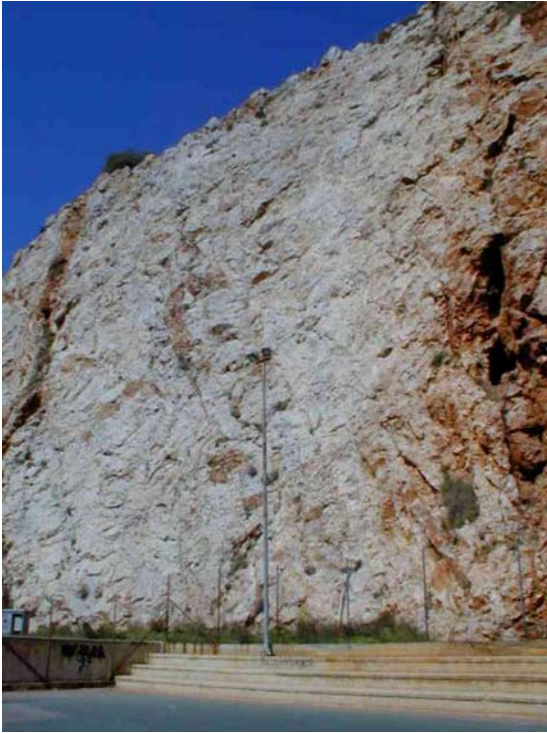
The slopes surrounding the sports infrastructure exhibit all the stability problems outlined above. The 30m high slopes are filled with over hanging blocks, the karstic fissures enclose numerous blocks and the intersected joint sets form several small wedges. Considering all the stability problems were obvious and expected, the main safety issues associated with the infrastructure were caused by the incorrect land-planning design of site and not by the rock mass condition. As presented in Figures 9, 10 and 11 all the facilities were constructed directly under the slopes without maintaining any safety distance. Even rows of seats were constructed under the over hanging blocks.

Figure 9. The basket ball field including the rows of seats are installed on the base of a slope (30m high), without keeping any safety distance. The section of the slope presented in this figure is intersected by a fractured and karstified zone filled with stalagmitic materials.

For the protection of the sports fields, the construction of a containment wall is proposed. It is recommended the containment wall be 2.5m high, with a 1m to 1.5m high metal net along its top. The wall should be constructed 2m away from the base of the slope and be combined with a metal net installed along the entire forehead of the slope. This metal net can prevent the falling rock blocks from jumping away from the slope and the containment wall can stop them before they end up into the infrastructure. The application of those protective measures presupposes the redesign of the tiers.

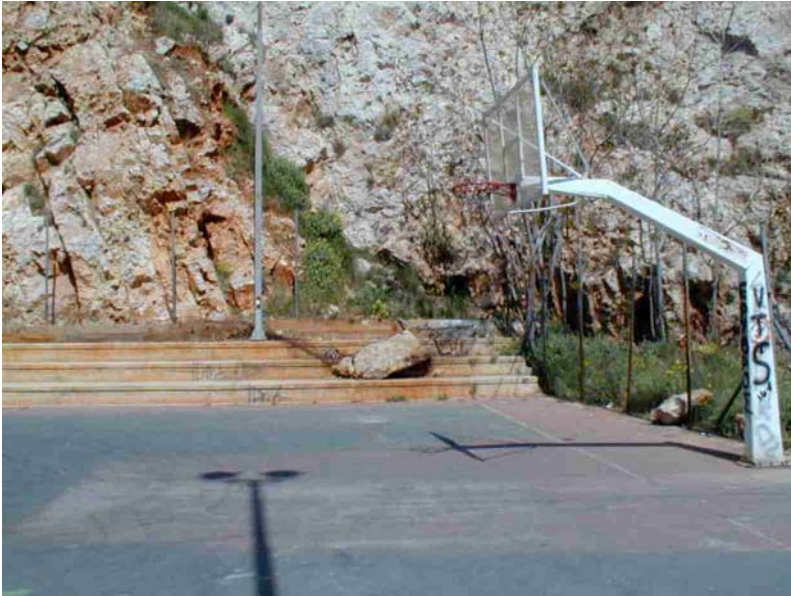
Figure 10. A big rock mass block coming from the fractured and karstificated zone mentioned in Figure 7. It caused damage on the tiers and on the fence of the basket ball field.

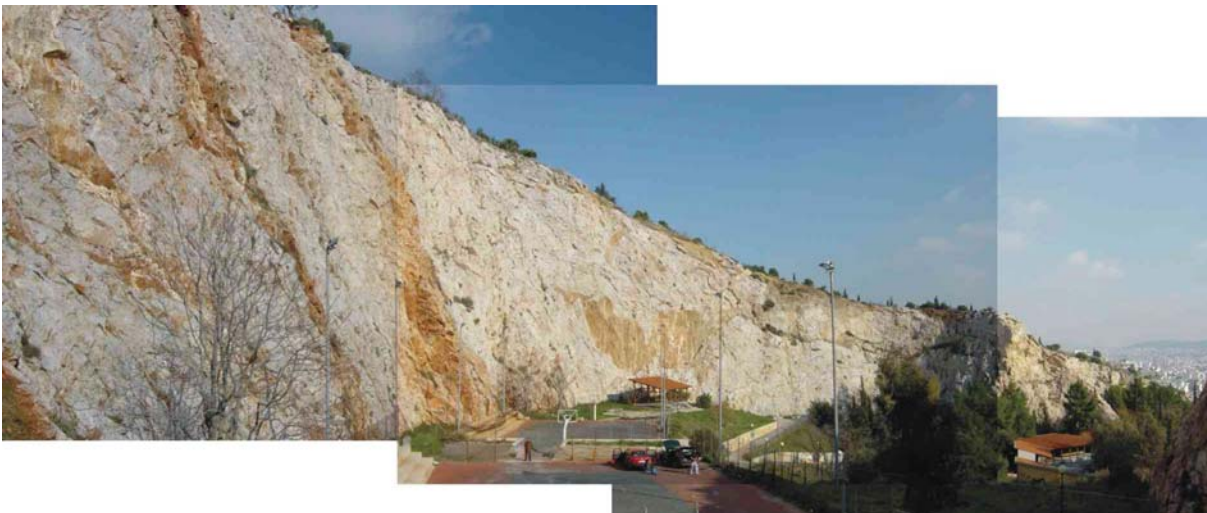
Combining the stability problems mentioned above with the land-planning design of the infrastructure it is easy to locate the sections of the slopes which exhibit slope stability problems and subsequently safety issues. Consequently, sections with intensive stability problems are; the area of large wedges over the theatre; the slopes surrounding the cave (Figure 7); and the slopes surrounding the sports fields, which exhibit severe stability problems along their entire length (Figure 11).

Figure 11. Panoramic picture of the slopes surrounding the sports fields. All the sports' infrastructures are located at the base of the slopes without keeping any safety distance.

If the basket ball and the volley ball fields were constructed 10 to 15 m away from the slope, the installation of a safety fence or a wide hedgerow between the fields and the base of the slope, could replace the containment wall system. Figure 12 presents an example of a more rational land planning design of the sports field.

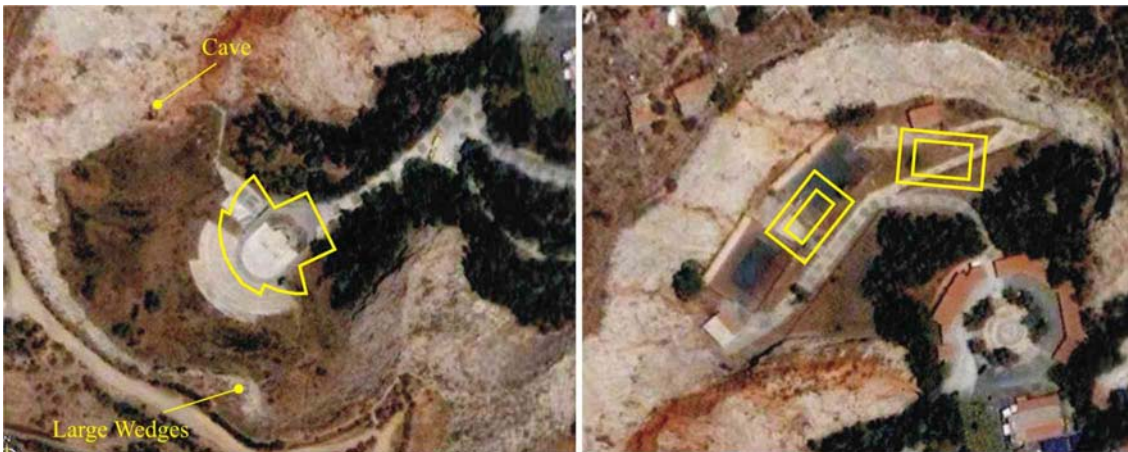
Figure 12. Aerial photographs of the theatre (left) and the sports field (right) presenting an alternative land planning design of the site. The yellow outlines present alternative locations of the infrastructures. The operation of the main facilities in those locations demands less protective measures.

As an example, Figure 12 presents an alternative land planning design of the site. According to the land planning design, if the theatre was constructed in the location marked with the yellow outline, then the distance between slope with the large wedges and the theatre could become efficient for eliminating the risk. The configuration of a flat area between the theatre and the slope, create an area capable of trapping the wedges in case of sliding. Consequently no spot rock bolts are necessary for the support of the wedges.
