# Instability phenomena, geoelectrical investigation and mitigation measures in the area of the city of Sighisoara, Romania

C. MARUNTEANU<sup>1</sup>, V. NICULESCU<sup>1</sup> & M. MAFTEIU<sup>1</sup>

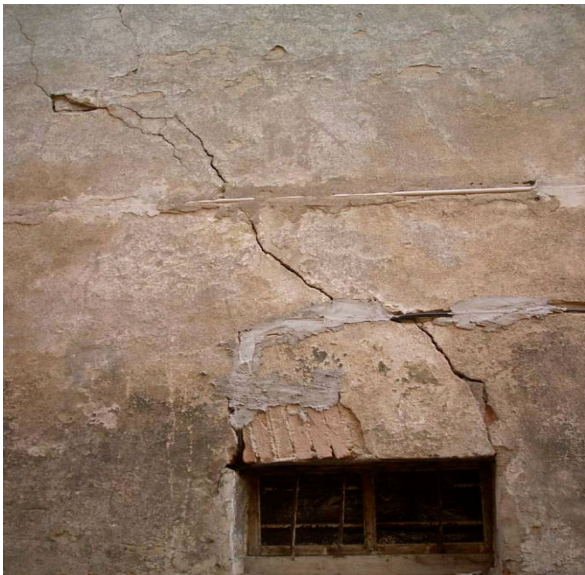
The main object of the geoelectrical and geotechnical investigation was Casa Wagner, a building from the XVII<sup>th</sup> century. The basement ceiling vaults have been built by bricks directly on the soil. In the last years the building was partially damaged by fissures in walls and basement. A fissure in the eastern front of the construction is shown in the figure 2.

**Figure 2.** Fissure in the eastern front of Casa Wagner

In the covering deposits, the accumulations of the water provided by the rainfall storages, the leakage from the supply and sewerage pipes or from cesspool exfiltration and by the irrigation of the gardens produce an important reduction of the shear resistance of the soils and of the filling determining the main cause of the ground instability. For this reason, the geoelectrical method was considered the most suitable for the ground investigation.

- Rehabilitation or repair of the sewage system with the deepening of the sewage pipes from 1.3 m to 3.0 m from the street level;
- Consolidation of the basement by under building of the vaults at a lower level than the initial level and reinforcing of the new foundation by concrete beams;
- Draining of the basement by gravel trenches.
