# The study of rainfall induced sliding of a fill slope in Shenzhen, China

**Abstract:** Due to over 200 millimetres of heavy rainfall on 19 August 2005 and over 300 millimetres of heavy rainfall on 20 August 2005 in Shenzhen, a fill slope was found to be sliding with an approximate volume of 150,000 cubic metres of material involved. A lot of cracks were produced during the two days. The accumulated horizontal deformation along the whole fill slope was up to 500 mm.

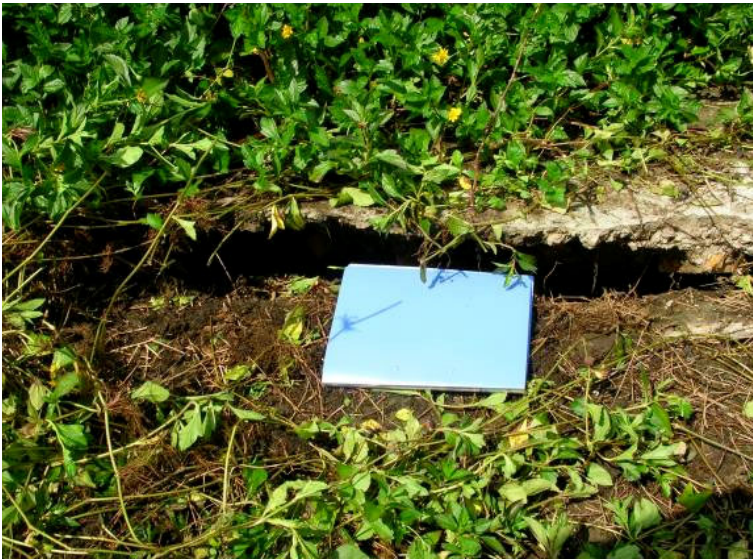
During the incidence of the fill slope, cracks were not only developed in the masonry retaining wall (Figure 3 and Figure 4), but were also developed in the fill slope (Figure 5 to Figure 6). There are three main obvious cracks at the back of the masonry retaining wall, six main obvious cracks on the berm of the fill slope and two main obvious cracks at the crest of the fill slope (Figure 1). Based on the possible boundary of the sliding fill slope, the scar volume is estimated to 150,000 cubic metres. Most of the cracks are tension cracks. The cracks at the back of the masonry retaining wall are open with voids open up to 200 mm, these at the crest of the fill slope up to 100 mm (Figure 5) and these on the berm of the fill slope up to 500 mm (Figure 6). Furthermore, the soil under the pavement on the berm of the fill slope settled up to 500 mm (Figure 7).

**Figure 3.** Crack on the top of the masonry retaining wall

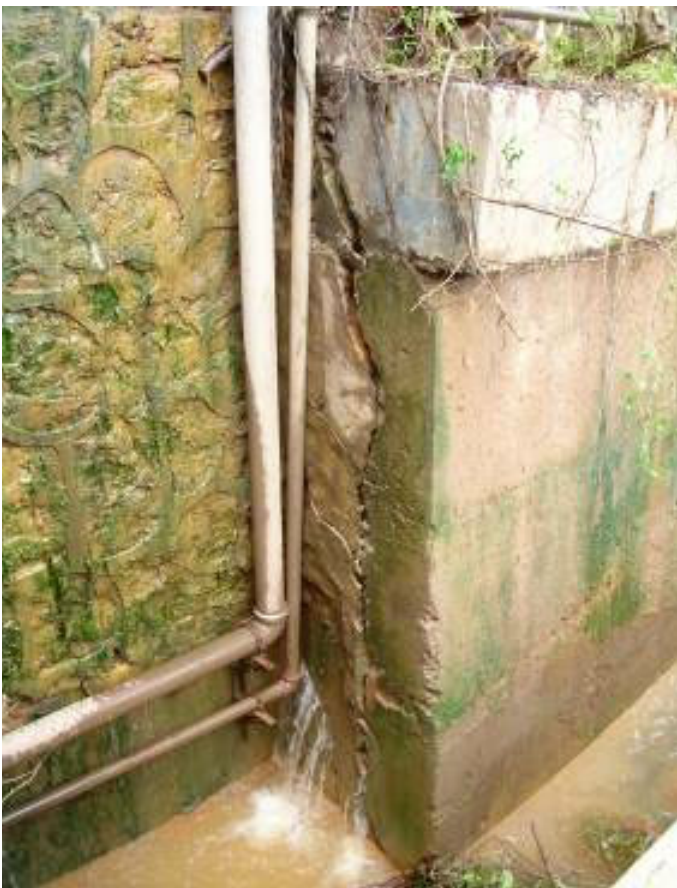
**Figure 4.** Vertical crack along the surface of the masonry retaining wall

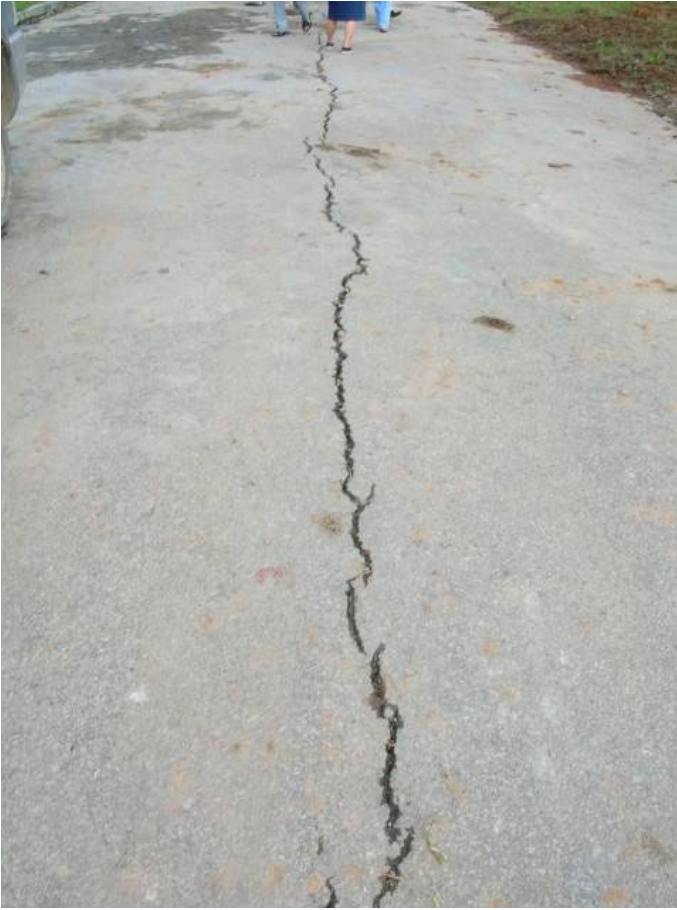
**Figure 5.** Crack at the crest of the fill slope showing horizontal displacement up to 100 mm

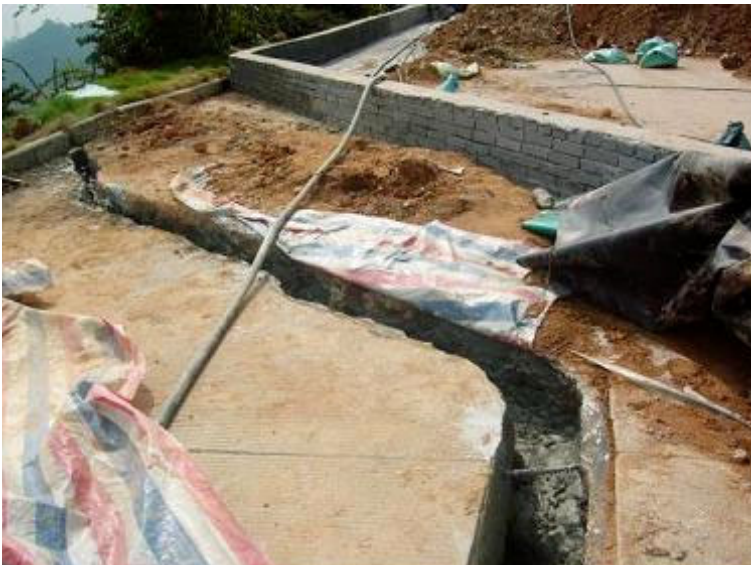
**Figure 6.** Crack on the berm of the fill slope showing horizontal displacement up to 500 mm

A 2.5 m rise of groundwater level and a 30 mm increase of horizontal deformation on the berm during the rainfall brought by Typhoon Damrey may be due to the many cracks on the berm.

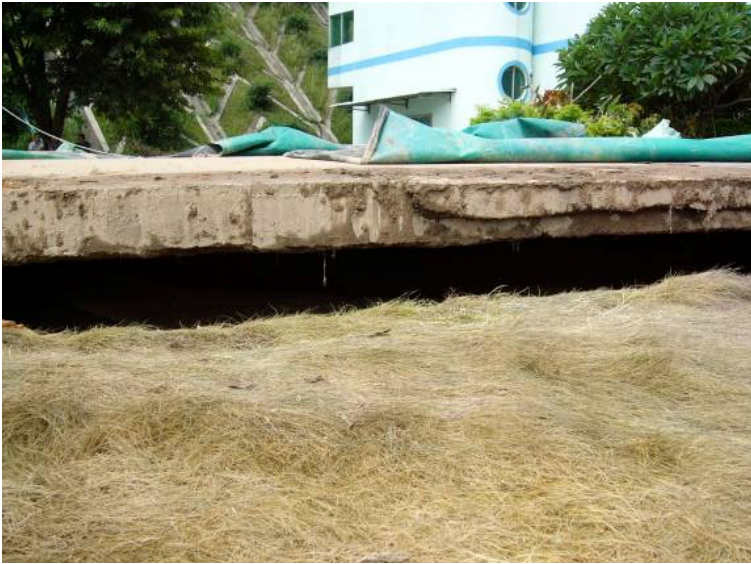
**Figure 7.** Soil under the pavement on the berm of the fill slope settled up to 500 mm

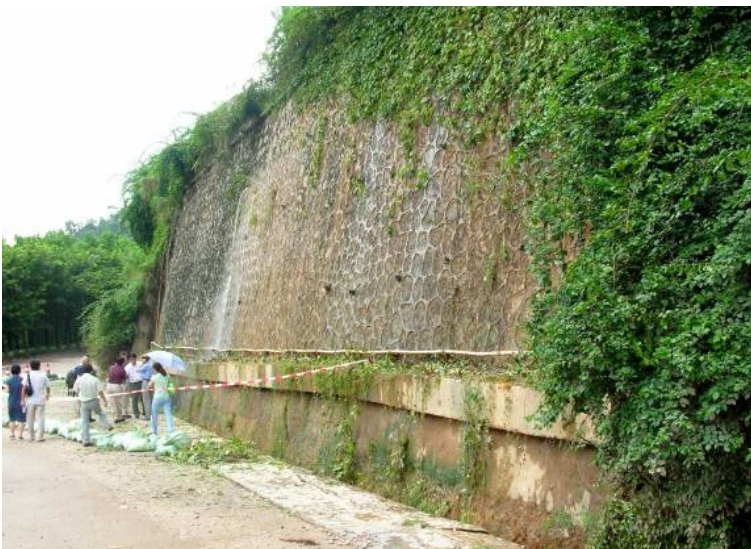
**Figure 8.** Groundwater flowing out of the weepholes of the masonry retaining wall

- As the fill slope is formed by end-tipping, its permeability would be greater, therefore, its infiltration capacity would also be greater, which would finally increase the groundwater level. There is evidence that the groundwater level at the back of the masonry retaining wall was extremely high (Figure 8). Therefore, there is a possibility of a deep-seated zone of large deformation close to the base of the fill, triggered by a significant rise of groundwater level followed the rainstorms on 19 and 20 August 2005.

- Another reason why the groundwater level at the back of the masonry wall is extremely high may be due to the blockage of the weepholes of the masonry retaining wall. Furthermore, it is postulated that the masonry retaining wall is under-designed without considering the rise of the groundwater level and a possible sliding of the fill slope along the sloping surface of highly decomposed sandstone.

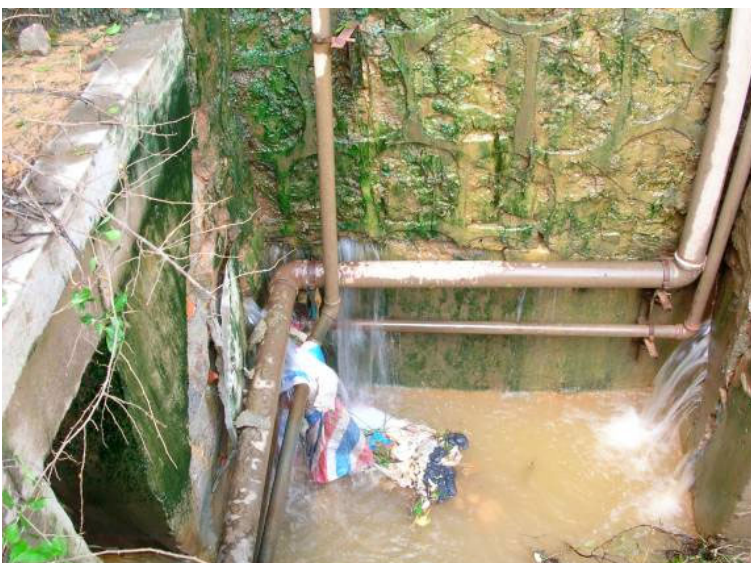
**Figure 9.** Groundwater flowing out of the cracks of the masonry retaining wall

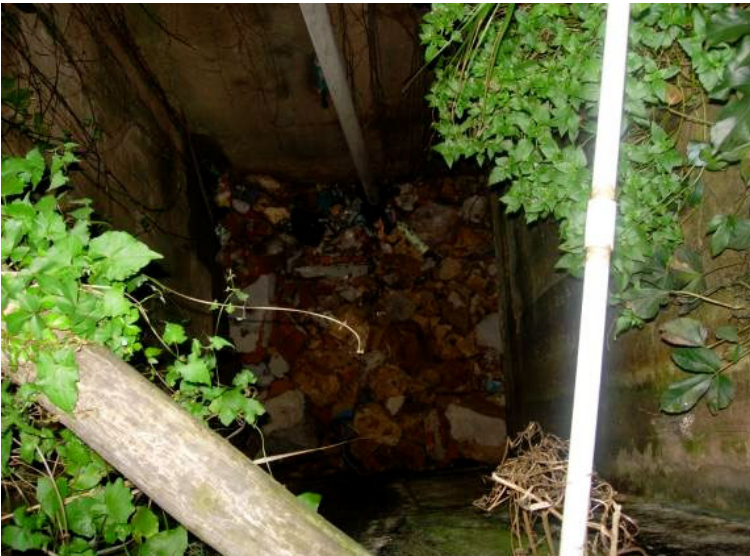
**Figure 10.** Drainage channel at the left crest of the fill slope was seriously damaged and blocked
