Erosion inventory in the region of São Sedro and Barra Bonita cities, State of São Paulo, Brazil

MARCILENE DANTAS FERREIRA¹ & OSNI JOSÉ PEJON²

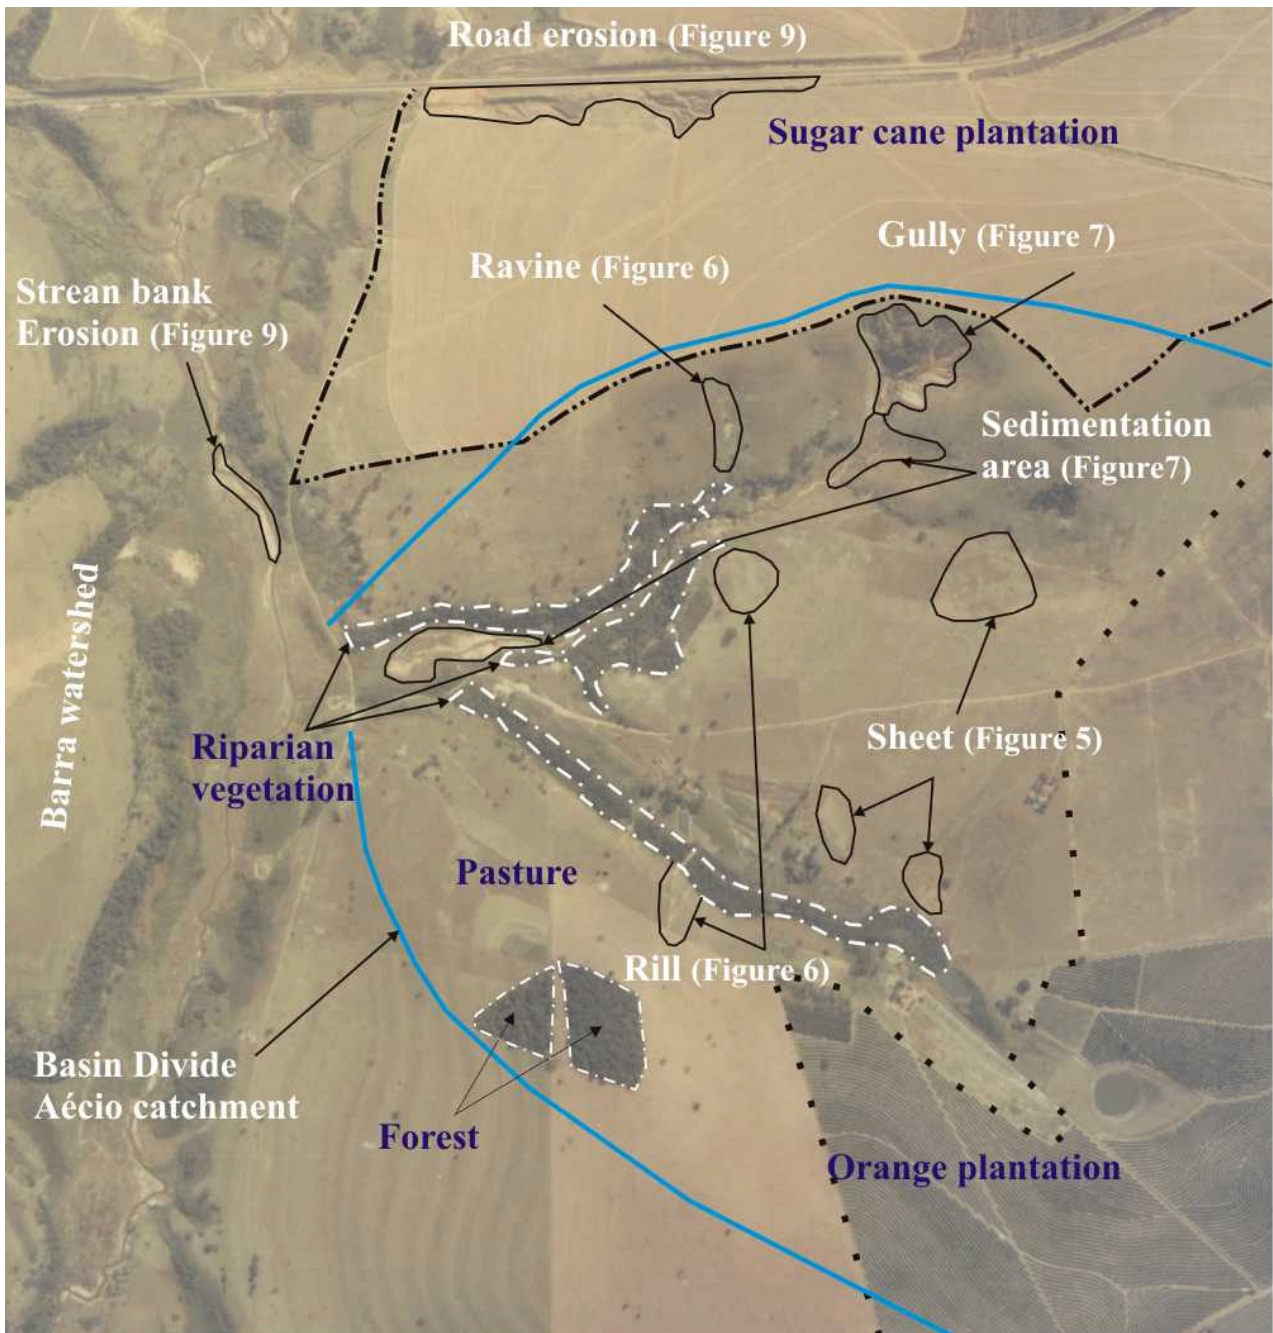
All erosional process types were found to be present. The Aécio catchment (see Figure 2), which is a first order tributary according to the Strahler classification, has been chosen here as an example of the results. This small area is affected for sheet, rill, ravine, gully and stream bank erosion processes.

Figure 4. Aécio catchment with erosion process features and land uses (Aerial photography 2000 at scale 1:30,000).

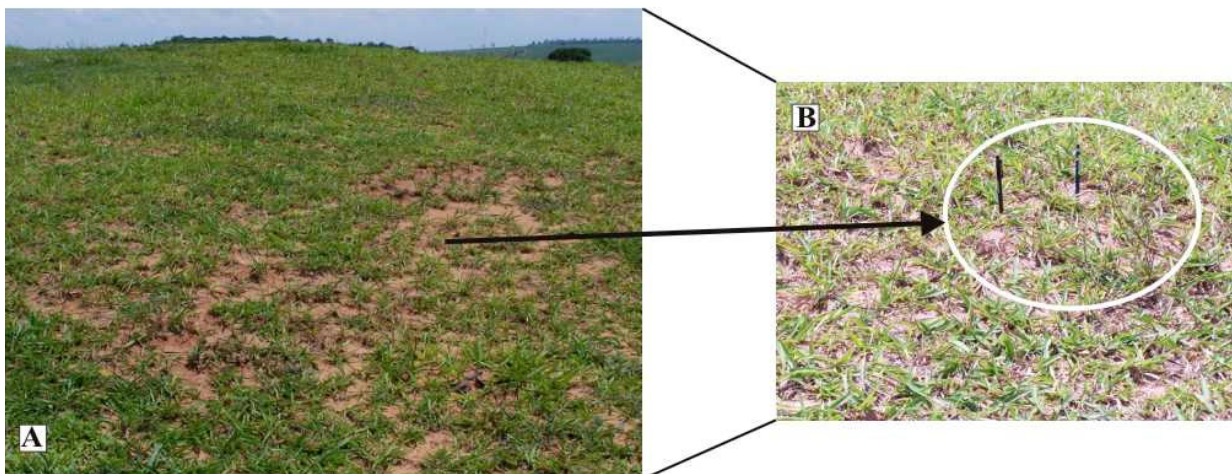
This process affects pasture land and orange plantations, (Figure 4) in the space between 2 terraces (50m) with declivity varying from 5 to 10%. The ground consists of unconsolidated sandy residual soil that has a high erodibility index. The terraces are not an effective means of controlling the erosion because the high rugosity of the micro relief (Figure 5). This process has affected pasture quality and the susceptibility of the terraces to sedimentation.

Figure 5. (A) Sheet erosion and (B) Detail of part of area A.

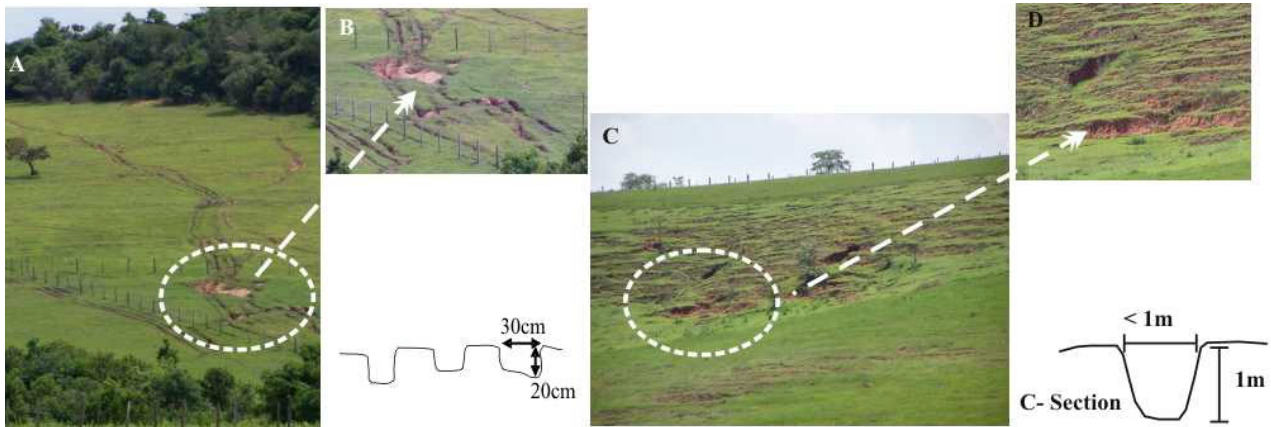
This feature occurs on convex/linear slope, in pasture and orange plantation areas (Figures 4 to 6), at a frequency of 6 features per 20m, where each feature is about 30cm wide, 20 cm deep and 500m long. They have low sinuosity, annual reactivation, low severity, low progress potential. Terraces do not act as good control measures. The main predisposing feature of rilling is the presence of unconsolidated sandy residual soils, with high erodibility index and an opportunity for concentration of water into the channels caused by animal activities. The rills have a great impact on water quality due to high sediment load and they require much rehabilitation to remedy.

Ravines are found on linear/concave slope with a declivity around 25° at a frequency of about 2 ravines/ha. Each one is about 1m wide, 1m deep and from 10 to 50m long (Figure 4 to 6). They develop due to the combined occurrence of unconsolidated sandy soils and water concentration resulting from deforestation, a steep slope and high rainfall. These features have a high progression potential with a severity varying from low to moderate, temporary water flow and there are, at present, no control measures.

Figure 6. (A) General view of the rills, (B) Detail and cross-section of rill, (C) Ravine and (D) detail and cross-section of ravine.

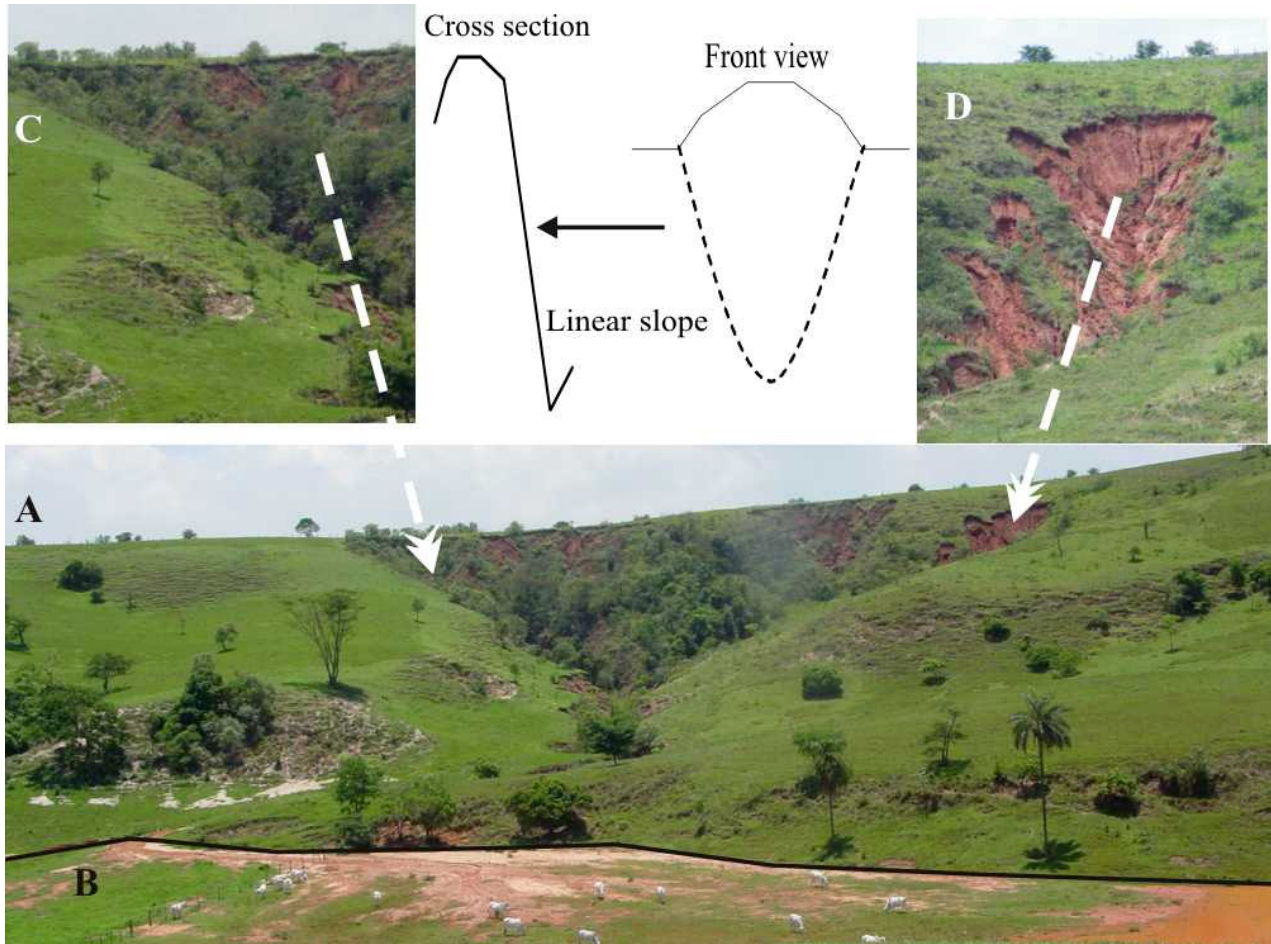
These features occur in convex/linear/concave collector slope, with declivity around 25°. They are 150m wide, 50m deep, and 120m long and lie orthogonally to the Aécio channel (Figure 7). There are 3 main branches having low angularity and variably sloping sides. The area affected is about 12,500m² and eroded volume is about 70,000m³. Gullies develop due to a combination of factors, such as the presence of transported soil or unconsolidated saprolitic residual soils, both with high erodibility indices, very steep slope, and intense rainfall.

The gully shows different activity conditions (active, dormant, stable), high severity degree, and 3 main branches. The drainage system in the area is affected by the gully progression and the water and soil qualities are both damaged.

Figure 7. (A) General view of gully (see different activity conditions), (B) Sedimentation zone, (C) Vegetated portion and (D) Reactivated zone.

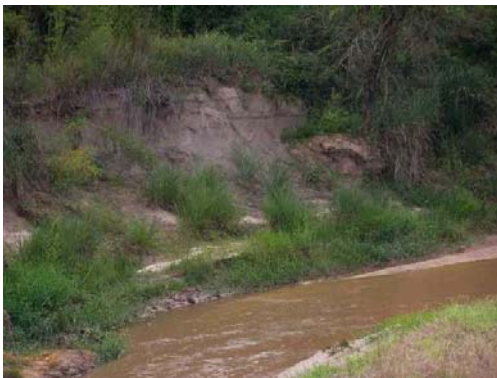
Streambank erosion is found in all rivers of the area and in terrace landforms and slopes, with or without riparian vegetation. Figure 8 shows an example of a 2m high, 50m long streambank where around 150m³ of material has been eroded. The eroded bank is composed of weathered rock underlying sandy alluvial material. These streambank features are due to river bend and flooding conditions. The feature is covered by vegetation; but the toe and upper bank are eroded. There are no control measures and they continue to grow. The process affects bridges, the quality of the water and rate of siltation.

Figure 8. Streambank erosion process.

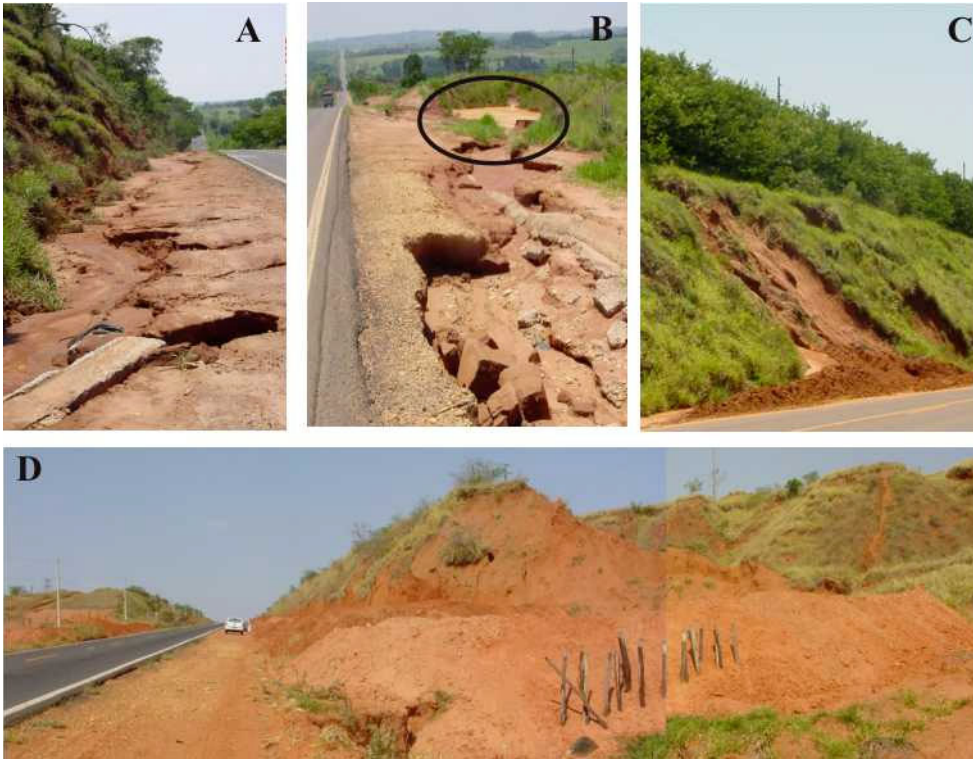
Both paved and unpaved roads are affected by erosion processes in that natural and man-made slopes are eroded due to discharge from surface water drainage systems and the roadway. Figure 9 shows examples recorded in the Barra watershed.

Figure 9 - Slope and road affected by erosion process (a- ravine, b- control measure, c- slipping and d- gully).
