Terrain failure in a suburban area of Almada - Portugal

P. C. LAMAS ¹ & J. A. RODRIGUES-CARVALHO ²

IAEG2006 Paper number 166

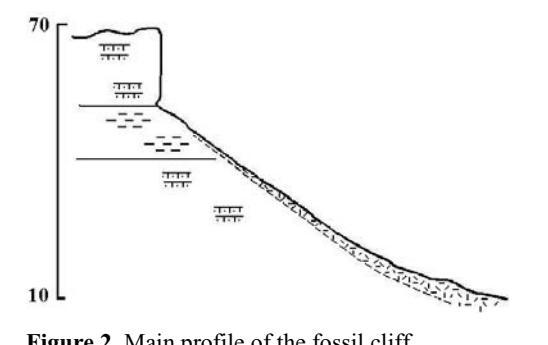
The stretch of scarps in reference is constituted by Miocene soft rock/hard soil layers. Its profile (Figure 2) was due not only to the lithology (soft sandy limestones and marly sandstones overlying silts and clayey silts and, closer to the toe, marls and sandy limestones alternating with some silts) and to the structure (direction of the slope almost perpendicular to the layers, which incline very gently towards SSE) but also to the sea erosion acting in recent geological times.

Figure 2. Main profile of the fossil cliff.

The frequent collapses at the higher layers of the slope and the consequent accumulation of the displaced materials at the cliff toe are responsible for a gradual widening of the slope profile, although in the upper part, where those phenomena are originated, vertical walls persist.

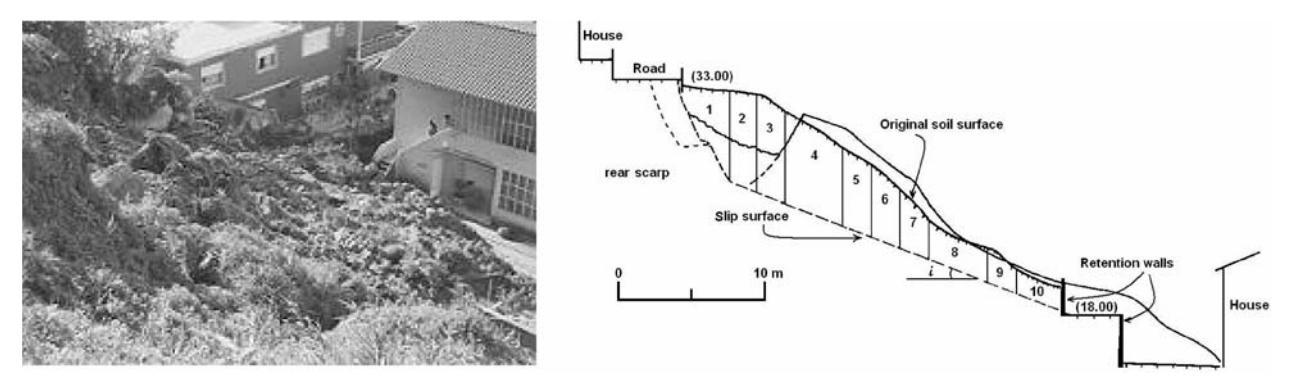
The rear scarp of the slide was initially 4 m high and, due to the percolating forces imposed by groundwater towards the slope, a fast backwards progression of that scarp was verified, threatening two small houses implanted a few meters back from the slope crest. Later, the excavation of the soil debris that filled the backyard of the house in front of the slope toe reactivated the movement, increasing the height of the rear scarp to 5.5 m.

These elements, in conjunction with the knowledge of the lower zone of the slope affected by the movement, allowed the definition of the position of the slip surface. For the interpretative model, the slipped mass was considered to have a maximum thickness of about 6.5 m in the zone of the slope crest, gradually decreasing towards the toe.

Figure 3. Sight of S. Pedro slide taken downwards; Interpretative profile.

The "graben" like sinking of a stretch of the slope crest during the movement and the maintenance of the verticality of the low vegetation that covered the slope, led us to classify this movement as a planar slide. Because it was a second occurrence in the same slope and large shear displacement had occurred on the slip surface we believe that the shear strength on the slip surface would have reached the residual shear strength.

functioned as a barrier to the percolating waters. Such conditions allowed the development of strong hydrostatic pressures over the wall and contiguous terrain and an inwards forced percolation. In the days before failure, in the light concrete pavement of a narrow street behind the crest of the slope, cracks occurred (or existing cracks were widened) parallel to the direction of the slope crest. We believe these tension cracks may have become totally filled by water immediately before failure. At the same time, a great amount of water and mud appeared in several points of the slope, mainly on the back of the recently built retaining wall, few meters above the slope toe wall.

On the basis of the geometry of the movement as it is shown in Figure 3, and assuming, at the moment of failure, a groundwater level 3 m below the level of the slope crest, the following value of ϕ' is given by limit equilibrium analysis for FS equal to unity and assuming c' equal to zero. (for FS=1: $\phi' = 24.3^{\circ}$ if c' = 0). The value of ϕ' calculated will be sensitive to the water pressures assumed. A calculation assuming a higher piezometric line within the slope, or assuming a water-filled tension crack at the crest, will give $\phi' > 24.3^{\circ}$.

Repeating the limit equilibrium analysis taking into account the existence of hydrostatic pressure corresponding to a column of water acting on a 6 m deep vertical crack at the crest gave $\phi' = 29.6^{\circ}$. (for FS=1: $\phi' = 29.6^{\circ}$ if c' = 0).

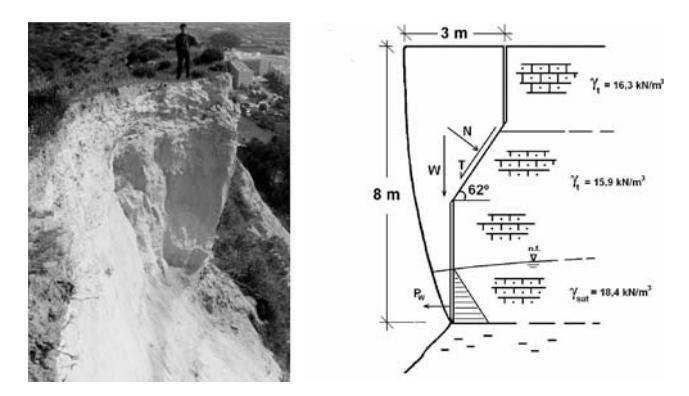
The block detachment occurred from a complex surface, formed in cross-section by three planes: two of them, both vertical, seemed to correspond to two different tension cracks; the third plane, with an inclination of about 62°, linked the two others (Figure 4).

The unstable block was not in balance over the underlying clayey silts, as it could be observed at the adjacent stretches of the scarp. The reason of this was that the stretch of scarp had been already affected by a previous movement, in 1988, with the detachment and fall of a lime sandstone panel, which partially buried a small building (Lamas and Rodrigues-Carvalho, 1994). The rock fall of February 1998 could result from shear in the marly sandstone exposed between the two tension cracks. The operating forces must have been the weight of the block, possibly helped by the hydrostatic force in tension cracks.

Figure 4. View of the scarp taken upwards, immediately after the rock fall of February/1998; interpretative profile of the detached block.

After the movement, the recent exposed surface revealed some moisture 1 m high from the base. Assuming that this could be the height of the groundwater level, perched on the impermeable clayey silt layers, the preexisting tension crack would enclose an equivalent height of water and the lowest 1m layer of sandstone might be saturated.

- W: weight of the potential unstable block; assuming a detached block with unitary thickness and 3 m wide at the top, as shown in Figure 4, its weight would be 228.2 kN. For this calculation, a water content of 5.0 % was assumed for the upper 7 m of the block while for the lower 1 m, the material was considered saturated.

Limit equilibrium analysis gave a value of FS of about unity when the peak shear strength values measured in the laboratory were assumed in the calculations: i.e. c' = 50.7 kPa; $\phi' = 33^{\circ}$. This appears to offer a satisfactory theoretical explanation of the failure.
