Weathering and deterioration evaluation of a Brazilian cultural heritage building

Abstract: Rio de Janeiro's Municipal Theatre building was built in an eclectic style at the beginning of the 20th century (1905-1909). Its design was inspired in the Paris Opera of Garnier and blocks of gneissic rock were used as masonry on the first floor. It has been considered a Brazilian cultural heritage since 1973.

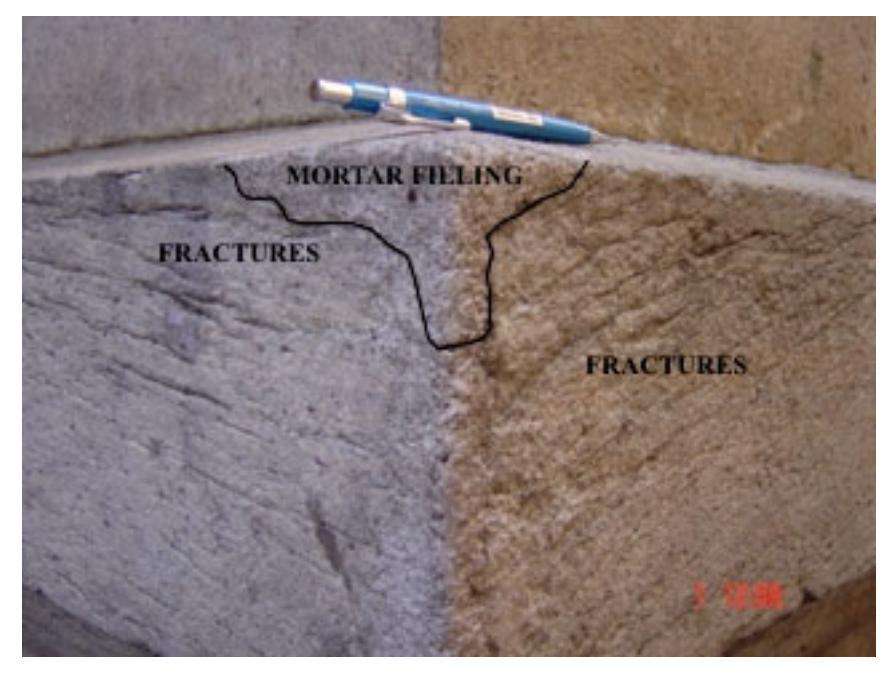
The weathering morphology is clearly controlled by the texture of the rock. It is noticeable that the formation and propagation of fractures through out the foliation occurs in the places where the gneissic foliation is more developed, producing peeling or exfoliation. Figure 3 shows it very well. It is worth noticing that this fact matches with the observations of Barroso et al. (1993) who, by studying the weathering of these same gneisses obtained from outcrops in the city, verified that the fracture propagation process began parallel to the rock foliation. When the metamorphic rock foliation gives way to a magmatic texture, the weathering morphology is revealed in a granular disaggregation, as it is exposed in Figure 4.

Figure 3. Fractures formed following rock foliation.

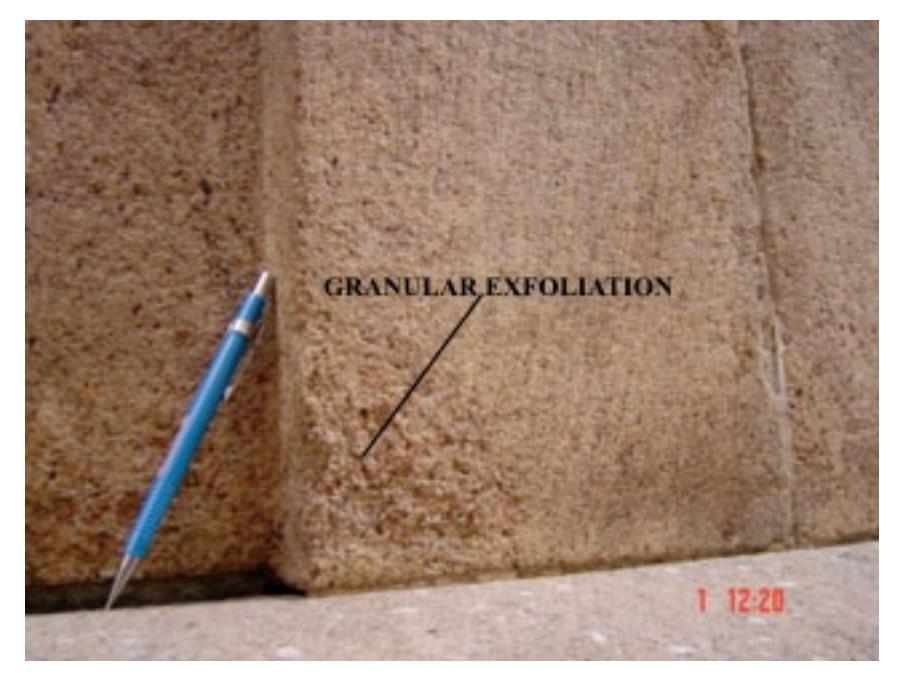
Figure 4. Granular exfoliation developed where foliation is absent.

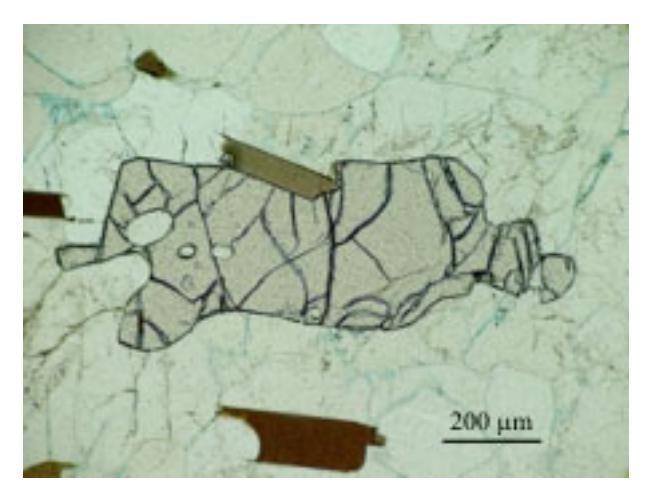
When the mineral alteration characteristics can be verified at a microscopic scale, some interesting behaviour is highlighted. Figure 5 shows a garnet with an enhancement in its internal micro fractures' shape. It is interesting to

Figure 5. Internal fractures of garnet become evident by iron oxide precipitation.

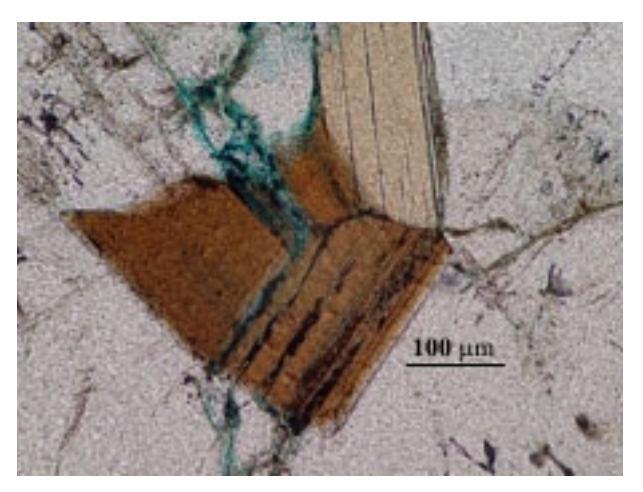
Figure 6. Biotite's cleavage marked by iron oxide.

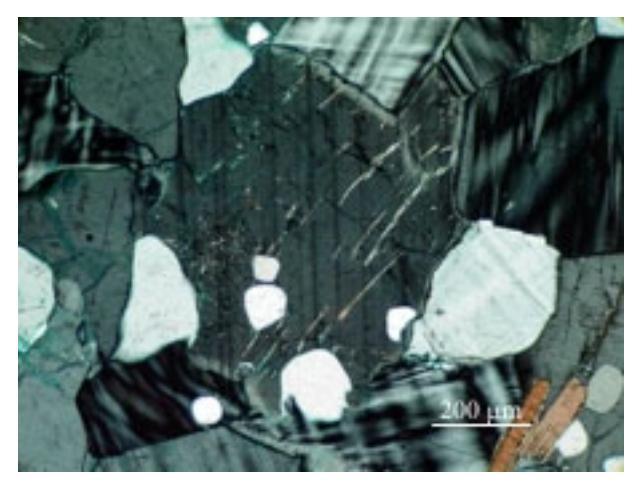
Figure 7. Sericite formation along microcracks in plagioclase.

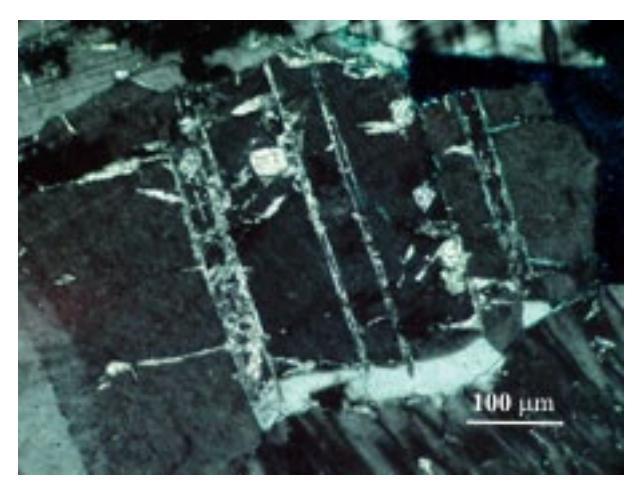
Figure 8. Sericite formation along plagioclase's lamellae.

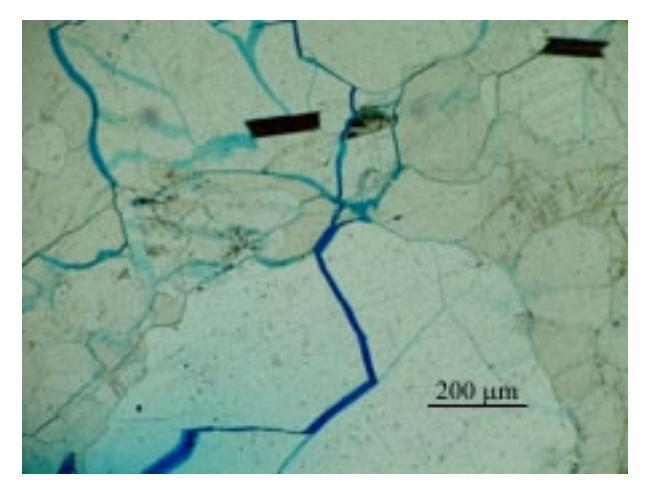
When it comes to the development of micro fractures (Figure 9), it is evident that they tend to propagate on the grain outlines (intergranular microcracks). This fact probably causes loosening to the rock matrix.

Figure 9. Presence of microcraks (blue lines) on grain outlines.

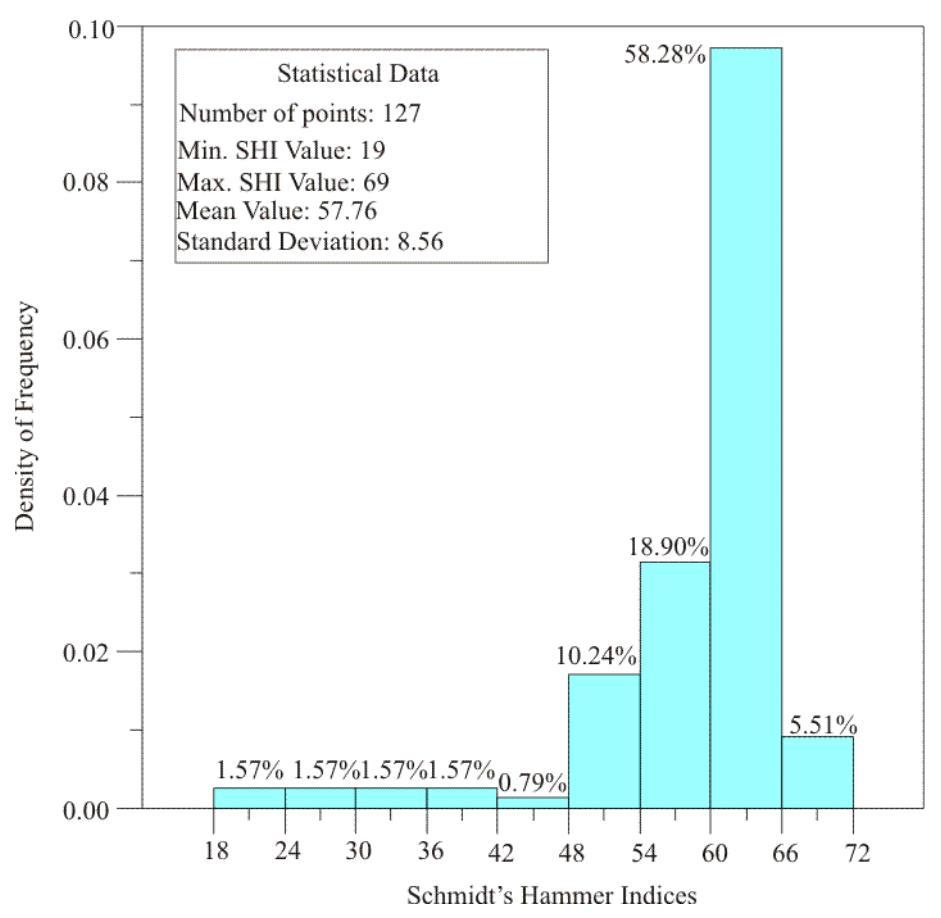
Figure 11. A typical histogram obtained for Schmidt's hammer values.

The unconfined compressive strength of the rock was calculated based on the chart presented by ISRM (1981) for L type hammers used vertically. By applying a 26 KN/m³ unit weight to this rock and considering the mean value of the histogram in Figure 11 (SHI = 58), a value of unconfined compressive strength of 220 ± 100 Mpa is obtained.

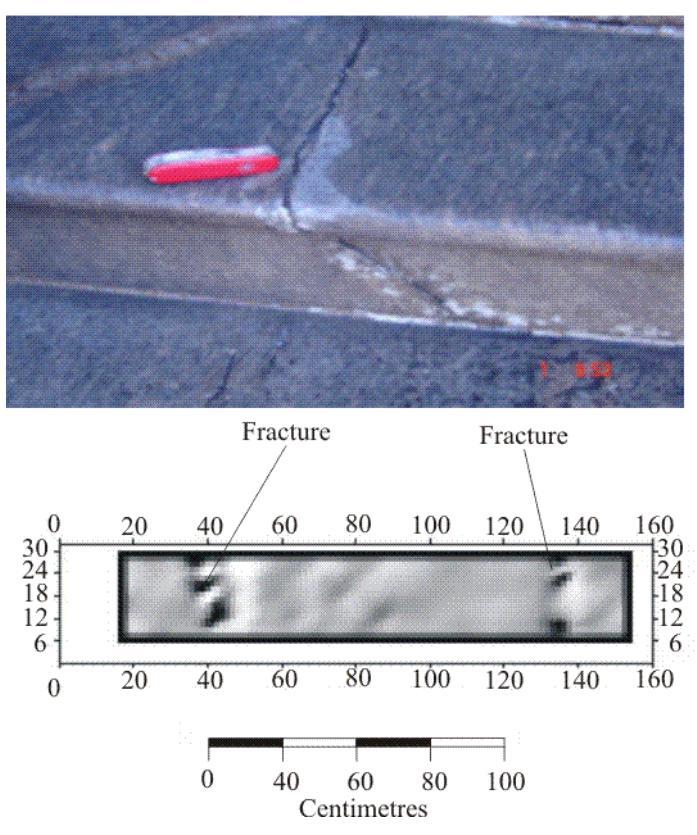
The Schmidt hammer proved to be very useful to map the rocks' fissures. This was only possible due to the fact that the values near these physical discontinuities became really low if compared with the remaining points of the rock. This investigation was held on the staircases of the Municipal Theatre and the data can be seen in Table 6. In Figure 11 there is a histogram that represents the condition of the external stairs of the Theatre. In order to map the fissures, Schmidt hammer data have been linearly interpolated on the sampling mesh. The shadow diagram presented in Figure 12 exemplifies the use of the technique on one of the steps of the staircase. The dark colours are low values of SHI and represent the presence of fractures or fissures on the rock when its distribution occurs in a stretched form.

Figure 12. A shadow chart making evident fractures on the stairs.
