# Urban geology of Maputo, Mocambique

# E M VICENTE<sup>1</sup>, C A JERMY<sup>2</sup> & H D SCHREINER<sup>3</sup>

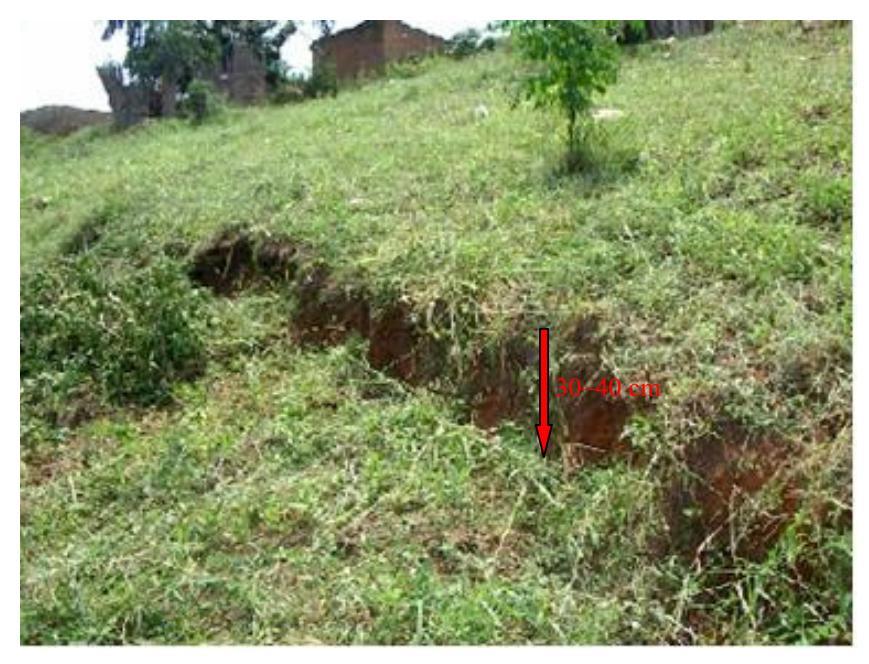
The first site is on an abandoned natural slope located along Nações Unidas Avenue in the South of the city where the coastal slope curves inland along the Maputo Estuary. The slope is at an angle of about 25 degrees and is, in general, straight and uniform when viewed along the slope from South to the North. It is vegetated with grass and shows a mid-slope tension crack with a vertical displacement of 30–40 cm (Figure 4). Evidence of water seepage is observed at the base of the slope. The City Council has undertaken remedial action through the construction of gabions along the base of the slope.

Figure 4. Shallow landslide along Nacoes Unidas Avenue with a vertical displacement of 30-40 cm.

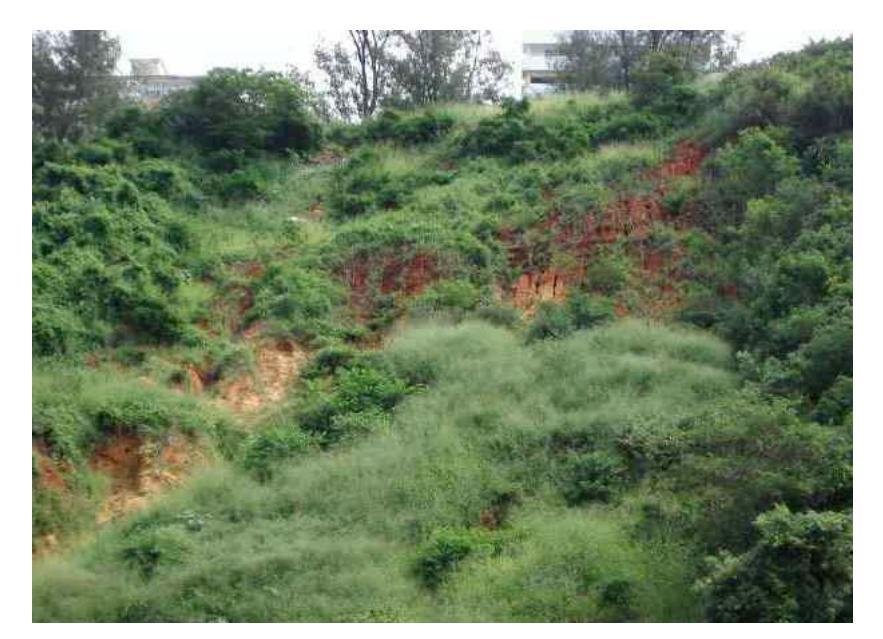
Figure 5. Gap of thick vegetation (30 m wide) in the slope along Friedrich Engels Ave (Photo taken from the Marginal Ave). New vegetation starts to grow up in the area.

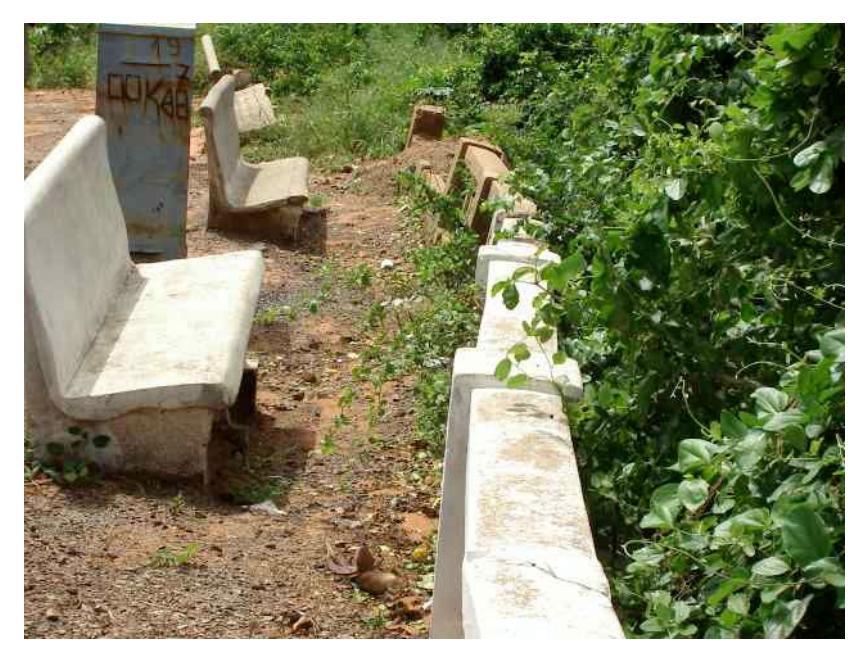
The second site is at Friedrich Engels Avenue. The coastal slope at this locality faces southeast towards Maputo Bay and is approximately 40 to 50 meters high with a slope angle of 60°. The slope is thickly vegetated with shrubs and small trees. The slope is considered to be active with the most recent failure comprising a high angle slump indicated by a gap of thick vegetation in an area of about 30 m wide (Figure 5). Additional evidence of movement is observed at the top of the slope where, a 5m high masonry retaining wall has required repair, distortions of the drainage system below the retaining wall are apparent and destruction of the protection wall in the North side of the promenade has occurred (Figure 6). These observations strongly suggest that this section of the slope is in an unstable state, and will continue to suffer minor failure unless stabilised. The landslide problems in this site were first observed following heavy rainfall in February 2000. As a result of poor drainage on Friedrich Engels Avenue, surface water was able to enter a tension crack that developed in the pavement of the road. Therefore, it is assumed that water flowing into the top of the slope raised the water pressure and reduced the soil's shear strength contributing to slope instability. Additional contributory factors also include, the existence of walls and paved surfaces with a weak drainage system and head loading (construction above neutral line of slide).

**Figure 6**. Evidence of movement at the top of the slope along Friedrich Engels Avenue. Protection wall in the North side of the promenade destroyed by the slope movement.

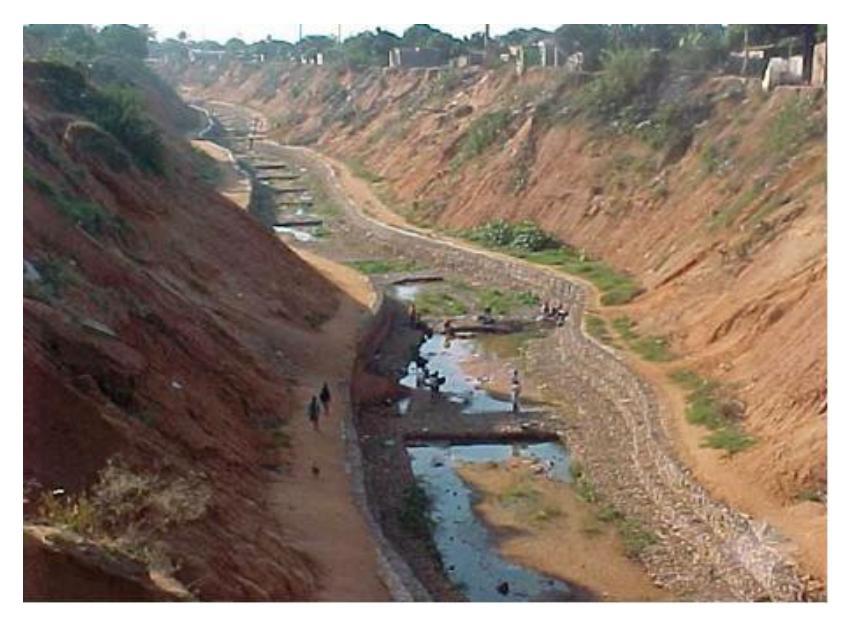
The Polana-Caniço and Ferroviário residential areas are crossed by gullies. The gullies are extremely large, (1 to 15 m deep), with very steep side slopes (typically 60 degrees) but with locally steeper sections (Figure 10). They are W-E oriented, however some follow the orientation of the roads, mainly the Julius Nyerere Avenue. Gullying failure has occurred in a built up area causing the destruction of a number of houses. In this location, the housing development is informal, unplanned and characterized by low quality houses inhabited by the poor who have no access to tenured land. The infrastructure and services are inadequate. Remedial works are generally completed soon after gullying occurs and typically comprise gabion baskets of rhyolite used to protect the floor of the gullies, to support the base of the sides and to protect them from further erosion. The sides of the gullies are still uncovered due to their steepness and can be unstable in future heavy rainfall events. Solid waste has subsequently been observed gradually filling the channel and impeding water flow with consequent implications for the future. In addition, gullies are being used to tip solid waste.

Figure 10. Deep gully cutting through the Polana-Canico Residential Area.

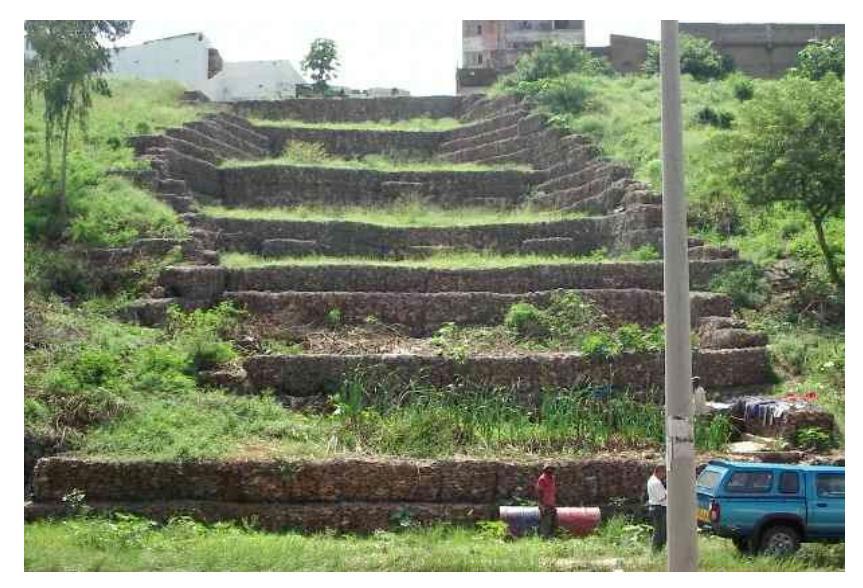
The gully in the Nações Unidas Avenue (Figure 11) is on the slope with an angle of about 25 degrees and is general straight and uniform facing the Maputo Estuary to the South. The slope angle (of approximately 25°) suggests a gullying failure origin as the depth of the gully is greater than would be expected for a slump and the width of the failure is proportionately too narrow (Forster, 2001). The gully was probably caused by failure of the drainage system at the top of the slope. Water seepage is also seen at the base of the slope. Effective remedial work has been completed by supporting the slopes with gabion baskets filled with rhyolite.

Figure 11. Gully along along the Nações Unidas Ave. Remedial work was completed by supporting the slopes with gabion baskets filled with rhyolite.

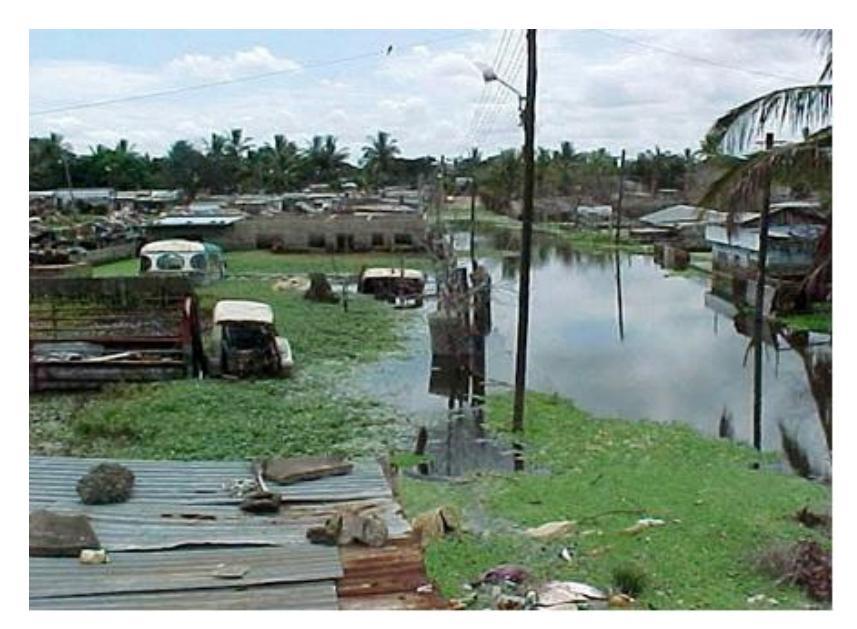
Areas of Maputo City are prone to flooding in heavy rainfall. The causes of flooding in these areas are mainly of geological and topographic nature but associated to land use practices. Two of these areas are the Inhagóia residential area and Bairro Indígena. The Inhagóia residential area is densely populated area and was covered by water after the 2000 floods (Figure 12). Two contributory factors can be identified. Firstly, the surficial sandy layers of the Congolote Formation are underlain by low permeability clayey layers of the Machava Formation reducing infiltration. Secondly the topographic location of the area played also an important role in water accumulation.

Figure 12. Flooded area in Inhagoia Quarter after the 2000 floods.
