Geotechnical aspects of the Strood and Higham railway tunnel relining and refurbishment

Abstract: The Strood and Higham Railway Tunnel is some 3.7km in length and was originally built as a canal tunnel enabling boats to pass freely between the river Medway and the river Thames. The tunnel was excavated between 1819 and 1824 through reasonably competent Seaford Chalk such that many sections were left unlined. In 1830, a 100m long section was opened out in cutting as a passing basin for the canal boats before in 1844 a single track railway was added to the tunnel. Finally in 1846, the canal was infilled to permit a double railway track to be built. Over the years, the operating railway has suffered disruption because of flooding, problems associated with old shafts and from chalk falls in unlined sections of the tunnel, one of which in December 1999 caused derailment of four railway carriages. Six months later one of the original construction shafts collapsed and the tunnel was closed for four weeks, re-opening only after a 30km/hour speed restriction was applied. This was clearly not a viable long-term solution and following option studies, in January 2004 a 12 month blockade began

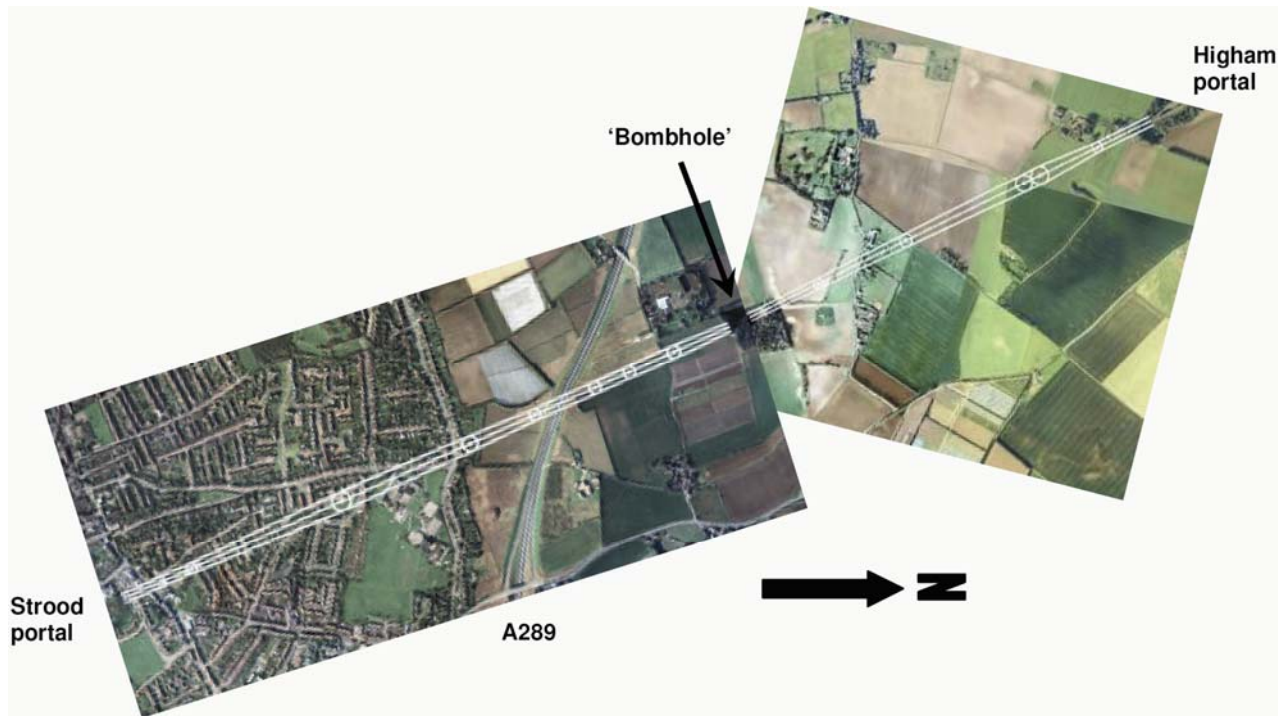
Figure 1. Tunnel location plan

Strood and Higham Railway Tunnel is located on the North Kent Line between Higham Station and Strood Station. The tunnel runs in a south-easterly direction (Figure 1) and was originally constructed as a canal tunnel as part of the Thames and Medway Canal which ran from Gravesend on the River Thames to Strood on the River Medway. The canal was first conceived by Ralph Dodd so as to allow sailing barges to pass between the two rivers thereby avoiding the longer sea journey around the Isle of Grain. Construction of the tunnel commenced in April 1819 and was completed in May 1824 being open to traffic on 14th October 1824.

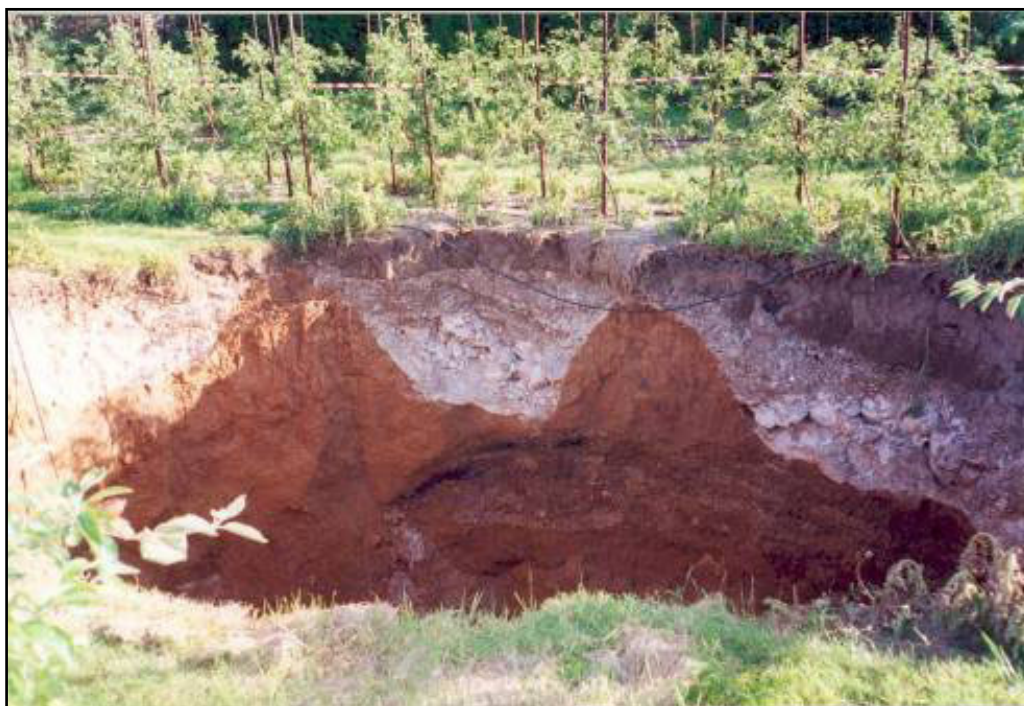
Figure 6. Surface void produced by collapse of shaft S4

Of the twelve shafts present along the alignment (with diameters ranging from 1.2m to 3m), five are in the Higham section and seven in the Strood section. Eight shafts were clearly visible in the crown of the tunnel and the positions of a further three were indicated by the pattern of brickwork lining the crown. The position of the remaining shaft, S4, was confirmed when, on 12th June 2000, a large hole (Figure 6) opened up in the orchard over the centreline of Strood Tunnel in the vicinity of a shaft position previously reported by the Kent Underground Research Group.

Although there was no distress to the tunnel, both tunnels were closed to rail traffic. Following inspections, Railtrack (now Network Rail) decided to keep the line closed and to inform immediately any landowners who had shafts beneath their land. It was also decided to carry out remedial works to any shaft considered to pose a significant risk either to the railway beneath or to the people or property near the shaft tops. Following a series of investigations, including historical searches, ground investigations in and around shafts and CCTV surveys up from the shaft base from inside the tunnels, many of the shafts were infilled with grout or foamed concrete. This work was carried out from the date of the collapse until when the line was reopened on 31st July 2000. Further investigations, however, were continued at shaft S4, with eight boreholes being drilled from the surface around the perimeter of the shaft to a depth of some 40m (i.e. 10m below the bottom of the shaft) to allow cross hole seismic tomography to be carried out.

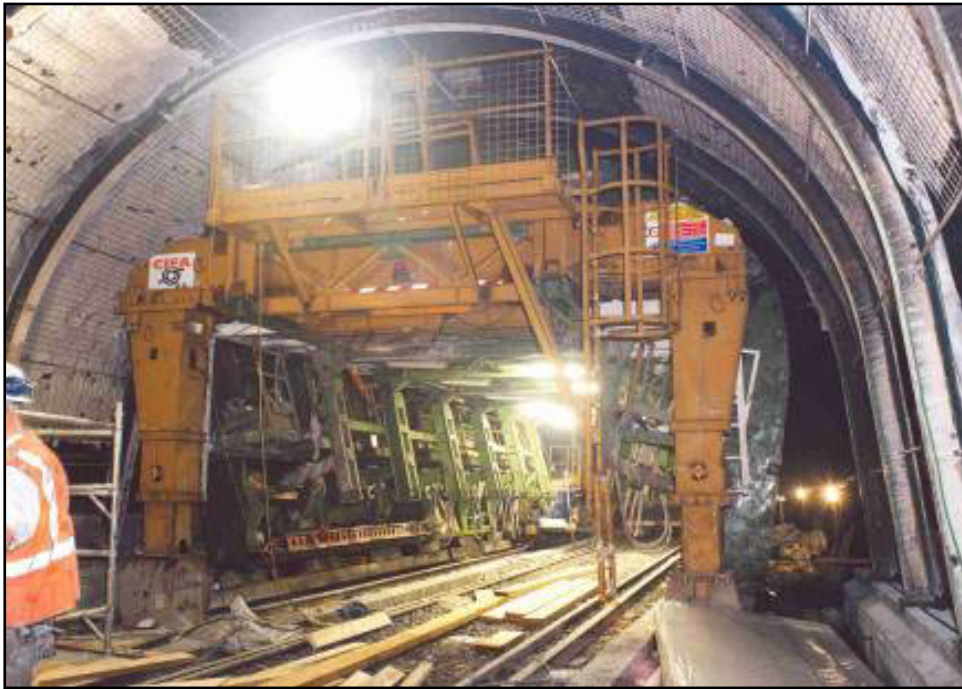
Figure 8. Tunnel lining works

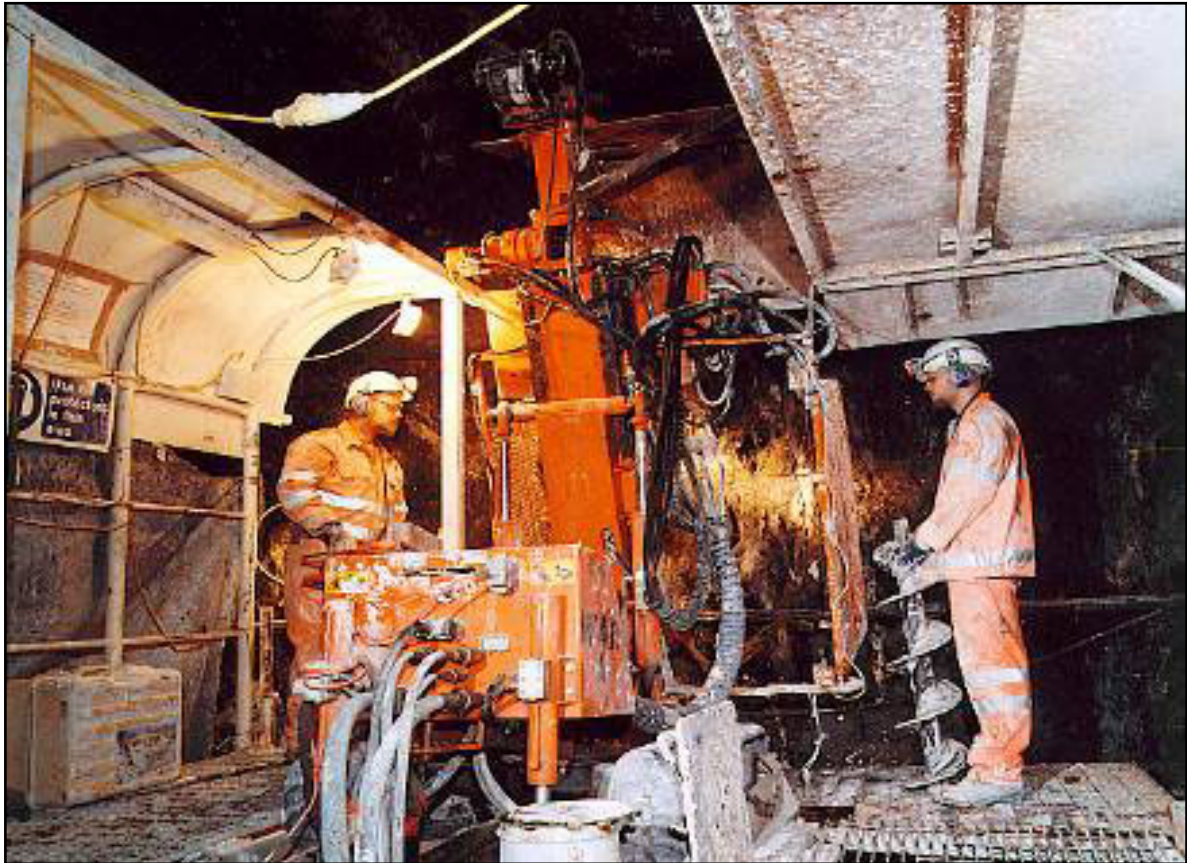
Figure 9. Auger rig used for piling operations

- Casting a 0.6m wide by 0.3m deep first stage capping beam along both sides of the unlined section of tunnel with inserts at 2m centres for positioning the raking minipiles.
- Installation of 300mm diameter concrete minipiles, some 7.5m long drilled outwards at 2m centres at about 17° to vertical, so as to extend through the canal fill and into the chalk sidewall. Each minipile was reinforced to its full depth by the installation of a 112mm diameter steel tube centrally placed in the hole, the tube acting as a tremie pipe during concrete placement. The piles were bored by three small auger rigs fitted with canopies to protect personnel from chalk falls (see Figure 9)
- Casting a 0.6m wide 0.5m deep reinforced second stage capping beam above the first stage capping beam and installed minipiles.
