# Technical developments in the monitoring of the Folkestone Warren landslide complex

GRAHAM BIRCH<sup>1</sup> & COLIN WARREN<sup>2</sup>

**Abstract:** The Folkestone Warren and adjacent sea cliffs have provided considerable challenges to students and practitioners in both engineering and geology since the decision was taken in the 1840's to use this route for the main line between Folkestone and Dover, Kent.

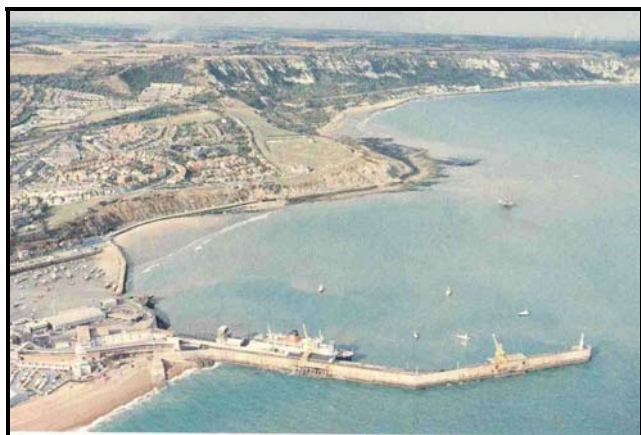
Figure 1. View east from Folkestone Harbour.

Folkestone Warren is the name given to the area of coastal landslide between Folkestone and Abbots Cliff, which occupies an area 2.7km long and between 50m and 350m wide, Figures 1 and 2. The back of the Warren is defined by the 'High Cliff', which is over 100m high and composed of Lower and Middle Chalk. In plan the Warren is cusped in shape and concave towards the sea. The hummocky lower ground within the Warren, known as the Warren Undercliff, comprises entirely landslipped material over which passes the railway. The geological sequence comprises some 200m of strata which dips gently at about one (1) degree towards the north-east, commencing with the ferruginous sands of the Folkestone Beds (Lower Greensand), passing up through the Gault Clay and then into the Lower and Middle Chalk. These deposits are overlain unconformably by thin and patchy deposits of clay with flints and red and brown sands with ironstones.

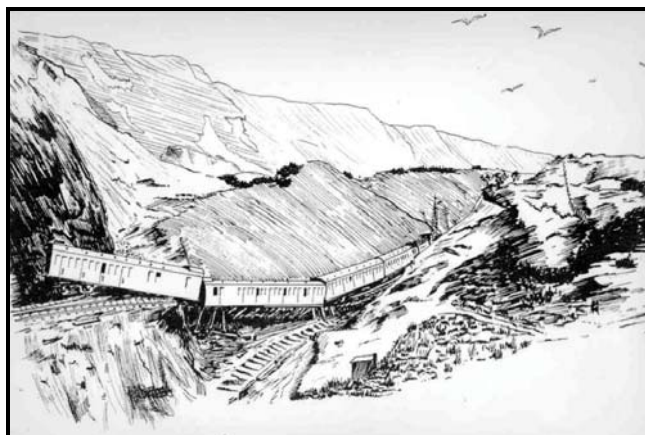
Figure 2. View east of the major slip in 1915.

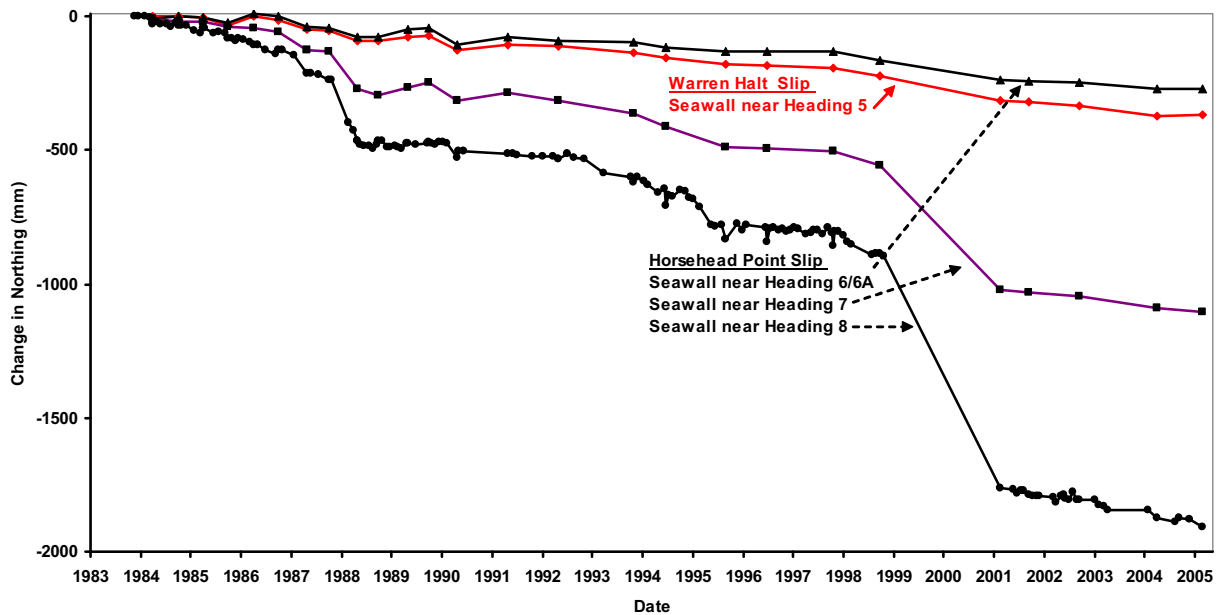
**Figure 6.** Movement of selected points at Warren Halt and Horsehead Point

Four such slips have been recognized in the Warren, east of Warren Halt (Warren and Palmer 2000). The nature of the movements was such that the greatest lateral displacement, rotation and downthrow occurs at the east end furthest from the hinge point. The excessive nature of the rotation at the east extremity can be observed immediately offshore of Horsehead Point where upthrust Glauconitic Marl/Gault dips steeply landward at 70 degrees. Further landward of this location shallower dips of 45 degrees are recorded in the Melbourn Rock (Middle Chalk) forming the Horse's Head itself. Increased movements have been reported in this area since the end of 2000 and this has led to the appearance of fresh cracks extending further west towards Warren Halt. The magnitude of these movements and stability of the Horsehead Point slip block is dependent on the three-dimensional geological make-up of the slip mass which itself is likely to influence the pore pressures acting on the basal slip surface, Figures 5 and 6.

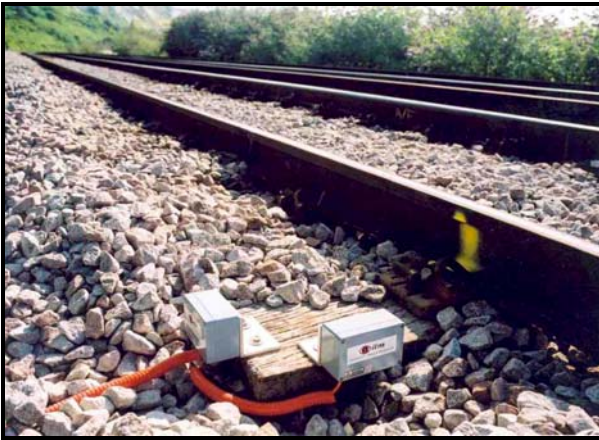
Figure 7. Tiltmeters measure real-time deflections.

Threshold levels, based on track geometry criteria, are set on the electrolevels (Red, Amber and Green), which allows swift remedial action to be taken in the event of significant ground movements, Figures 7 and 8.

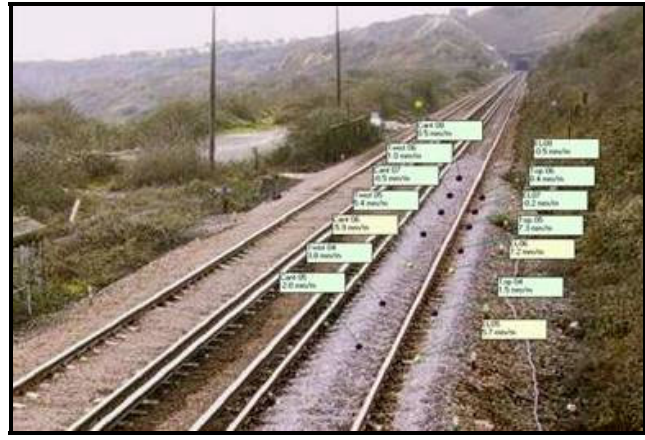
Figure 8. Tiltmeter locations at Warren Halt.

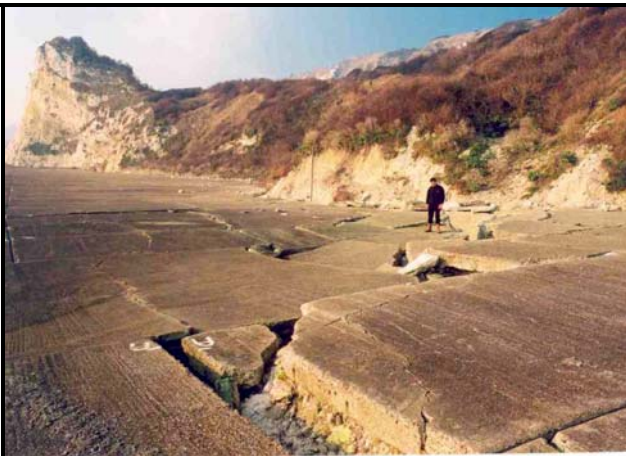
Figure 9. Severed concrete apron at Horesehead Point in 2001.

The density of undergrowth within the Warren Undercliff precludes comprehensive geomorphological mapping to a consistent level of detail throughout the Warren. However, there are a variety of stereo aerial photographs available dating back to the earliest RAF sorties in 1947, which have been used to determine the ground morphology from 'snap shots' in time. A further means by which the morphology is revealed, albeit in a transient way, is the occasional clearance of selected areas of scrub to maintain the habitat for a rare species of moth, the fiery clearwing (*Bembecia chrysidiformis*), which is found only at Folkestone Warren. It is the latter clearance behind Horsehead Point that revealed the existence of graben features bounded by opposite facing normal faults, or 'antithetic' faults, to accommodate the principally lateral nature of the ground movement, Figures 9 and 10.

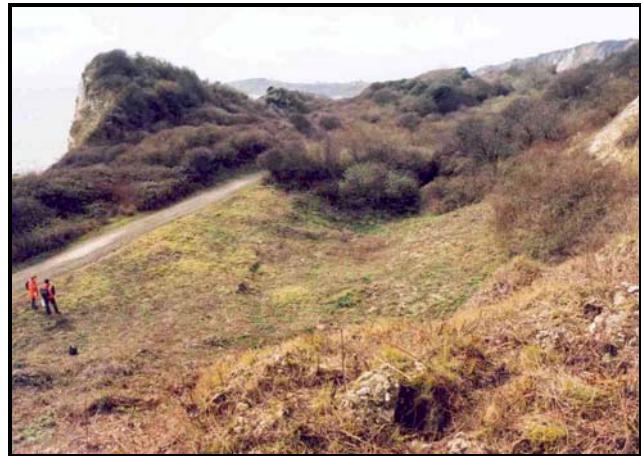
Figure 10. Graben feature at Horsehead Point in 2001.

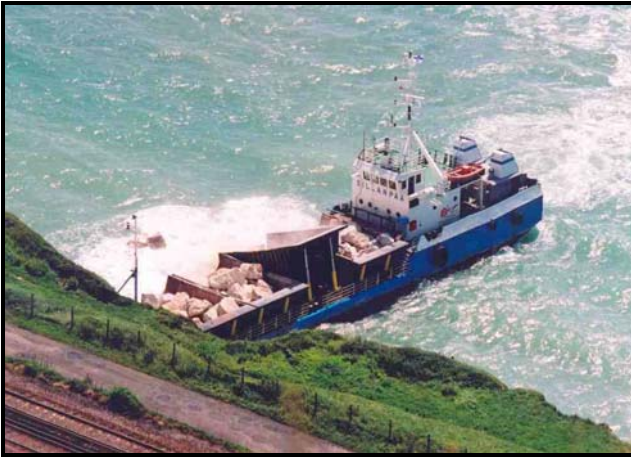
Figures 12. Rocks are off-loaded at high tide.

The recent phases of rock revetment work have been the single most positive contribution to maintaining the coastal defences which, in turn, protect the railway, Figures 12 and 13. The rocks are supplied by quarries in Carboniferous Limestone in Nord-Pas-de-Calais, just across the channel from Folkestone Warren. The rocks, which weigh between 4 and 8 tonnes each, are selected for their durability, prismatic shape and light grey to brown colour.

The rocks are shipped via the ports of Dover or Boulogne in loads of 1,500 tonnes and transferred into smaller barges which unload the rocks within specific drop zones at high tide. The rocks are placed during low water to a designed profile and specification that requires a five point contact in order to achieve the required placed density of 1.87 tonnes per cubic metre.

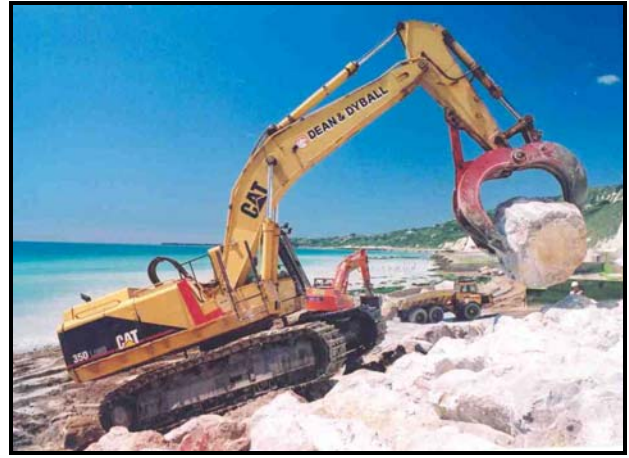
Figure 13. Rocks are placed at low water.
