## Dereliction problems from exploitation of residual soil and ornamental stone at Ubatuba, São Paulo State, Brazil

This paper describes the early stages of an inter-disciplinary investigation that has been conducted to formulate strategies for reclamation and redevelopment of these sites. It attempts to address three key issues: 1) environmental recovery; 2) reduction of hazards; and 3) economic activity. The materials subject to mineral exploitation are derived from the Precambrian crystalline basement of the area (mostly consisting of granites and gneisses). The residual soil is considered an important asset for urban development as it has been used as fill in the construction and maintenance of roads, housing and engineering works in general. Tropical climatic conditions associated with the local hilly landscape gave rise to thick (10-30m) weathered profiles so that exploitation of these deposits required only very simple technology. The ornamental stone (granite bearing pyroxene, commercially known as Ubatuba green granite) is predominantly exploited in the form of rock boulders scattered on hill slopes or within the soil mass. According to previous inventories, there were 33

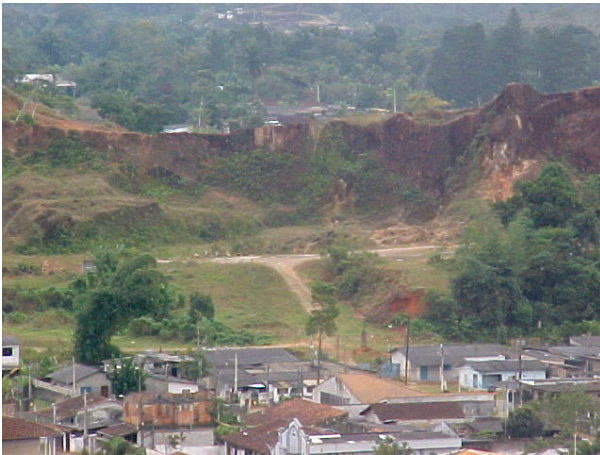
**Figure 5.** Example of an abandoned environmentally degraded site. Note close proximity of housing.

- One former residual soil (“saibro”) exploitation site is being redeveloped as a municipal landfill facility for domestic refuse;
- 39 sites were pre-classified as being environmentally degraded (see Figures 5, 6, 7, and 9), in which geotechnical and engineering geological problems were present, including significant ground instability, mostly in combination with severe removal of vegetation and scenic deterioration. One of these sites is currently licensed (mining and environmental) and from which residual soil is being extracted (Figure 7). A further 10 sites were considered to be semi-active as illustrated in Figure 6 (mainly sporadic unlicensed operations), and 28 sites were considered to be completely abandoned and/or derelict, a number of them involved difficulties in identifying those liable for reclamation works (see Figures 5 and 9).

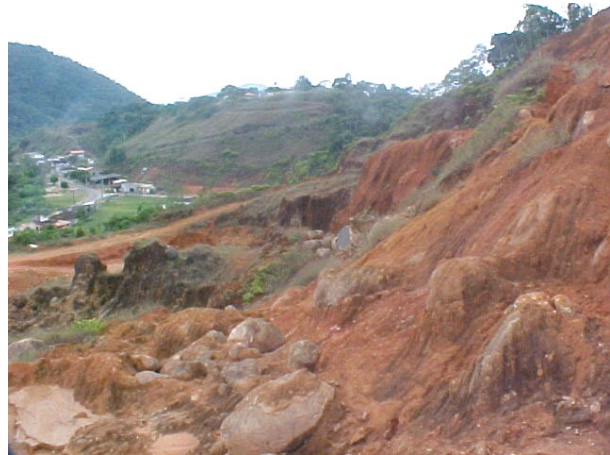
**Figure 6.** Example of an environmentally degraded site. Semi-active mineral exploitation contributing to hazardous conditions due to potential instability.

and/or urban infrastructure (roads, electricity distribution lines, buildings etc) as exemplified in Figures 6, 7, 8, and 9. These included either environmentally degraded sites (some semi-active) or partially recovered sites (Figure 4).

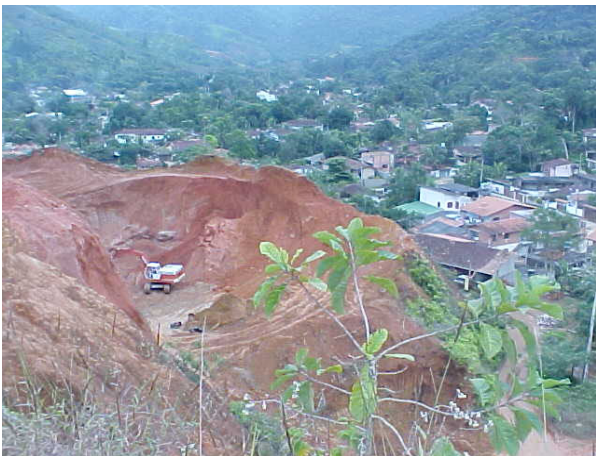
**Figure 7.** Example of an environmentally degraded site. Active mineral exploitation of residual soil (licensed). Hazardous area due to declivity, ground instability and close proximity of housing areas.

An approach that could be considered would be to allow exploitation from selected derelict sites where potential residual soil deposits have been identified. In fact, twelve sites have been preliminarily identified having reserves and should be further studied in more detail. These sites correspond with physiographic compartments (see Table 1) where thicknesses of soil weathering profiles were estimated to be greater than 5 meters (see also Figures 7 and 9).

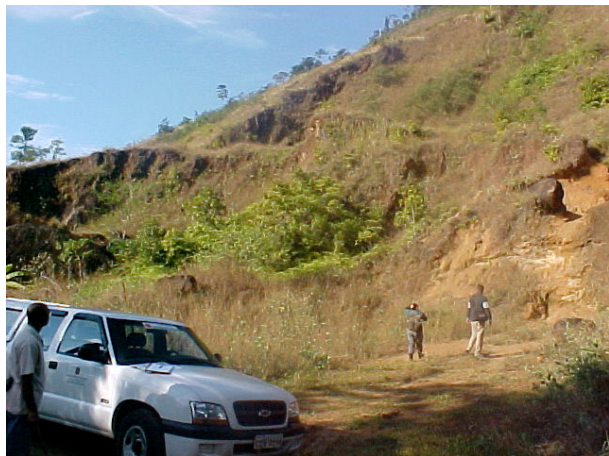
**Figure 8.** Example of an abandoned, partially recovered site. Note hazardous area due to ground instability, close proximity of road, and potential for occupation by low income populations.

- 21 sites were classified as being partially recovered (Figure 8), such that different conditions, geodynamic processes and magnitudes of ground instability were observed in combination with poor or no natural re-vegetation, thus also entailing some scenic deterioration in relation to the surroundings;

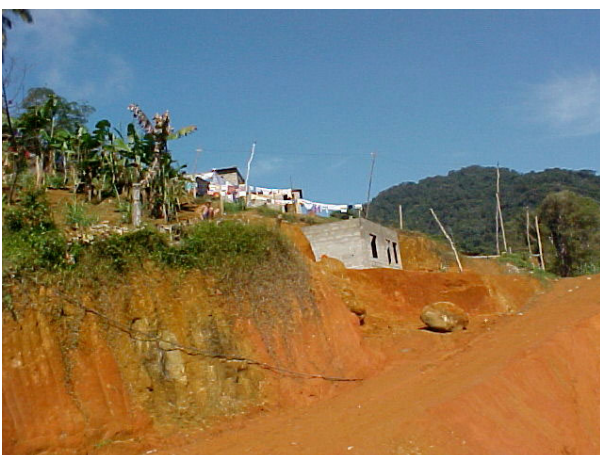
**Figure 9.** Example of unsightly and environmentally degraded site with potential for mineral exploitation of residual soil. Hazardous area due to declivity, ground instability (note detached blocks of rock), and informal occupation by low income populations

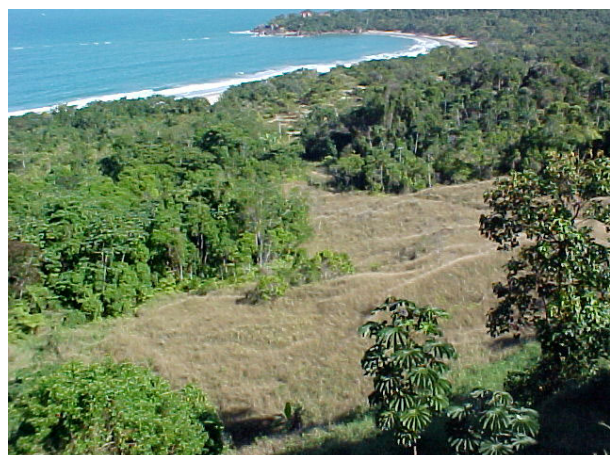
**Figure 10.** Example of recovered site. Note re-vegetation by grass and reduction of scenic deterioration

- 34 sites were considered to be recovered (Figure 10), in that they are reasonably stable in engineering geological terms, free of significant erosional or other geodynamic processes (e.g. soil piping, soil creep), covered at least by primary re-vegetation (as cited above), and reasonably integrated in scenic terms with surrounding environment and land uses;
