## Rainstorm-induced landslides in Kisawa village, Tokushima Prefecture, Japan

**Abstract:** From the end of July to the beginning of August 2004, a typhoon (called Typhoon No. 10 in Japan) attacked Shikoku Island and the Tyugoku area of Japan before moving towards the eastern part of the Korean Peninsula. Due to this typhoon, rain fell very heavily on Shikoku Island. From July 30 to August 2, the accumulated precipitation reached 2000 mm, and a daily precipitation of 1,317 mm was recorded, which was greater than the Japanese historical daily rainfall record of 1,114 mm. During this period, a huge number of landslides was triggered on Tokushima Prefecture, among which some catastrophic landslides on Kisawa village caused the loss of two lives and severed roads. Field investigations showed that the displaced soil mass from the source areas of these landslides travelled long distances with low apparent friction angle, showing the characteristics of high mobility. Because the main rocks of the displaced landslide masses are weathered greenstone and serpentinite, which are usually not liquefiable, questions were then raised as to why these landslides were of such high mobility. Sample

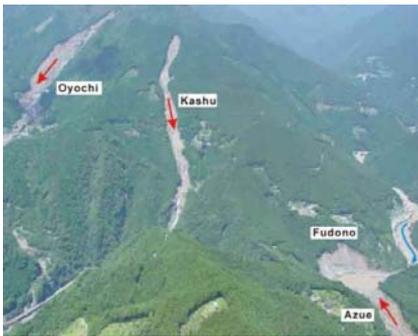
**Figure 4.** Oblique aerial view of the Oyochi, Kashu, and Azue landslides (photo by Shikoku Regional Development Bureau, Ministry of Land, Infrastructure and Transport, Japan)

The Oyochi and Kashu landslides occurred on the same ridge and side of a mountain (Figure 4). Oyochi landslide was triggered mid-slope on the mountainside, about 1 km from the Oyochi settlement (Figure 5) at approximately 20:30 hr, August 1. Two people were caught up in this landslide, and their bodies have not been found. The displaced materials of about  $0.5\sim 1\times 10^6$  m<sup>3</sup> from the cover and weathered bedrock moved downslope to the river, and hit the opposite side of the channel. A part of the displaced mass crossed a ridge on the opposite slope (area I in Figure 5), and transformed into a large debris flow, traveling a further 2 km along the valley (area II in Figure 5). In this area, the bedrock is mainly composed of greenstone and serpentinite with visible cracks. Immediately below the source area, the displaced landslide mass is meters thick, and contains some huge boulders. The deposited mass could be liquefied by stamping feet, indicating the highly liquefiable character of the landslide materials.

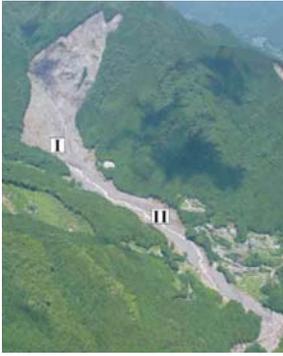
**Figure 5.** Oblique aerial view of Oyochi landslide (photo by Shikoku Regional Development Bureau, Ministry of Land, Infrastructure and Transport, Japan). The head scarp is situated at an altitude of about 1000 m, while the join of the slope to the Oyochi valley is about 560 m. The slope angle averaged 34 degrees

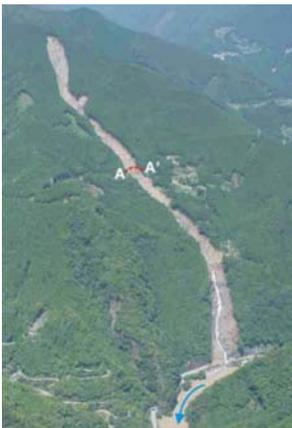
**Figure 6.** Oblique aerial view of Kashu landslide (photo by Shikoku Regional Development Bureau, Ministry of Land, Infrastructure and Transport, Japan). The head scarp is situated at an altitude of about 910 m, while the altitude of river floor is about 300 m. The slope angle averaged 27 degrees

Kashu landslide (Figure 6) occurred on the same slope near the Oyochi landslide, and almost at the same time as the Oyochi event. According to a local resident, Kashu landslide started on the lower valley slope near Kashu settlement (below A-A' in Figure 6), and was followed by another two failures, finally retrogressing almost to the ridgeline of the mountain on August 2.

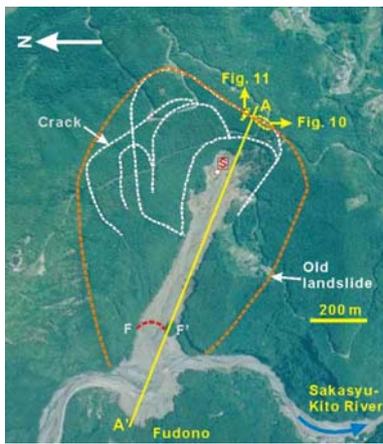
**Figure 7.** Oblique aerial view of Azue landslide and the unstable blocks after the August 1, 2004 event (photo by Nakanihon Sky Service Station, Japan). The area below F-F' was displaced in 1994 during a rainfall. The broken brown line outlines the area of the ancient landslide. The white broken line marks cracks from reactivation of the old landslide

Azue landslide is located on the left side of Sakashu-Kito River, in front of the Kashu landslide (Figure 7). A remarkable scar indicating an ancient landslide is also visible at the same site (Figure 7 outlined approximately by a broken line). We also found a small-scale linear depression on the mountain top during our survey. The new landslide occurred near the southern boundary of the old landslide scar, and the sliding surface was in the weathered bedrock layer. Azue landslide has a width of about 130 m, a horizontal length of about 1 km, and a depth ranging from 10 to 20 m. The volume of the displaced material was estimated to be about  $1\sim 2 \times 10^6 \text{ m}^3$ . The displaced material slid down the slope, crossed Sakashu-Kito River, and rose up the opposite mountain slope to a height of about 30 m (immediately below the Fudono area), destroying and carrying away the Fudono bridge, which was built on the national road (Figure 8).

We were told that a landslide occurred 5 years ago on the area below the red curve (F-F') shown in Figure 7, also during heavy rain. We noticed that a smooth surface of relatively hard bedrock crops out (below F-F' on Figure 7), which strikes N45°E and dips north. We infer that this surface formed an impermeable or less permeable layer, which facilitated a rapid rise in the local ground-water table during the storm, which in turn triggered the slope failure.

Above the main scarp of Azue landslide, another huge block moved slightly. After the landslide, numerous cracks with significant displacements were found on the slope above the main scarp (and along the scarp of the old landslide). The white dashed lines that were drawn basing on the observed cracks outline the boundary of each sliding sub-block. The road on the left hand side of the old landslide scar was severed by a crack, where there was subsidence of about 2.0 m (Figure 10). The subsidence increased to 2.5m over about two weeks. It exposed a well-consolidated sliding surface of the old landslide, which originated in the bedrocks and strikes N44°W and dips 48°W. The deformation observed from the ground surface indicates that the deforming landslide shows translational movement in general.

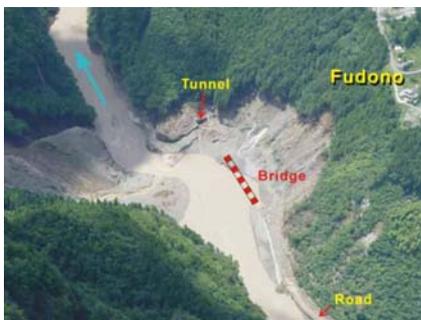
**Figure 8.** Oblique aerial view of the Fudono area after the landslide (photo by Shikoku Regional Development Bureau, Ministry of Land, Infrastructure and Transport, Japan)

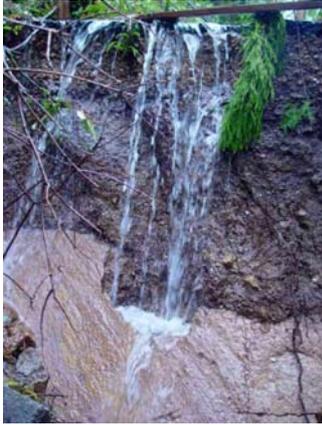
**Figure 10.** Exposure of the sliding surface beneath the old landslide. The materials above/below the sliding surface are weathered green stone

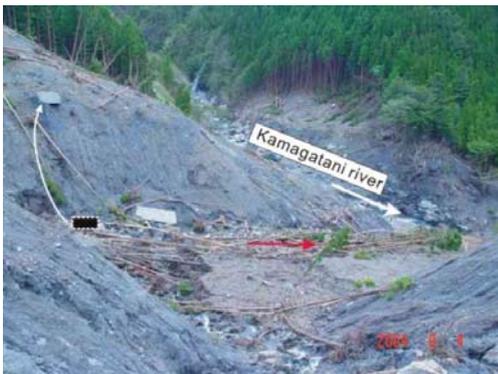
**Figure 13.** A displaced concrete block from the soil-conservation (Check) dam on the slope opposite the landslide source (Black area outlined by the broken white line: former location of the block; Red arrow: the flow direction of the valley water; White curved arrow: the move direction of the block)

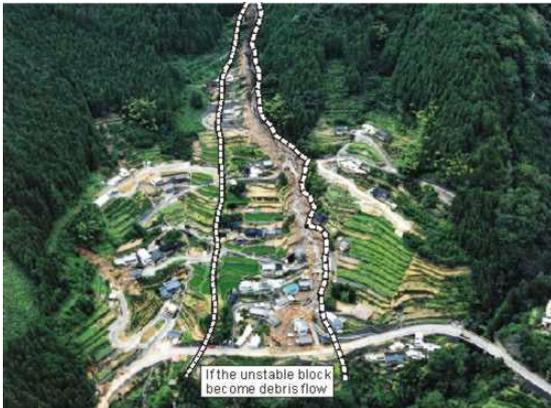
Figure 15. Traveling path of Shiraiishi landslide as well as the predicted damage area if the unstable block become debris flow

Shiraishi area was designated as the landslide prevention area on 1962, basing on the Japanese Landslide Preventive means, and the mountain stream was also designated as the debris-flow-risk-rich stream. Shiraishi landslide was also triggered around 20:00 hr on 1 August. The landslide on the source area sized 70 m in length, 35 m in width, and 2-3 m in depth, and was originated on a slope of about 29 degrees (Hiura et al 2004). The scarp of this landslide was at the elevation of 540 m, and toe was at the elevation of 290 m reaching the national road, and the horizontal travel distance was about 550 m. The displaced landslide mass was approximately 5,000-7,000 m<sup>3</sup>. The landslide transformed to debris flow when came to the lower slope part. Many houses were destroyed or damaged by this event (Figure 15). Fortunately, the residents of this area noticed some unusual phenomena, such as the ground water flowing out from the middle part of the mountain slope and unusual sound by moving rocks. They recognized these landslide precursors, and started to evacuate by themselves from 15:00, and then there was neither fatality nor injury. This is a good case coupling the precaution of disaster precursor with evacuation successfully. It is noted that after this event, an unstable block on the upper part of the source area formed and was keeping moving. Three extensometers were installed to monitor the movement (Figure 16). The monitored displacement and rain precipitation
