Ageing tests for dimension stone - experimental studies of granitic rocks from Brazil

MARIA HELOISA BARROS DE OLIVEIRA FRASCÁ¹ & JORGE KAZUO YAMAMOTO²

¹ *Geology, IPT - Institute for Technological Research, São Paulo 05508-901, Brazil (e-mail: mheloisa@ipt.br)*

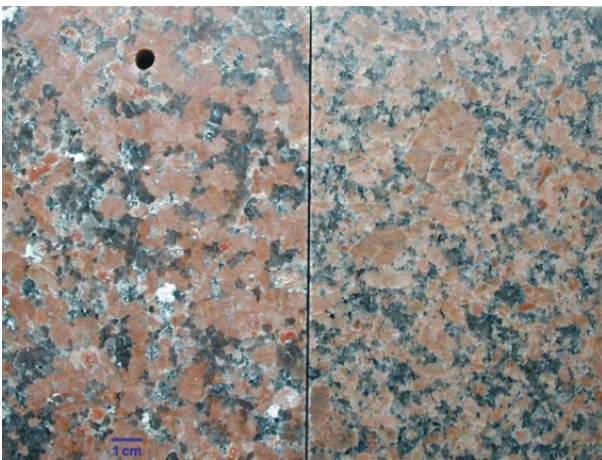
Figure 2. Formation of salt (in white) in surface microcracks and locally on biotite after exposure to sulphur dioxide (control specimen on the right).

Three test specimens per sample were tested. From each sample, a standard specimen was set aside for control. Inspections were carried out periodically by registering the observed modifications. A detailed description of this method and major results were presented by Frascá & Yamamoto (2004). The main degradations observed are shown in Figures 1 and 2.

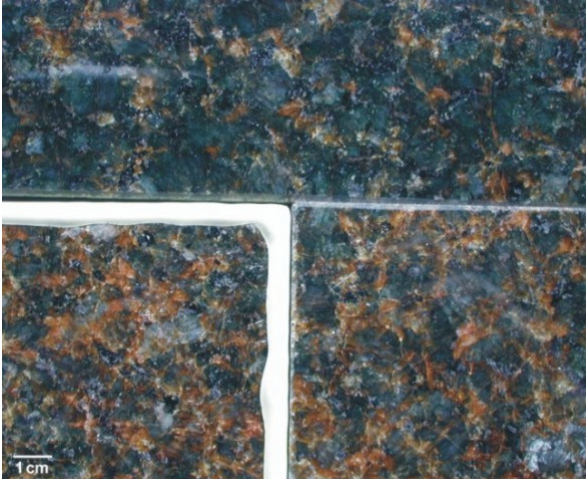
Figure 3. Increasing of pre-existent oxidation after exposition to salt mist (above: control specimen).

Three specimens per sample were tested and one per sample was set aside for control. They were maintained permanently inside the chamber and removed only for periodic inspections. During each inspection, which did not last more than 30 minutes, the specimens were washed to remove the salt on the surface. Any changes were then registered. The main results observed are illustrated in Figures 3 and 4.

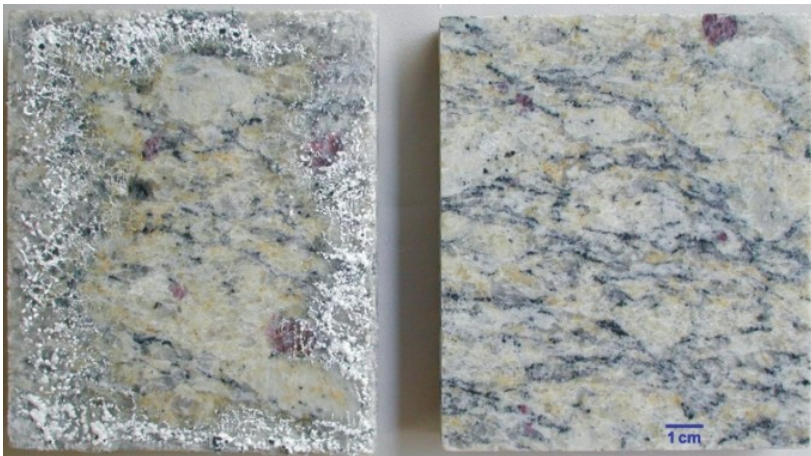
Figure 6. Crystallization of salts at the borders of test specimen, preferentially on biotite sites (control specimen on the right).

The major aspects of efflorescence formed by the partial immersion in sulphuric acid are illustrated in Figures 6 and 7 (a, b). The most typical degradations observed in the studied granitic rocks are shown in Figure 8 (a, b).
