An approach to mitigation of landslide hazards in a slum area in São Paulo city, Brazil

Abstract: The paper presents engineering geology studies for landslide hazard assessment and to support the project of the mitigation civil works in the Jaguaré slum, located in São Paulo city, São Paulo State, southeastern region of Brazil. These studies are part of a landslide hazard mitigation program of the city government comprising a total of 192 slums located in São Paulo city.

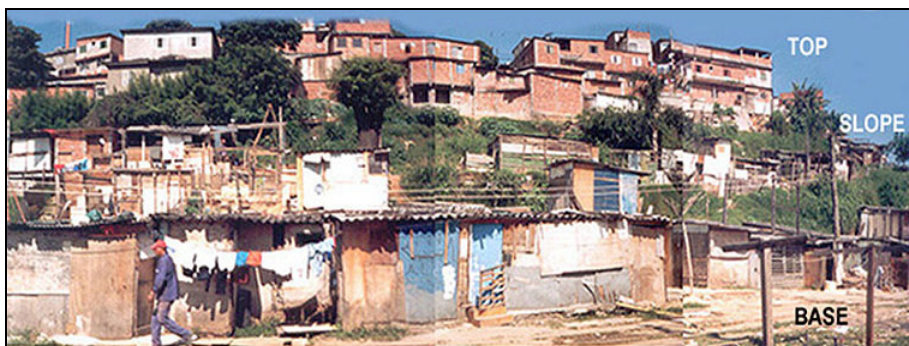
Figure 5. Partial overview of the highest landslide hazard sector identified in the Jaguaré slum.

The analysis of these preliminary investigations resulted on the identification of the highest landslide hazard sector present in the Jaguaré slum. It is located in northeast region of the slum and comprises an area of 5,000 meters, occupied by 56 houses. This sector can be subdivided into three main segments considering the landslide hazard situations: top, slope and base (Figures 4 and 5).

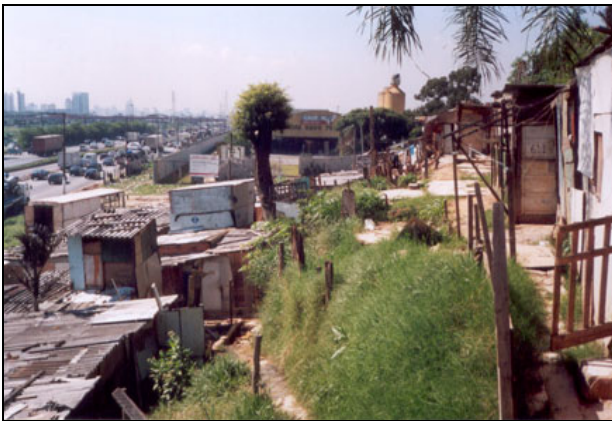
Figure 7. Typical occupation presents in the highest landslide hazard sector.

The surface investigations comprised detailed topographic survey and new field surveys. The detailed topographic survey was carried out at a scale of 1:1,000 with topographic contours of one meter. The newly identified hazard areas were mapped to improve the eventual reallocations of land within the implementation of the mitigation civil works. New fieldwork was carried out to characterize the typical weathering profiles present in the highest landslide hazard sector, to identify the geological structures and its potential influence on the triggering mechanisms of slope processes and to observe the human modifications that act on the slope susceptibility degree (points of concentration of pluvial and served water, inappropriate cuts and landfills, structural fragility of the edifications and others, (Figure 7).
