# Physiochemical changes in London clay adjacent to cast iron pipes

A M SCHMIDT<sup>1</sup>, D N CHAPMAN<sup>2</sup> & C D F ROGERS<sup>3</sup>

**Abstract:** This paper is based on ongoing research into the interaction between soil, in this case London Clay, and cast iron pipes. Current literature on this topic only focuses on the performance and failure of the pipe rather than on the pipe-soil system. Independent studies have observed that burst rates in cast iron pipes increase after periods of severe wetting and that these failures coincide with areas of clay soil, and in particular London Clay. The hypothesis of the current research proposes that in fact the soil is the significant contributor to the failure mechanism.

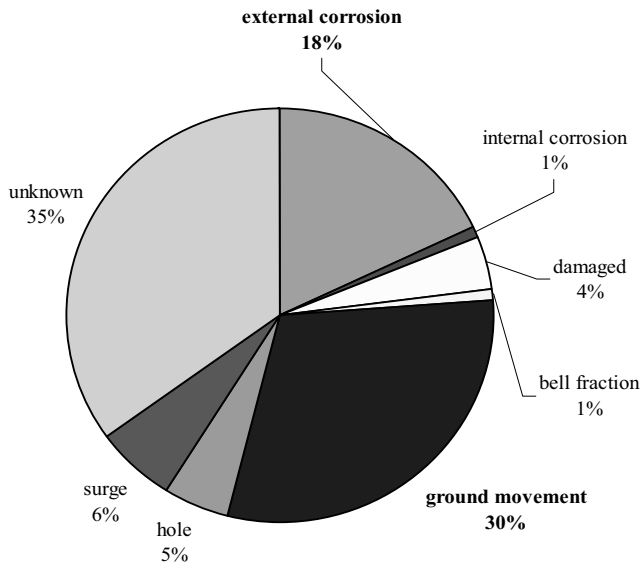
**Figure 1.** Causes of Failures of Cast Iron Pipes (after THWS Repairs Database, 1999)

Pipeline failure occurs for many different reasons, but external corrosion and ground movements are prominent factors (see Figure 1). However, this figure is likely to refer only to the dominant cause of failure and so combinations of these causes would not be shown. For example, corrosion could weaken the pipe before failure occurs as a result of a second cause, say ground movement. This figure does, however, show failures are influenced by the bedding soil. Therefore, the two most important processes in a soil defining its corrosivity and the causes of

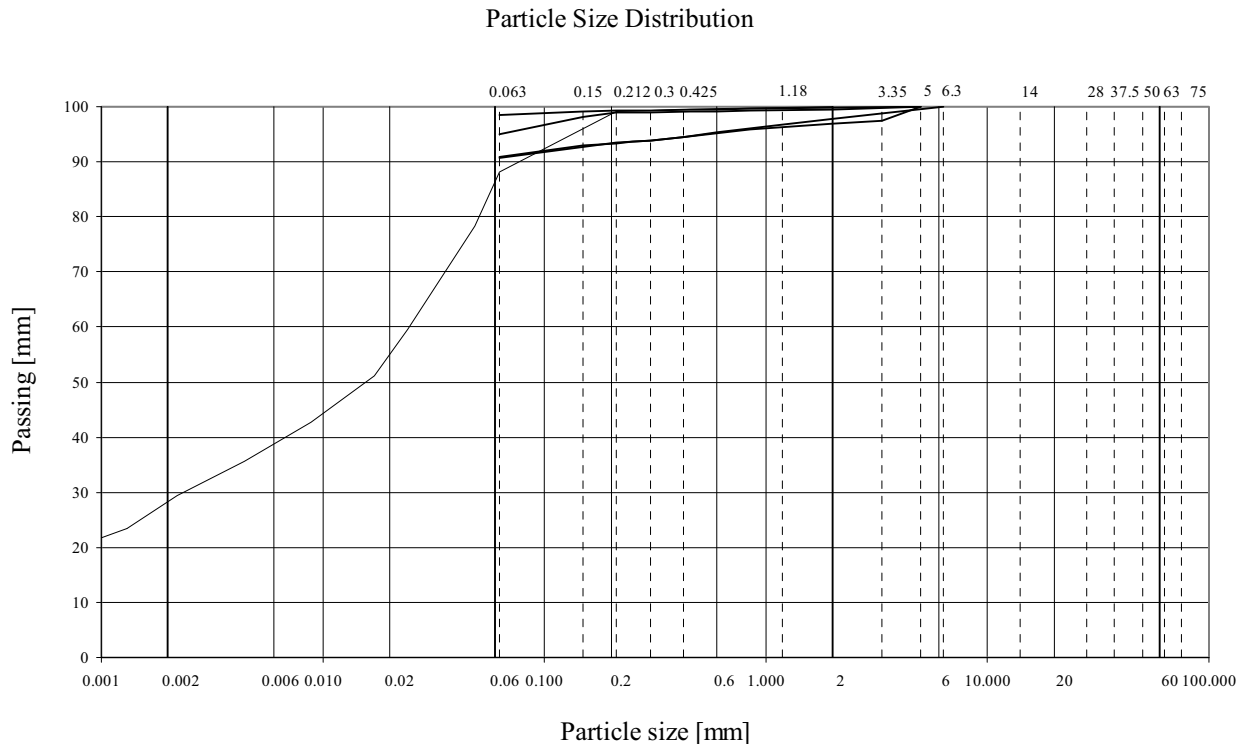
**Figure 5.** Particle size distribution of the in situ London Clay used in the experiments

The next step after crushing was sieving to remove the small amount of larger particles ( $\bullet$  2.0mm), as this would make it easier to obtain a more homogeneous samples during the consolidation process. The resulting London Clay contained a high clay content and all the soil properties subsequently referred to are related to this sieved material (Figure 5). It was assumed that even though the larger particle fractions were removed, the in situ conditions of the clay would still be accurately simulated.

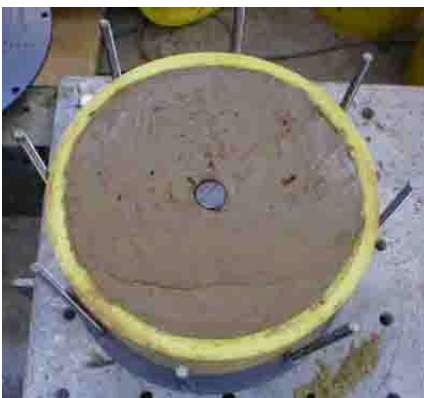
**Figure 7.** Clay sample containing the cast iron rod

These tests were designed to simulate the natural corrosion under laboratory conditions. A larger container (277.6mm diameter) was used for these tests. After the consolidation had finished the 200mm high central section with an undisturbed clay sample was taken out of the consolidometer. The centre of the clay was cut out with a tube and replaced with a 24mm diameter cast iron rod (Figure 7). The top and bottom of the tube were then sealed with plastic plates. The top plate had small holes drilled every 10mm radially from the centre (Figure 8) so that it was possible to measure the electric field developing between the cast iron and the clay without opening the sample.

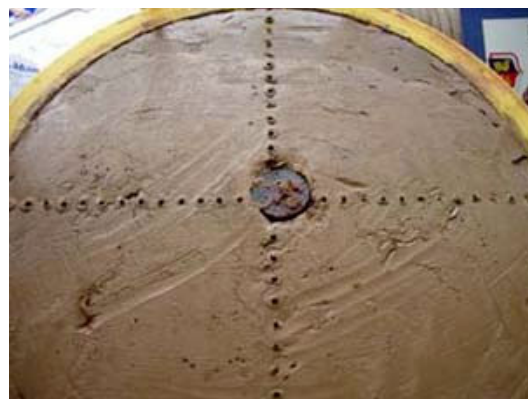
**Figure 8.** Open sample after measuring the electric properties between the cast iron rod and the clay

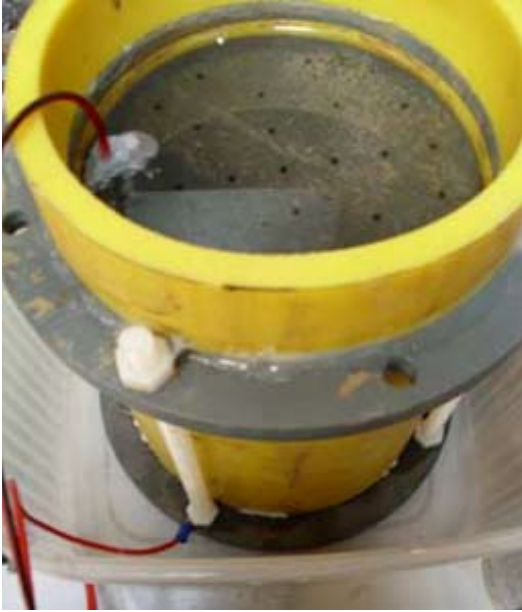
Figure 9. The second test arrangement

The second test arrangement was designed to increase the corrosion rate and the migration of ions into the soil. 200mm high samples with a diameter of 158.6mm were chosen for this test. The undisturbed sample was taken from the consolidation equipment and placed between two cast iron plates. Both plates had holes drilled in them to facilitate water flow created by the introduced electric field. The bottom plate was fixed to the tube, while the top

plate was able to move to accommodate possible soil movements. A small water reservoir was installed above the top plate and filled with deionised water during the test (Figure 9).

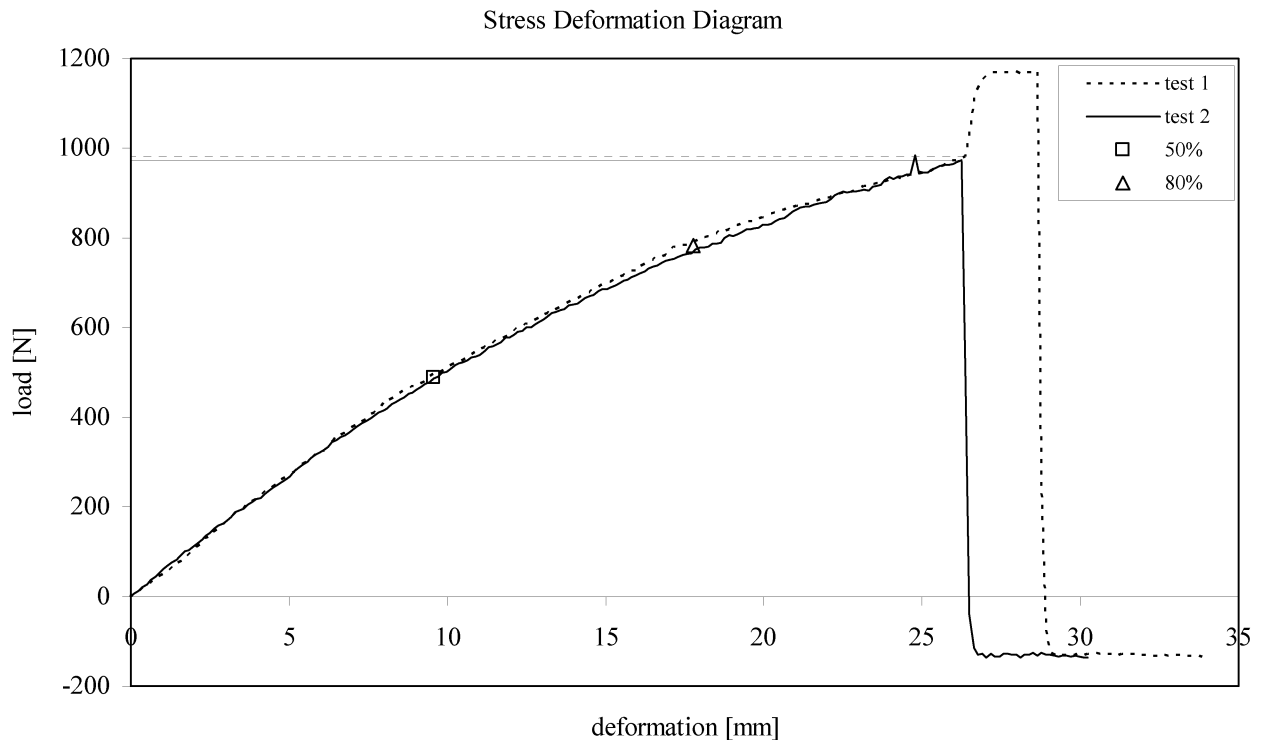
**Figure 12.** Load-deformation curve of the U-shaped specimen

To determine the maximum allowable stress, two of the “U” shapes were put under stress until failure and the stress-deformation curve was measured. Both samples failed under a similar load of approximately 970N. The stress corrosion behaviour was recorded at 50% and 80% of the failure pressure, the required deformation being taken from the curves shown in Figure 12.
