The threat of abandoned mines on the stability of urban areas

BARRY G CLARKE¹, MICHELLE WELFORD² & DAVID B HUGHES³

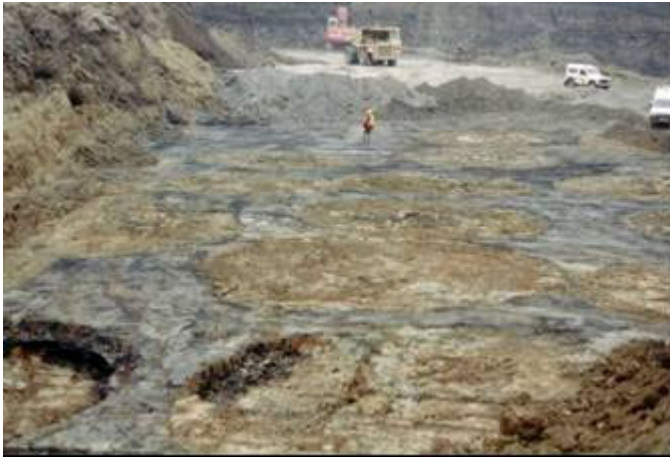
Figure 2. Bell pit workings uncovered during opencast operations at a site near Wakefield. (Photo courtesy of Carl Drury, The Banks Group).

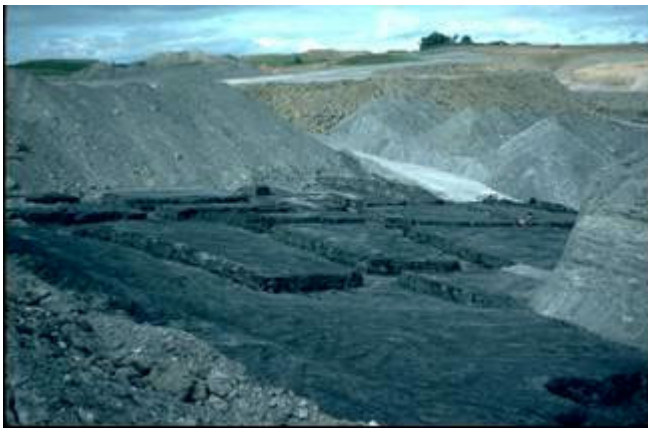
Figure 3. Room and pillar workings uncovered during opencast operations at Buckhead Site, Co Durham

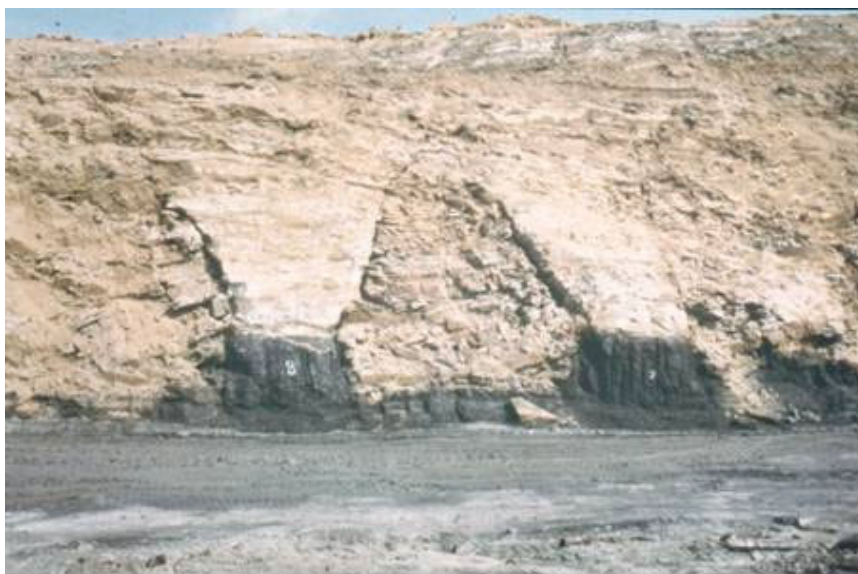
Figure 6. Crown hole collapse uncovered during opencast excavations (Photo courtesy Prof Paul Younger)

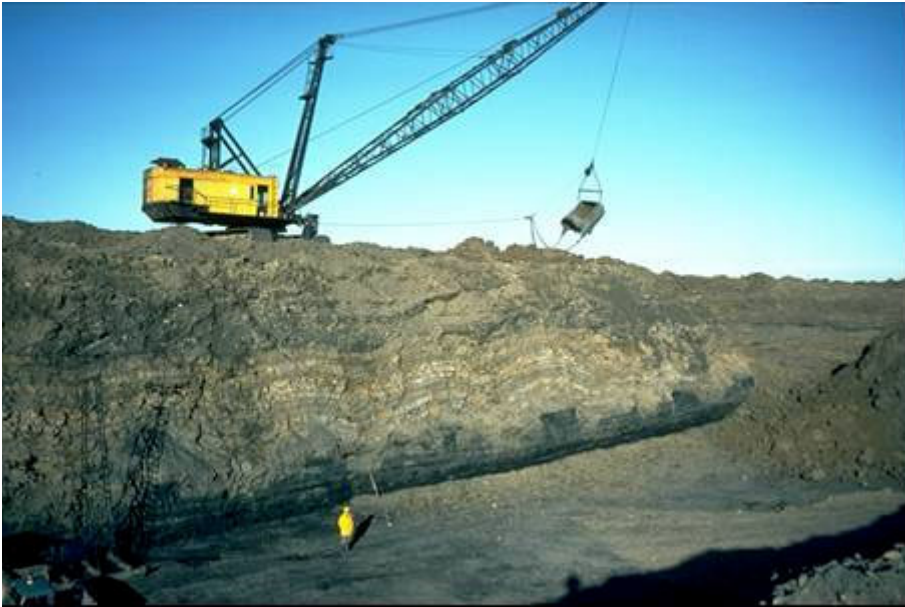
Figure 7. Creep deformation over pillars uncovered during opencast excavations at Langley site, Co Durham

Opencast excavations have revealed that there is another failure mechanism possible, that is, the deformation of the roofs of rooms over time (creep deformation), which also results in ‘areal’ subsidence (see Figure 7).
