## Spatio-temporal changes to the coastal zone of Vari (Greece), using remote sensing and GIS techniques

**Abstract:** The aim of this paper is to examine the spatio-temporal, qualitative and quantitative changes in the natural environment and morphology of the coastal area of Vari, a suburb of Athens, Greece. The changes were studied using maps, aerial photographs and GIS techniques. Qualitative changes including man-made alterations that took place in the area of Vari bay during the last hundred years were detected by comparing the geomorphologic characteristics portrayed by recent topographic maps with those visible on old maps (edition 1885). Quantitative changes, in the same area, were noted, registered and assessed in terms of surface changes by interpreting aerial photographs taken between 1945 and 1987. The results showed that intense housing construction associated with the urban 'sprawl' of Athens in the south-west coastal zone have resulted in the following effects:

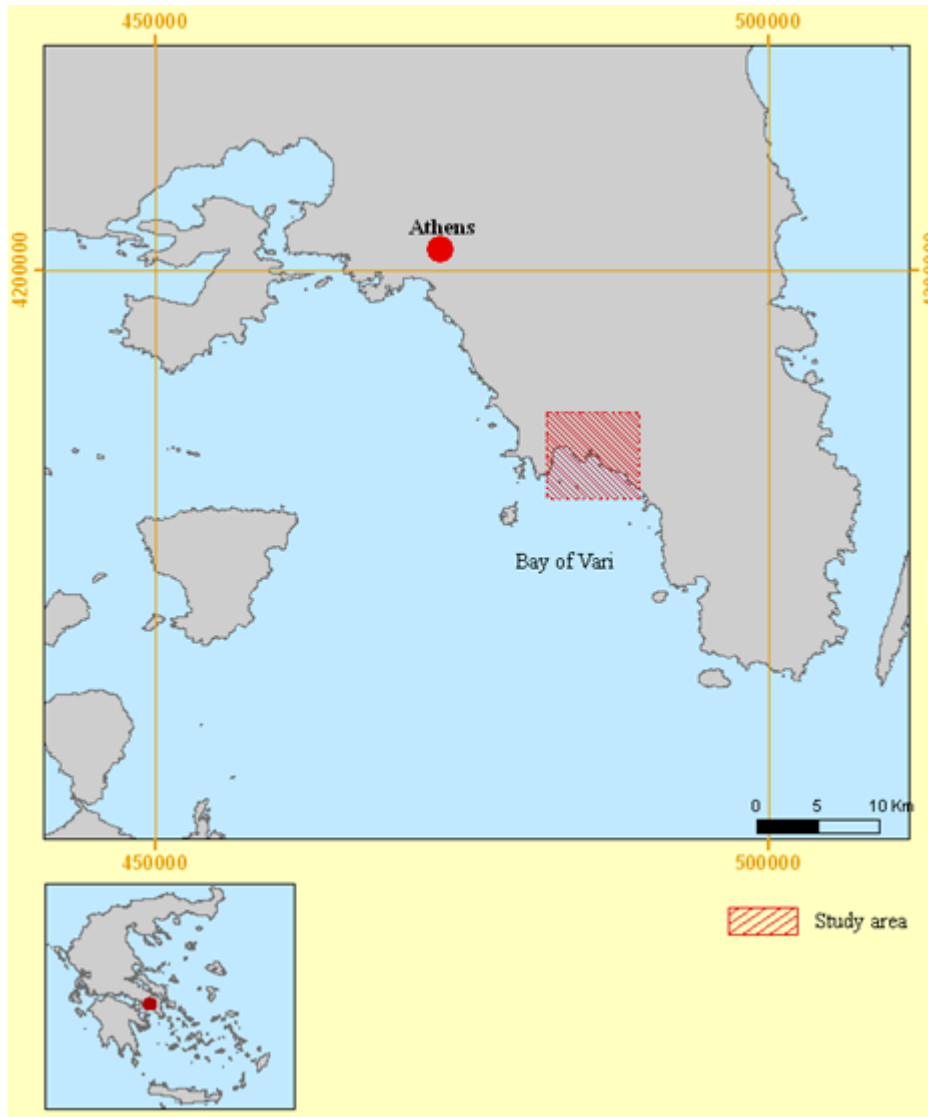
**Figure 1.** The study area

The Bay of Vari is located about 30 km southwest of Athens (Figure 1). With the exceptions of the eastern and western parts the area is characterized by a subdued topography, with gentle slopes and altitudes ranging from sea level to 30 m. Urbanization has taken place over the past thirty years.

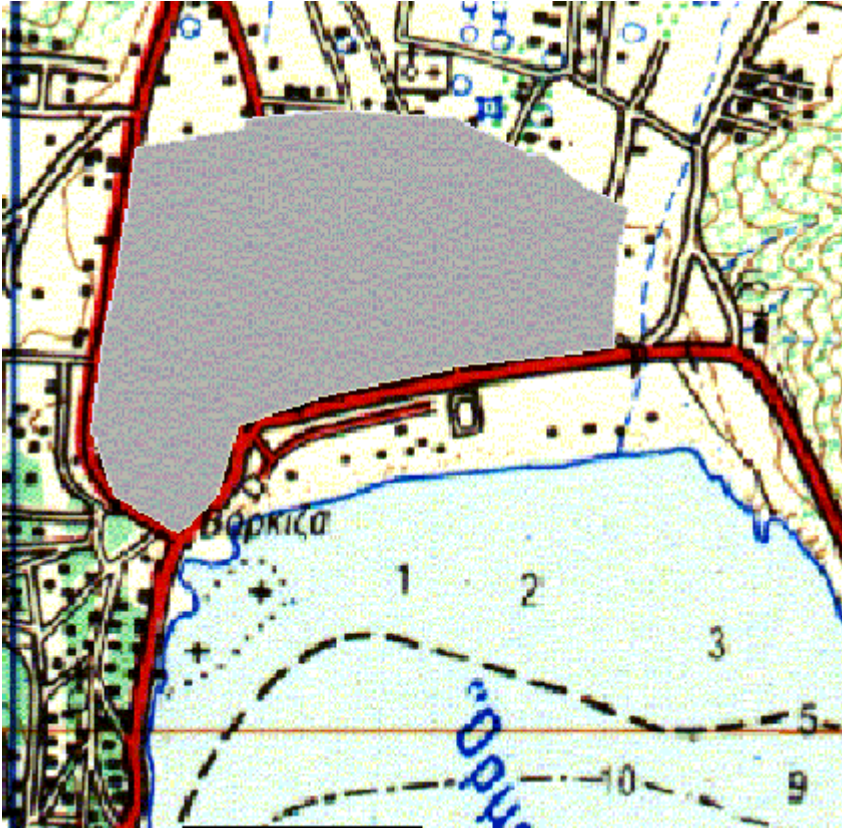
Figure 6. Area considered to be flood-prone (grey shading).

Figure 6 shows an area to the north of the road that is inferred to have an increased risk of flooding, due to inappropriate construction. This area needs further investigation in order to assess the potential for flooding due to runoff from the surrounding terrain at times of elevated rainfall, and to make recommendations for the possible construction of flood defences.

The embanked Athens to Sounio road separates the site of the former lagoon into northern and southern compartments. It thus acts as an artificial obstacle to drainage, preventing the natural conveyance of water from the northern compartment to the sea. The combination of an inadequate drainage network, illegal housing developments, burning and elimination of forest areas, and the construction of extensive earth fills without regard to the natural physiography of the area have all resulted in the increased risk of flooding.
