# Analysis and evaluation of rockfall hazard around Afyon Castle, Turkey

**Abstract:** The Afyon Castle is a tourist destination and a historical site in the City of Afyon in Turkey. The castle is located on a steep hill, with a height of 226 m. In close proximity to the castle there are settlements. The hill consists of volcanic trachitic andesite. The rock contains columnar joints and flow layering. Due to these discontinuities, blocks with varying sizes have fallen down in the past. The settlement areas near the castle are now under threatened because of the rockfall risk. In this study, rockfall analysis was carried out along two sections of the hill. Fall-out distance, bounce height, kinetic energy and velocity of the rocks along each section were investigated. The results of the analyses were evaluated to the areas delineated as susceptible to rockfall risk highlighted. Possible remedial measures were suggested on the basis of the field observations and the rockfall risk evaluation.

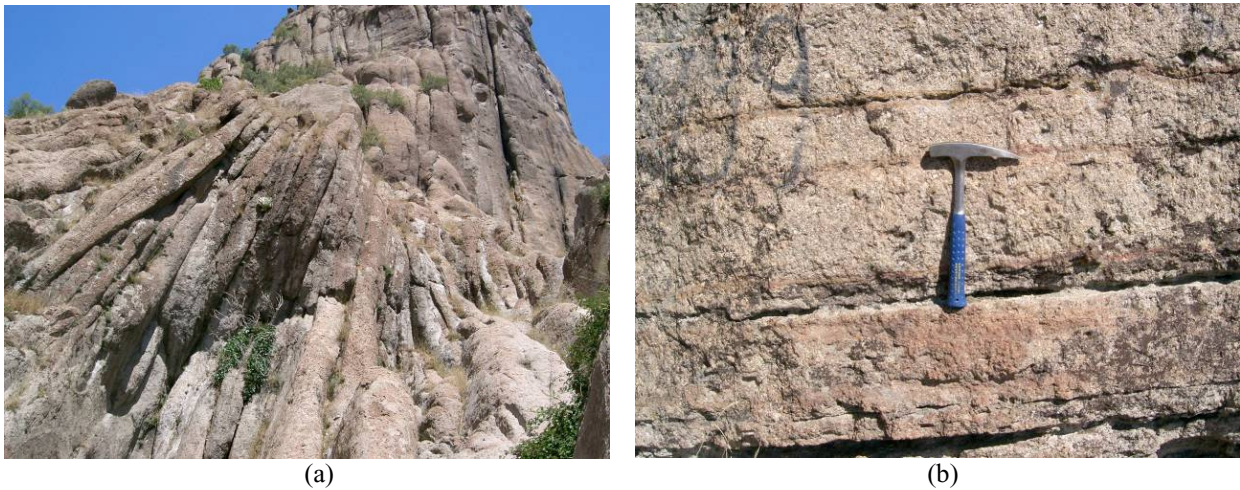
**Figure 4.** Photograph of (a) the cooling joints and (b) flow layering in the trachitic andesite

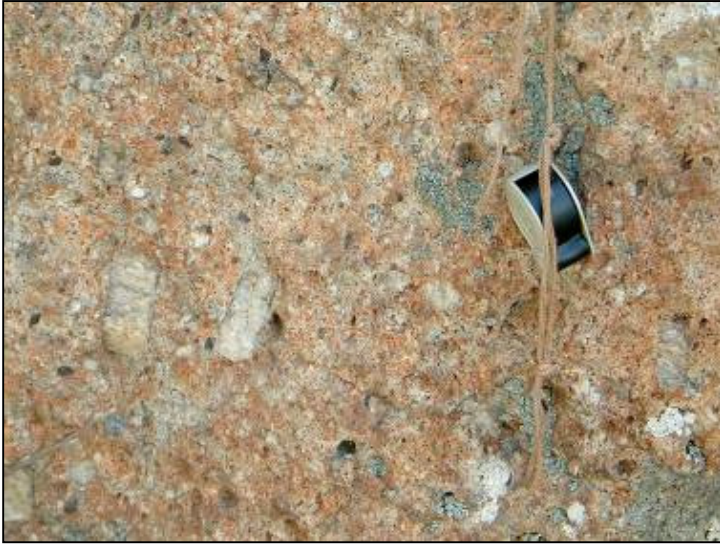
**Figure 5.** Sanidine phenocrysts in the trachitic andesite
