# Coping with underground risks during the development of a new underground metro station in Rotterdam

ROBERT BERKELAAR<sup>1</sup>

<sup>1</sup> Rotterdam Public Works, Engineering Dept. (e-mail: r.berkelaar@gw.rotterdam.nl)

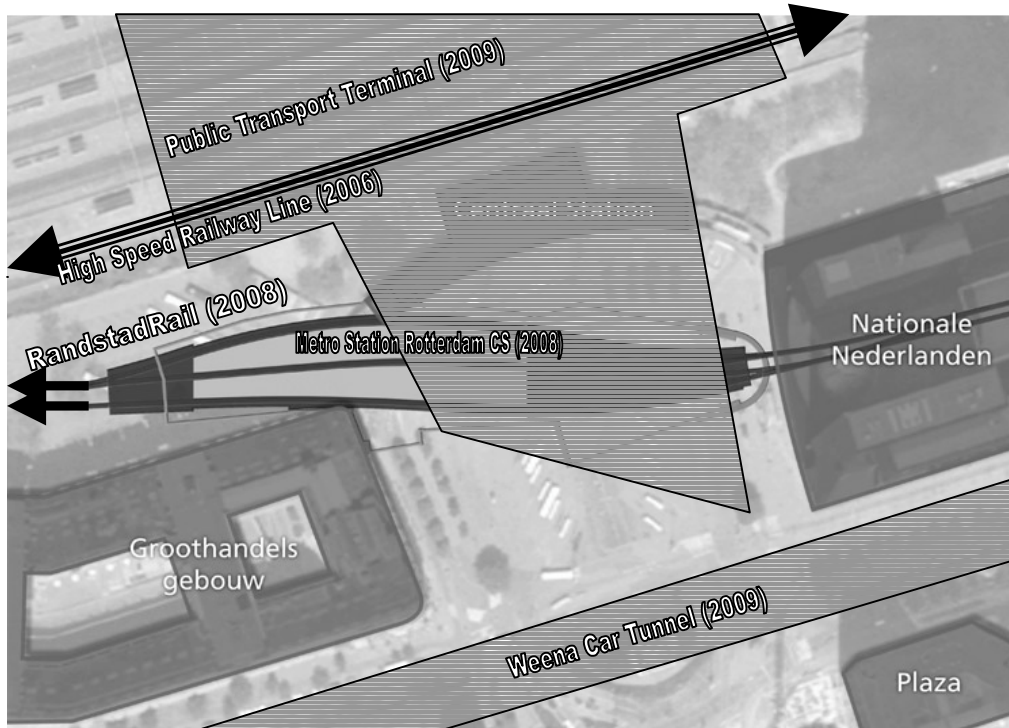
**Figure 3.** New metro station Rotterdam CS with adjacent projects and structures

The project distinguishes itself by the very complex conditions under which the project has to be realised. The development of the underground metro station is a key project which interfaces with other big projects under construction or to be realised shortly at the same location, Figure 3. Among these are the expansion of the Weena car tunnel, the RandstadRail project which will be connected to the new metro station, a new public transport terminal will be build on top of the metro station, tram traffic will be led over the construction pit and the upgrading of the train station will take place directly next to the construction of the new metro station.

The building pit itself encloses the present metro station. One of the prior conditions during construction is unobstructed running of metro traffic in this station during all mentioned building activities. The continuous flow of pedestrians (approximately 50,000 passengers each day at the metro station) cyclists, trams, busses and taxis in and around the zone of building activities makes the project even more complex. Another important factor is the presence the ING 'Nationale Nederlanden' headquarters in a 151m high skyscraper on the eastern side at approximately 10m from the building pit. On the western side the building pit touches a monumental building from the 1950s, the 'Groothandelsgebouw'.

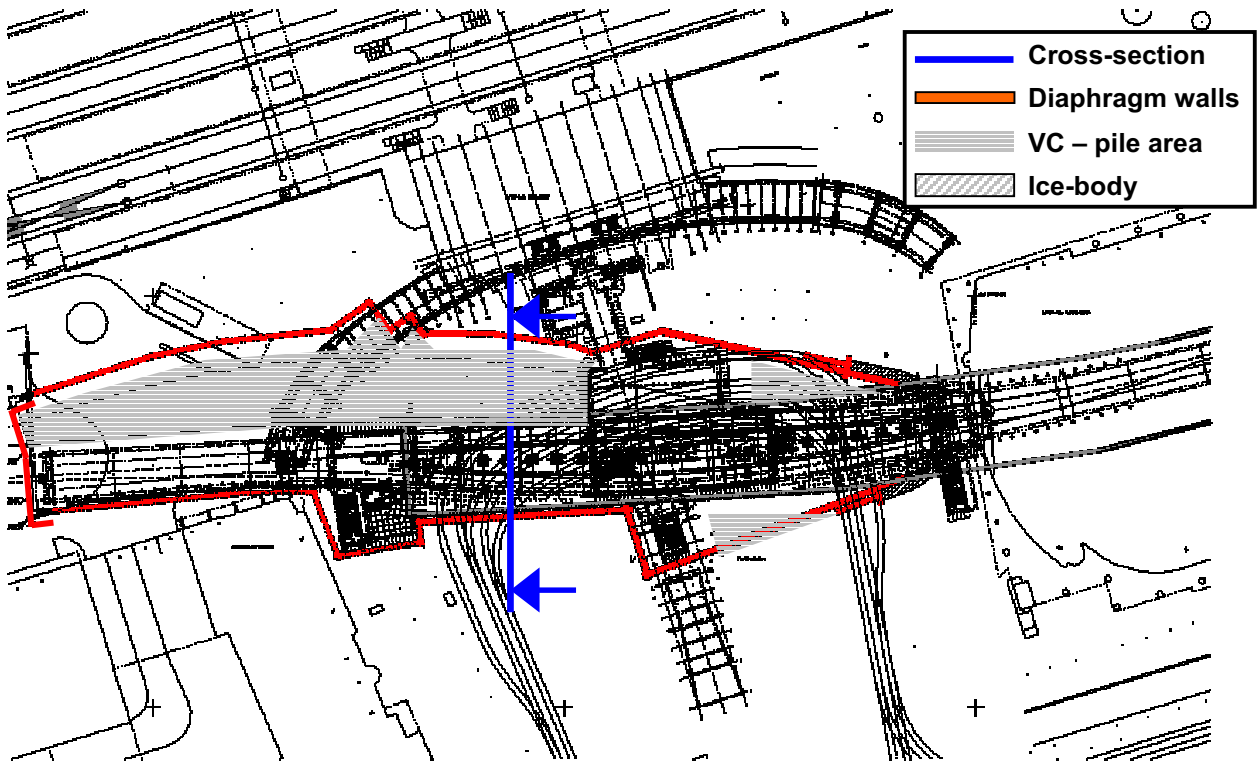
**Figure 4.** Building pit contours new metro station, situation at the end of Phase 1

Not only has the project to be executed under very complex site conditions, the technical aspects are very challenging and on the cutting edge of technology as well. The development of the new metro station is split in two phases. Phase 1 consist of making the walls for the construction pit needed for phase 2. This is being done by installing 490m of diaphragm walls around the existing metro station to a depth of 38m below reference level NAP. At this level a thick continuous clay-loam layer is present and thus a watertight construction pit is created. NAP is approximately equal to surface level in the project area. Within these contours 650 vibro-combination piles are driven to a maximum depth of 28m below NAP. These piles will serve as the foundation of the new metro station and the public transport terminal on top of it, Figure 4 and 5. In the second phase of the project, which is tendered as a separate contract, the building pit will be closed on the eastern side between the diaphragm walls and around the metro tunnel with a semi-permanent ice-body, Figure 4.

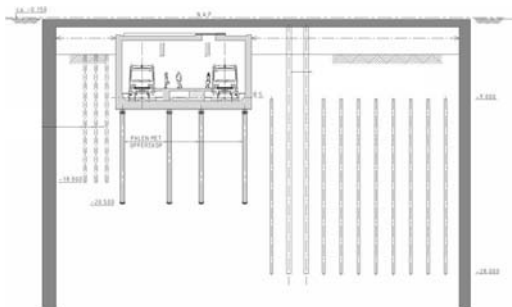
**Figure 5.** Cross-section, initial situation start phase 2

After tests of water tightness of the diaphragm walls and the ice-body the pit will be excavated in phases and the existing metro station will be exposed. In this stage the foundation of the metro station will be reinforced by approximately 1,000 Tubex piles. These vibration free piles will be installed under the metro tunnel while metro is continuing, Figure 6. After this the frame work of the new metro station will be transformed from 2 to 3 tracks with longer platforms and ready to carry the load of the new public transport terminal, Figure 7.

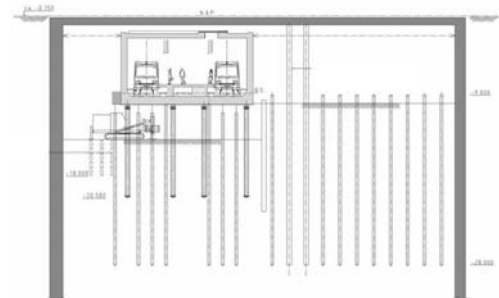
**Figure 6.** Cross-section, Tubex-pile installation under metro station

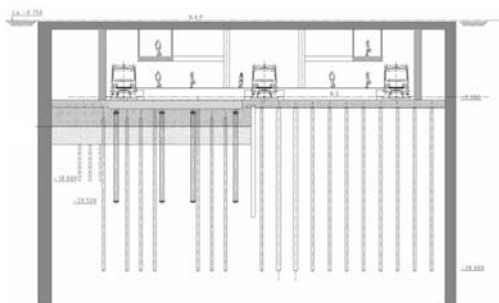
**Figure 7.** Cross-section, final situation

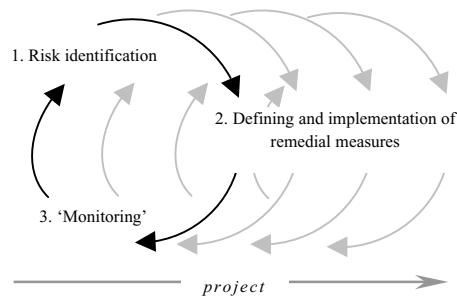
**Figure 8.** Risk management, pro-active approach

Risk management is the next step to monitor and control the risks in the construction phase as identified during the risk analyses. During the construction phase of the new metro station Rotterdam CS technical monitoring and risk control techniques are used. With these tools, which complement each other, it is possible to perform pro-active risk management. Together they are used to update the risk profile, control technical- and project risks and support communications and negotiations with large stakeholders, Figure 8.

- Technical monitoring involves monitoring of the technical parameters of the construction process. In order for corrective actions to be made effectively it is essential to compare the measured technical parameters with predefined hazard warning levels. Beforehand fall-back scenarios have to be defined in order to be able to react in time with the appropriate measures.
- Risk control involves the pro-active structural monitoring of risks concerning the technical aspects and the possible consequences for time, cost and quality in the construction process. New risks can arise or risks may change with unforeseen circumstances and changes in the plans or activities.

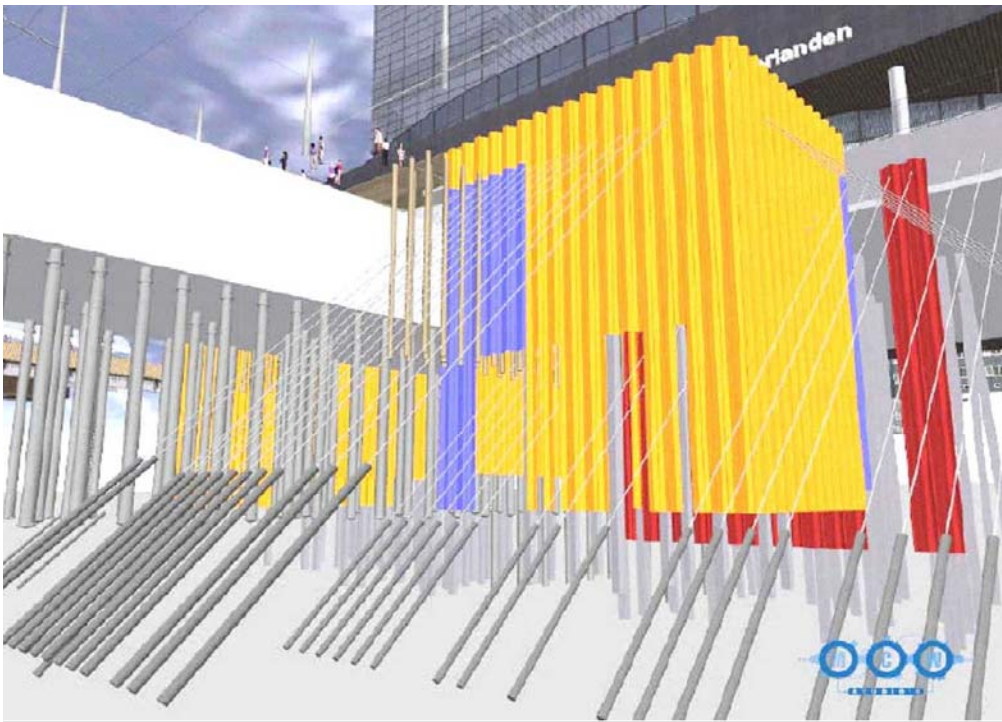
**Figure 9.** 3D-Visualisation of obstacles near the ING headquarters (MCW Studio's - Rotterdam)

In 1987 the construction of the ING headquarters was started. The building pit for this skyscraper consisted of sheet pile walls back tied with ground anchors. The ground anchors were only partially removed after construction was finished. These anchors were potential obstacles for the construction of the diaphragm walls and of emergency exits of the new metro station which had to be constructed at that point, Figure 9.

During the design phase the supposed locations of the anchors was indicated by as-built drawings. The reliability of these drawings was very limited however. The design was adopted in such a way that conflicts between the

diaphragm walls and the anchors remains were minimised. This was achieved by adjusting the diaphragm wall contours and by limiting the depth of the diaphragm walls locally. These 'shallow' diaphragm walls were installed to a level where the anchor remains were encountered. Below this depth the walls were extended in depth by high pressure jet grout columns. Where conflicts were inevitable, and the jet grout extension option was not sufficient, the design prescribed removal of the anchors by vertical or inclined drilling techniques. During the installation of the diaphragm walls the anchor remains were encountered indeed. The contractor proposed removing those remains with the hydraulic diaphragm wall trench cutter, which was very successful in the end.

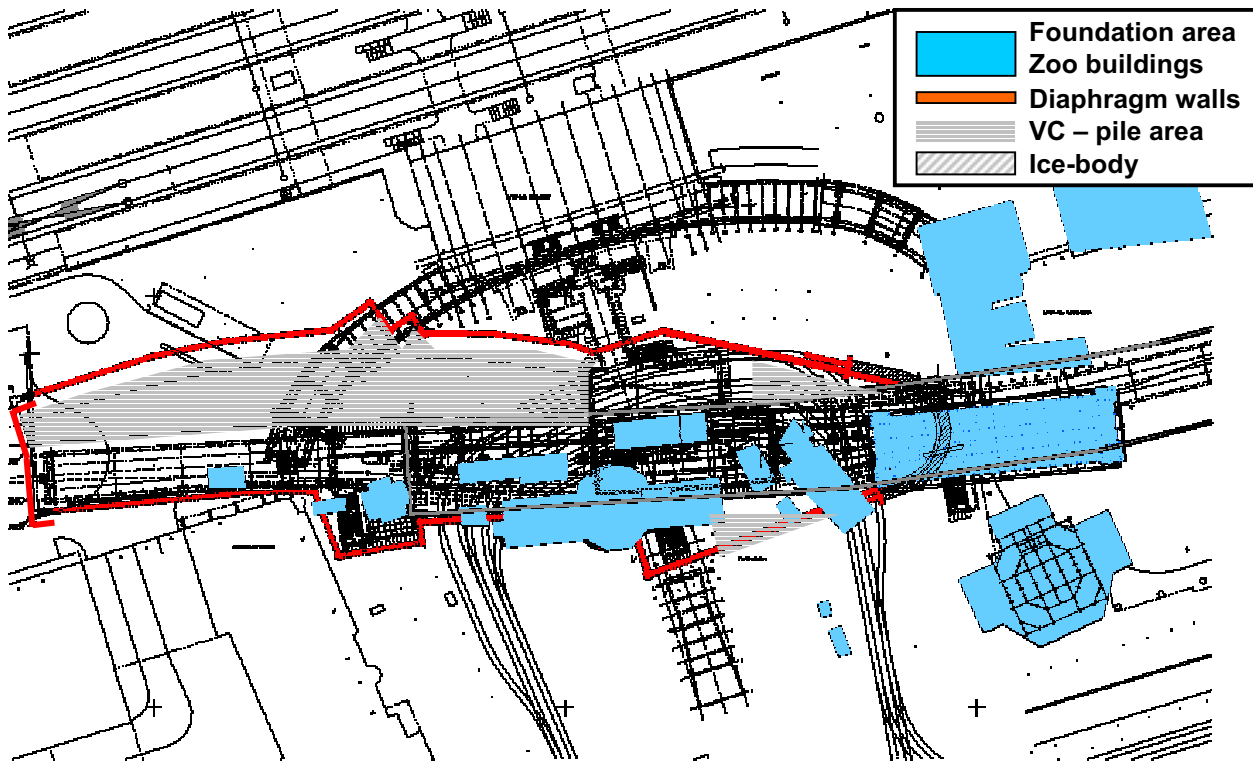
**Figure 10.** Obstacles: former Rotterdam Zoo buildings

The zoo was initiated in 1857 as a small zoological garden. The garden developed to a, at that time, famous zoo and of such a size that it formed an obstacle for the expansion of the city of Rotterdam. It was decided by the city council to move the zoo to the northern side of the railway yard and demolishing of the old buildings was commenced upon. These activities could not be finished as the big fires following the German bombardment in WWII destroyed all remains of the Rotterdam Zoo completely. In the years after that all debris was removed and the area was made barren. The foundations, however, were left in place. The risk analyses identified these foundation remnants as big risks for the construction of the new metro station since the location and type of foundations remnants were unknown and the impact on construction activities could be very big.

The historical- and obstacle investigation was therefore aimed in filling in the gaps of knowledge on the foundation remnants and by doing so reducing its risks. During the design phase of the project desk studies in the private archives of the Rotterdam Zoo, Rotterdam Public Works and various libraries were performed. These studies resulted in a range of maps, drawings, photographs and illustrations of the developments of the Rotterdam Zoo from start to end. By a lot of puzzling and back tracking the locations of almost all buildings were identified with respect to the current topography. Now that the locations of most buildings were known a lot of effort has been put in trying to reveal the exact building plans. This was very important as to determine the type of foundation of the buildings in the project area. One can imagine a shallow footing foundation having much less impact on the construction of diaphragm walls compared with the impact of deep wooden pile foundations. In the end the foundation details of most buildings were recovered with a supposedly acceptable degree of accuracy, Figure 10. With aid of these data the potential conflicts between the diaphragm walls and the wooden piles could be identified.

During the design phase, 40 cone penetration tests (CPTs) were made to verify the presence of foundation obstacles within the diaphragm wall contours as indicated by the historical investigation. Of these 40 tests only one reached its target depth. Most tests refused on 2.5 m below surface level. As a result pre-digging to 2.5 m and removing all debris and obstacles following the diaphragm wall contours was prescribed in the contract. After filling back these trenches with clean soil another test run with CPTs had to be made. At this time only one out of 40 did not reach its target depth. During the installation of the diaphragm walls no wooden pile foundations were noticeably encountered. There are several possible explanations for this: 1) the accuracy of the old plans was overestimated and the deep foundation remains were therefore not located within the diaphragm wall contours, or 2) the wooden pile foundations were present but removed and not documented during the construction of the present metro station in the 1960s or 3) the wooden pile remainders were present but easily removed by the hydraulic diaphragm wall trench cutter and not reported by the contractor.
