# Teplá trachyte weathering phenomena and physical properties of a rare volcanogenic building stone

**Abstract:** One of the few deposits of trachyte suitable for dimension stones is situated in the Western Czech Republic, 6km east of the town of Teplá. The buildings of the famous monastery of Teplá are the best example of the use of Teplá trachyte over more than 800 years.

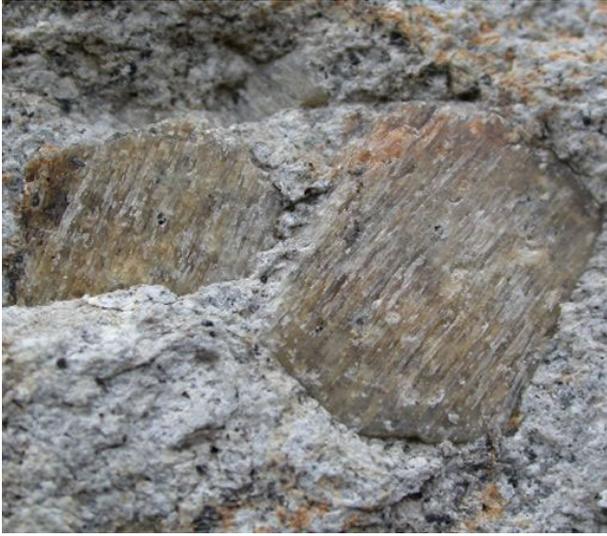
**Figure 2.** Drachenfels trachyte, Germany with phenocrysts of sanidine (size of sanidine: 4cm).

Deposits in Germany	Name	Age	Deposits in Italy	Name	Age
Siebengebirge, Rhine province	Drachenfelstrachyt, Figure 2	Miocene	mine of Zovon di Vò, Euganean Hills near Padua	Trachite Zovonite "Grigia Antiacida"	Oligocene
Reimerath (Mayen), Rhineland-Palatinate	Reimerath-Trachyt	Eocene	mine of Zovon di Vò, Euganean Hills near Padua	Trachite Zovonite "Calda Variegata", Figure 3	Oligocene
Selters, Westerwald	Selters-Trachyt	Oligocene

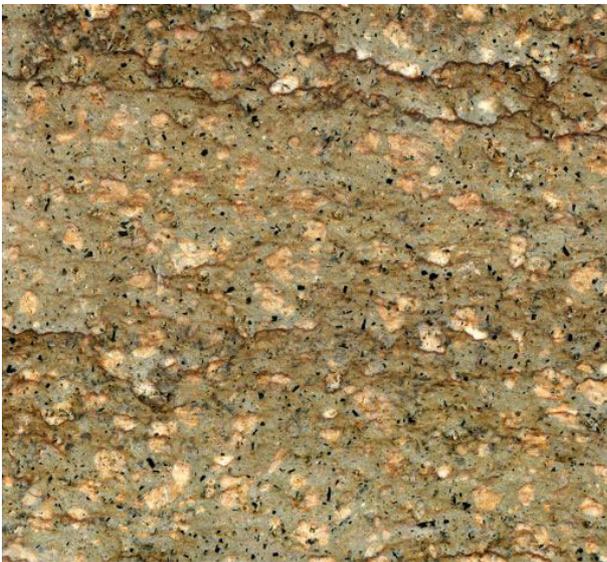
**Figure 3.** Trachite Zovonite “Calda Variegata”, Italy. Brownish variety of Trachite Zovonite “Grigia Antiacida” with its typical brown striae of limonite. The phenocrysts consists mainly of feldspar (full-scale).

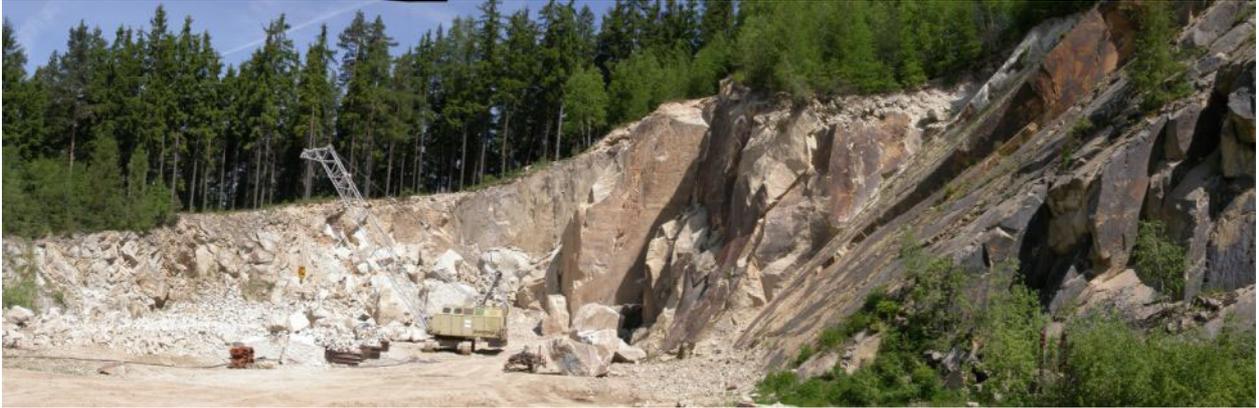
**Figure 4.** Panoramic view of the large, active Spicák quarry east of Teplá monastery. The quarry is run by a Czech-German joint venture company.

The active quarry at Spicák hill was originally owned by the monastery, 3km to the west. The trachyte at this site occurs in a dome-shaped formation as is typical for a subvolcanic intrusion (Figure 4). The quarry has been active since the construction of the Teplá monastery in the year 1193. Teplá trachyte is an important, stable and very good quality and dimension stone. Famous historical buildings where it has been used (mainly as intersection material) include the cathedral of Xanten (Figure 5) and many buildings in the Netherlands. The Teplá trachyte is also widespread in the Netherlands. Trachytic slabs are used in the facade of modern buildings like the university hospital of Pilsen.

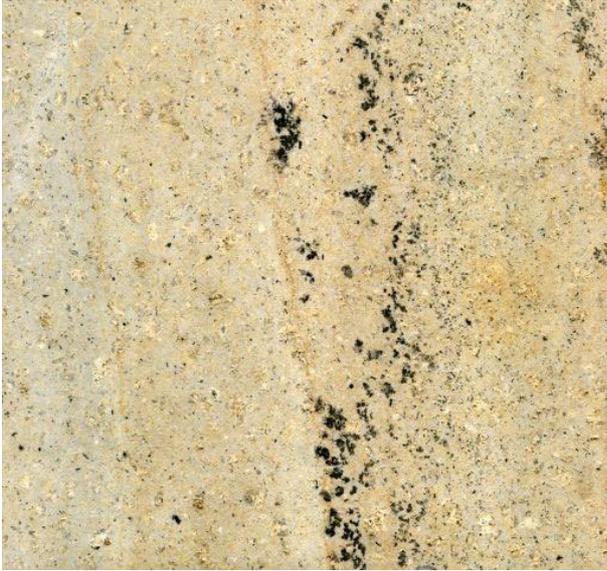
**Figure 6.** Slab of a typical yellowish-beige trachyte from the quarry (full-scale).

The so called Stenská-trachyte or Tepla-trachyte (Müller 1997) which is quarried at the Spicak is one of the acidic neovolcanic stones of the Bohemian Massif with a strong alkaline character: alkalitrachyte. The colour varies from light grey to yellowish-beige, alternating in the quarry with greenish colours (Figure 7). The groundmass is dense to fine-grained. Typical for this trachyte are brownish striae and black manganese-oxide and hydroxide dendrites (Figure 6, 7 & 8). The genesis of these phenomena is related to secondary precipitation from hydrothermal circulation.

A classification scheme of weathering forms was developed for trachytic dimension stones on the western facade of the church. This scheme is based on the established classification scheme of Fitzner *et al.* (1995). Due to different periods of restoration a lack of original material from 1193 in the wall of the church is obvious. That is one of the reasons why different weathering forms occur side by side in the facade. Another reason for variation is inhomogeneity in the rock itself (see Figures 6 & 7).

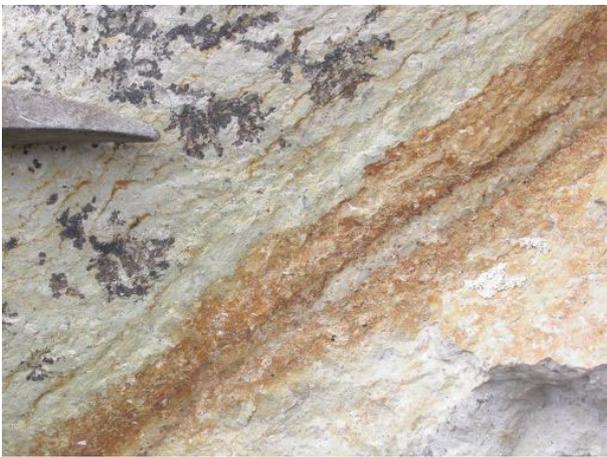
**Figure 7.** Trachytic block with brownish striae, black manganese-oxide and hydroxide dendrites and greenish colour (size: approx. 20cm).

- Alveolar weathering: rare weathering form on trachytes.
- Clearing out of sanidine, Mn-oxides and hydroxides: loss of the matrix due to granular disintegration into sand or flaking.
- Frame formed weathering as a combination of flaking and scaling: form is caused by an improper use of non-flexible cement mortar.
- Notching: precipitation fronts of circulating dissolutions and hydrothermal alteration fronts with greenish colour in the trachyte (see Figure 7) vulnerable to weathering.
- Brownish discolouring: observed on newly intersections.

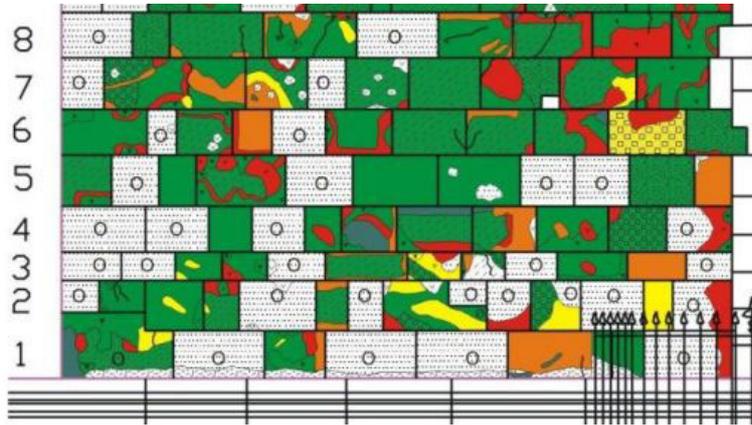
**Figure 10.** Mapping of weathering forms on the lower part of the western facade of the monastery church (cp. Figure 9). Simplified explanation of the colours: green (relief), yellow (flaking), orange (flaking due to scaling), red (scale), grass-green (soiling), white with black dots (technique of workmanship with a point chisel), black line (fissures).

In Figure 10 the variation in weathering is illustrated graphically. The predominant colour is green which represents the decay form 'relief'. Relief means a change in the morphology of the stone surface due to partial or selective weathering. The white coloured and black dotted blocks do not show any signs of weathering. The original surface shows point chisel marks which derive from the restoration period 1930/1931. Other important weathering forms are various degrees of flaking (yellow, orange and red colours). These decay forms only appear in the uppermost millimetres to centimetres of the stone surface. They are mainly caused by the treatment of the stone cutters. The adjusted feldspars were cleaved by the mechanical stress (Figure 12; Gillhuber 2005). After the flakes and scales are removed a relatively stable surface of trachyte appears.
