# The impact of landslides and erosion in the Corangamite region, Victoria, Australia

**Abstract:** The Corangamite region in southwest Victoria, Australia is subject to a variety of geohazards, among which landslides and erosion have the most significant impact. Over the past fifty years, landslides have resulted in loss of life and many millions of dollars damage to municipal infrastructure and development. Soil erosion by water and wind has also impacted on the region's waterways and environment, threatening a diverse range of assets from urban water quality to Ramsar-listed wetlands. More assets are placed at risk each year, as the increasing regional population results in an acceleration of anthropogenic modifications to landscapes.

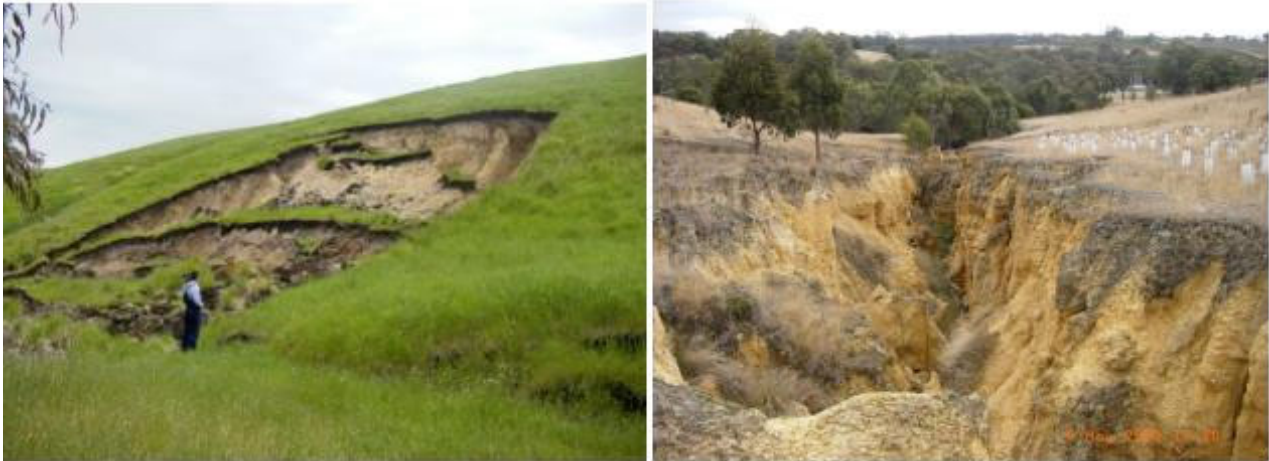
**Figure 2.** Landslide and gully erosion examples from the Corangamite region.

Landslides were mapped as all forms of mass movement from debris creep to rock falls. The landscapes of the Corangamite region are among the most landslide-prone in Australia, with the vast majority of landslides mapped in the Southern Uplands and the dissected south west of the Western Plains. Landslides vary in area from a few square metres to over 120 hectares and in volume from a few cubic metres to over ten million cubic metres. They are triggered by prolonged and/or intense rainfall, man-made changes to the landscape and rare earthquake events (Dahlhaus & Miner 2002). Even though some landslides are relatively small, the costs can be significant. As an example the landslide shown in Figure 2 threatens a major water supply pipeline, resulting in remedial works costing approximately \$200,000.

| Date | Event / location | Description | Impact |
|---|---|---|---|
| 2001 – present | Moorabool River landslide | Relatively small-scale landslide following heavy rain, threatens to sever main water supply pipeline (Figure 2). | Water main endangered, investigation and remedial works ~ \$200,000 |

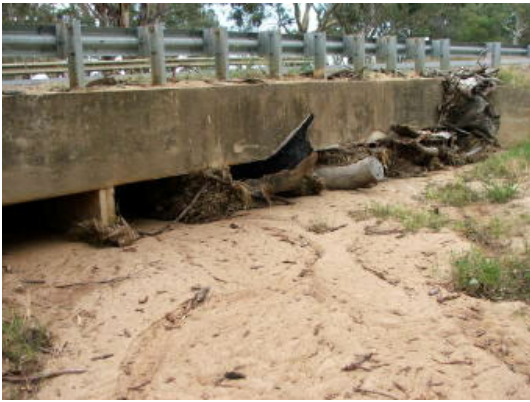
**Figure 4.** Sediment impact on bridge and road infrastructure

In relation to the impact of erosion on infrastructure, there are two recent examples in the Corangamite region that provide an indication of costs. Heavy rains in February 2005, caused erosion which resulted in a build up of sediment and debris at a bridge on the Bacchus Marsh - Geelong Road (Figure 4), with a relatively low cost for remediation (\$3,000). The same event also caused a collapse of a main road (Jetty Road), with an immediate cost of \$5,000 for the cleanup operation and an expected cost of around \$200,000 to remediate the road.
