## Landslides geohazard map for Portland, Oregon, USA

DR. SCOTT F. BURNS<sup>1</sup>, WILLIAM J. BURNS<sup>2</sup>, JASON C. HINKLE<sup>3</sup>,  
DAVID H. JAMES<sup>4</sup>

**Abstract:** After a large precipitation event, the 6th-9th of February 1996, when 20 centimetres of rain fell in four days in Portland, Oregon, our research team mapped 705 landslides in the area. This was a 100-year event climatically for landslides so we wanted to make sure we got a clear impression of the causes of the landslides. From the data of the survey we constructed a landslide hazard map that is now used in land use planning. Each landslide was described using 20 different criteria such as volume, dimension, scarp height, process, geology, soils, and slope angle. The landslides fell into mainly four zones. The West Hills Silt Soil Province had 374 landslides that were mainly earthflows less than 500 cubic metres in size because the parent material is mainly loess and ML soils. Mitigation of most of these slides was mainly from gabion walls, which have been very successful. The Fine-grained Troutdale Province of southeast Portland had 72 landslides that were mainly reactivations of larger earthflo

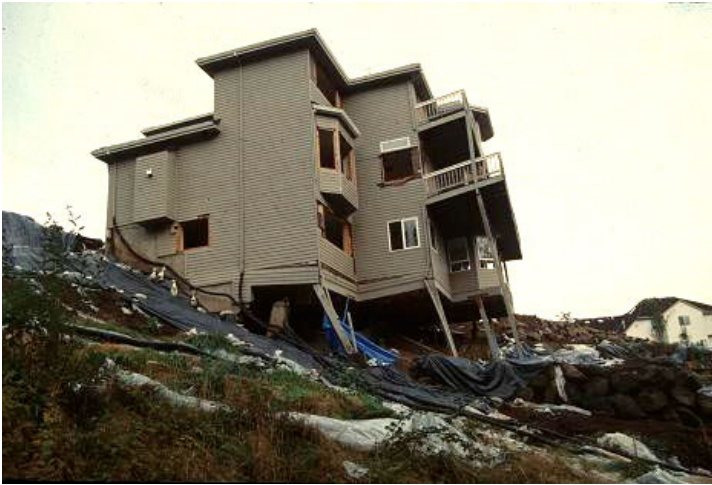
**Figure 1.** A slump near Tigard, Oregon (Burns *et al.*, 1998, Slide #695)

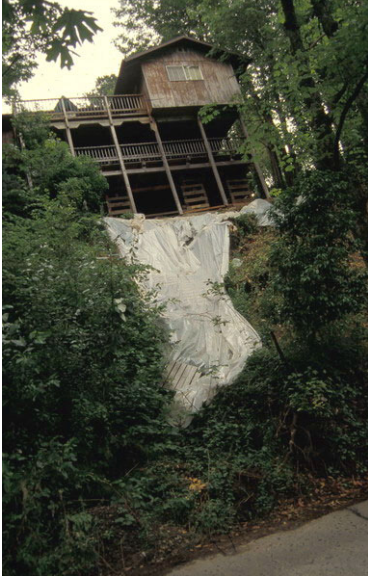
**Figure 4.** Earthflow in the West Hills began where a gutter deposited water (Burns *et al.*, 1998, Slide #119)

In 9% of the cases, we could actually point to places where humans had influenced the concentration of storm water on the slopes. Broken water pipes, broken drainpipes, clogged gutters, and runoff from driveways and patios were examples of humans inadvertently helping the landslides. If the people at these sites had controlled the storm water, the landslides could have been prevented or at least decreased in severity. An example of a clogged gutter concentrating water on the slope below a house leading to a landslide is in Figure 4.

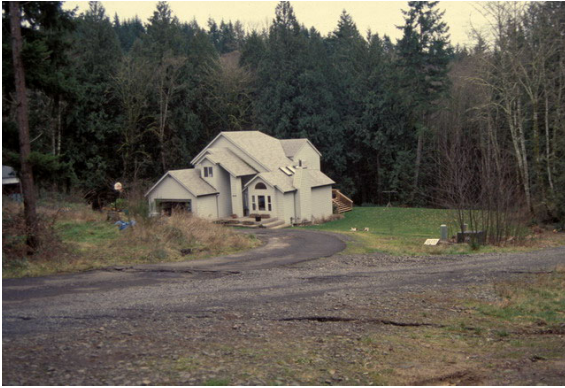
**Figure 6.** Toe of ancient landslide moves 0.3 metres laterally and causes distress for house (Burns *et al.*, 1998, slide #263)

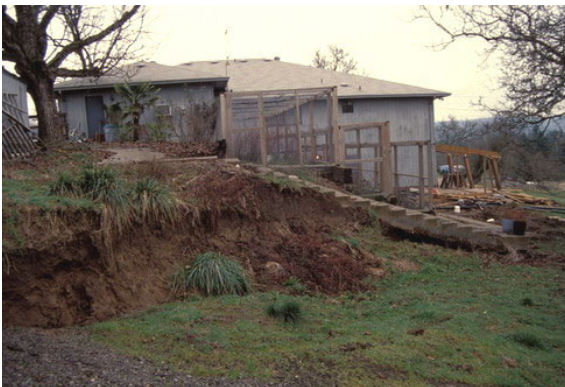
**Figure 7.** Ancient landslide in the Troutdale Fm drops one metre (Burns *et al.*, 1998, Slide #272)

again. Reactivation of the palaeoslide on Holly Lane (Burns *et al.*, 1998, slide #272) destroyed four homes with a one metre drop at the headscarp in February, 1996 and then another drop of one metre the following winter (Figure 7). These palaeolandslides can be identified by locating ancient headscarps and the hummocky topography (rolling hills) of the slide surface (Figure 8).

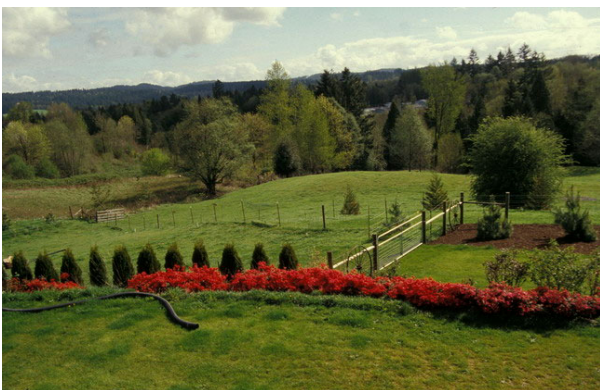
**Figure 8.** Hummocky topography, one cannot see any new movement (Burns *et al.*, 1998, Slide #272)

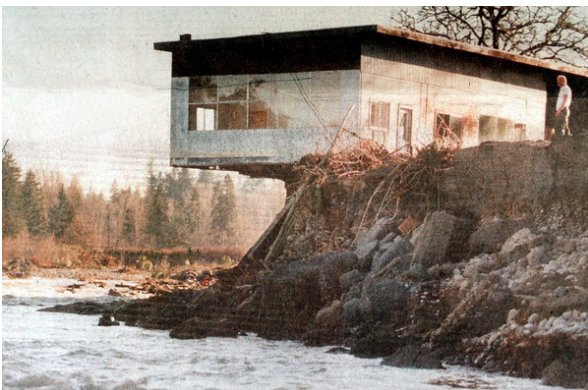
**Figure 9.** Clackamas River undercutting slope along the Rivers Province (Burns *et al.*, 1998, Slide #685)

Where the slope was in contact with the river, undercutting occurred and caused the slope to fall into the river. These slides were especially common in the meander bends of the rivers. There were 14 lots of a mobile home park undermined in the meander bend of the Clackamas River just west of where Highways 212 and 224 merge (Burns *et al.*, 1998, slide #230). The only death during the storm in the Portland area occurred when the Sandy River undercut the bank of the home of Harold and Jacqueline Jank on the Old Columbia Highway in east Troutdale (Burns *et al.*, 1998, slide #162). The landslide carried their home into the Columbia River.

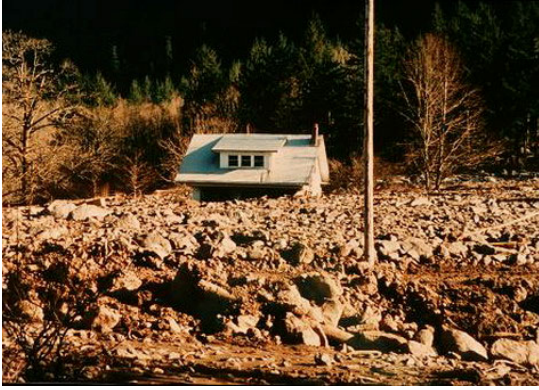
**Figure 10.** Debris flow buried the Royse homestead, Dodson, Columbia River Gorge (Burns *et al.*, 1998, slide #128)

The two most famous debris flows occurred on Thursday, February 8th at Dodson, 56 kilometres east of Portland in the Columbia Gorge (Powell, 1998). At the west end of Dodson, a slow moving debris flow (moving at about eight kilometres per hour) half buried the 50 year old homestead of Carol and Hersh Royse (Figure 10) (Burns *et al.*, 1998, slide #128). A fast moving debris flow came down Tumult Creek (Burns *et al.*, 1998, slide #130) at a rate estimated to be 48 kilometres per hour. Both of these debris flows crossed I-84 and the Union Pacific Railroad tracks. The highway was closed for three weeks. Resident Mark Chandler of Dodson reported that the Tumult Creek stopped flowing for a while just before the first debris flow came rushing down.

The stoppage probably was created by debris slides upstream blocking the creek; the debris flow originated when the debris dam was breached. Estimates of the volume of the debris flow deposits range from  $7.65 \times 10^5$  to  $1.91 \times 10^8$  cubic metres (Powell, 1998). The area around Dodson received 33 centimetres of rain in the four-day event.
