Study on the formation mechanism and design of control engineering for the super-huge Tiantai landslide, Xuanhan County, Sichuan Province, China

QIANG XU, RUNQIU HUANG, TIANXIANG LIU, XUANMEI FAN, HUA GE, & XIAOBING SONG

Abstract: On 5 September 2004 a catastrophic super huge landslide was induced following prolonged heavy rain, at Tiantai village, Xuanhan Country, Sichuan Province, in China. The landslide was 950m to 1200m long, 1400m to 1600m wide and its average thickness was 23m. It had an estimated volume 25 million m³, which is uncommon for rock landslide in China. Approximately 2983 houses and 59600m² of land were destroyed which caused 1255 people, and nearly 317 families to lose their houses. Furthermore, an estimated 2.1 million m³ of debris from the landslide became deposited into the Qianhe River. This formed a rock dam some 1500m wide and 20m high impounding a lake about 60 million m³. Because the Qianhe River was blocked and water level rose, 5770 houses and 4930 acres of cropland in Wubao town located further upstream, became submerged. In total 19,360 people were temporarily evacuated as a result of the landslide and its secondary affects. The direct economic loss

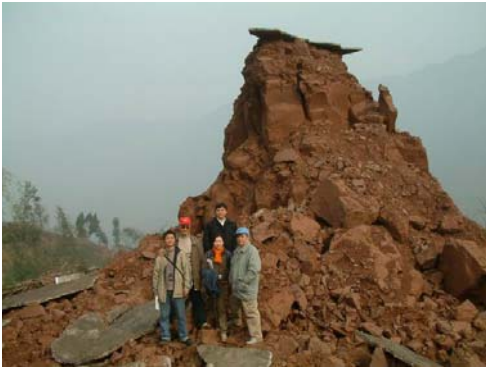
Figure 3. Large blocks of rock and debris which were displaced by the landslide.

The landslide appeared to fail not as a single ‘block’ but consisted of about 50 complex, secondary ‘blocks’. The duration of the landslide has been estimated to be in the order of 8.5 hours, from 15:00 to 23:30, on 5 September 2004. The middle and front part of the landslide slipped first via translational type of movement and slumping into the Qianhe River. The landslide changed dramatically the surface morphology to the extent that houses, ponds and gullies were no longer recognisable. In some instances however, certain morphological features remained intact in spite of having been transported at least 140m (Figure.3).

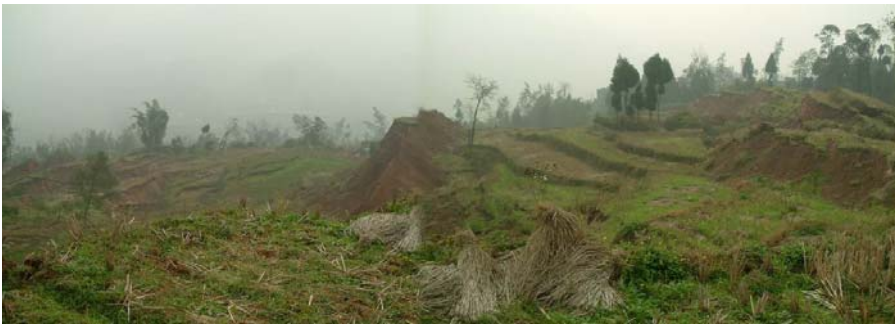
Figure 4. Spreading in the middle part of the landslide generating a series of terraces and scarp.

Spreading was observed in the central part of the landslide and this resulted in the generation of a series of terraces and scarps (Figure 4). This has been interpreted to represent secondary ‘gliding’ of large ‘blocks’ (possibly defined by joint sets in the bedrock). Beyond the edge of the landslide graben and multiple reverse fissures were observed.
