Cost effective stabilization of clay slopes and failures using plate piles

Abstract: Progressive, seasonal soil slips occurring on expansive clay slopes at a large, developed, landscaped commercial site, and in a slide-prone residential subdivision in Northern California, prompted a progressive shift from conventional slope reconstruction methods to a more innovative approach to slope stabilization. These sites have been plagued with predominantly translational soil slips on the order of 0.3m to 1m deep, that generally initiate after prolonged rainfall events, especially those in excess of 50mm/day. Based loosely on limited experimentation by researchers on similar shallow clay slips, Kleinfelder personnel expanded on their idea of installing 88.9mm-square plastic pins to designing 6.35mm (1/4 inch) thick galvanized steel, 63.5mm by 63.5mm (2.5-inch) angle iron with a 0.3m (12-inch) by 0.6m (24-inch) flange plate pile, approximately 2.1m long. Kleinfelder's (patent pending) technique utilizes plate piles laid out in a 1.2m-centred offset grid pattern. This stabilization method is being used to provide stabilization on un-failed and some existing failed slopes. Preliminary costs ar

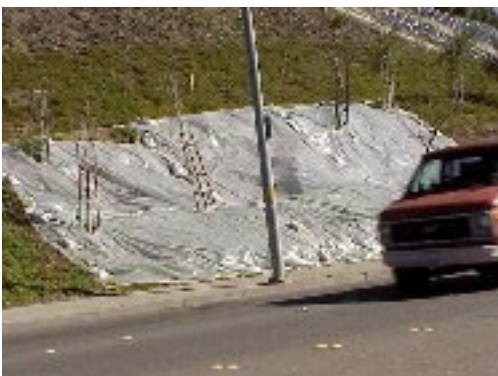
Figure 1. Translational landslide on landscaped slope

The landslides vary in depth from 0.3 to 1m-deep and range in width from 3m to several tens of meters wide (Figure 1). The failure surface is parallel to slope and the landslides are most closely described as translational earth block slides (after Varnes, 1978), with some flow deformation at the toe. Debris within the landslides typically consist of soft to stiff, wet clay (either residual/colluvial soils or clay fill), which is underlain by either stiff to hard clastone or clastone-derived engineered fill.

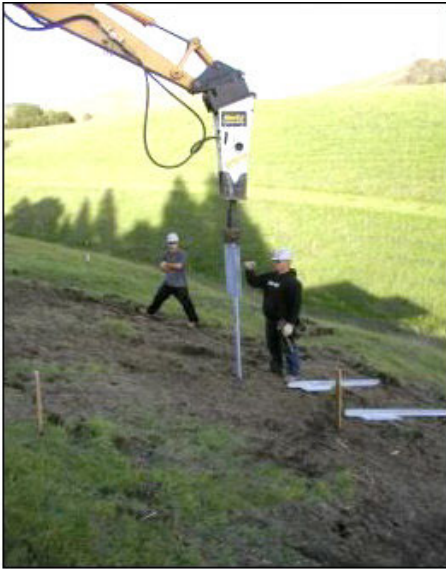
Figure 4. Installation of a plate pile with a modified hoe-ram attachment on an excavator

Depending on the stiffness of the underlying materials, plate pile can be installed either by direct push method by an excavator bucket or driven by either a hoe-ram or "head-shaker" compactor attached to an excavator or backhoe, equipped with a modified "cup" that fits over the end of the plate pile (Figure 4). Plate piles are sufficiently light (approximate 27kg) and can be manoeuvred and placed into position by a single labourer. Depending on site and access conditions, plate piles can be installed at rates of 20 to 25 per hour.

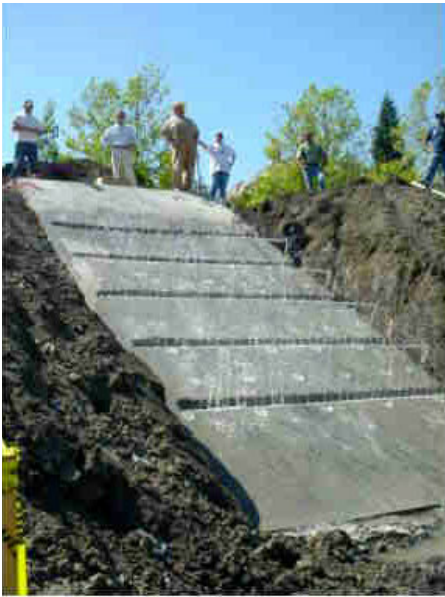
Figure 5. Concrete slab at test site outfitted with an array of plate pile sleeves and subsurface irrigation lines

The residential test site is located within the Blackhawk gated residential development in Northern California. The slopes surrounding this development have been prone to numerous shallow landslides that have developed within residual and colluvial clayey soils, typically underlain by weak claystone bedrock. To test the effectiveness of the plate pile stability method, a series of full-scale field tests were performed at the Blackhawk Geologic Hazard Abatement District (GHAD) Test Site. Short, et al. (2005, in press) have summarized the testing and evaluation procedures that demonstrate the effectiveness of plate piles in stabilizing shallow landslides and potentially unstable slopes underlain by clay. Short, et al. (2005) experimented by constructing a 2H:1V (26.6°) test fill slope underlain by a concrete slab outfitted with irrigation lines (to simulate pore water pressure) and a geometric arrangement of PVC tubes/sleeves in which various configurations of plate piles can be inserted (Figure 5).

The slab is designed to act as a predetermined slip surface or zone of weakness on which to initiate slippage. As part of the testing, a 1m thick layer of compacted clay fill was placed over the concrete slab. During the experiment, the surface was soaked (to simulate a rain event) and then the irrigation lines embedded in the subsurface concrete slab were turned on to increase the effective pore pressure acting on the base of the soil and soil/concrete interface (slip surface). The test continued in the unreinforced slope until translational failure was initiated within approximately 7 minutes. The test was then repeated, this time with plate piles inserted into the sleeves in the concrete on a 1.2m-on-center lateral spacing, in rows 3m apart. Short, et al. (2005) show that failure did not occur in the second trial, even after 13 minutes of subsurface irrigation. It should be noted that no tension cracks formed and excess water from the subsurface irrigation lines exited the slope through “piping”, without loss or movement of the soil mass. The 1.2m by 3m offset grid pattern that was shown to be stable resulted in a stabilized configuration using less plate piles than that in the commercial, further reducing the cost of stabilization by an additional 50%.
