Qualitative assessment of geohazard in the Rječina valley, Croatia

CEDOMIR BENAC¹, VLADIMIR JURAK², MAJA OSTRIC³ &
NEVENKA OZANIC⁴

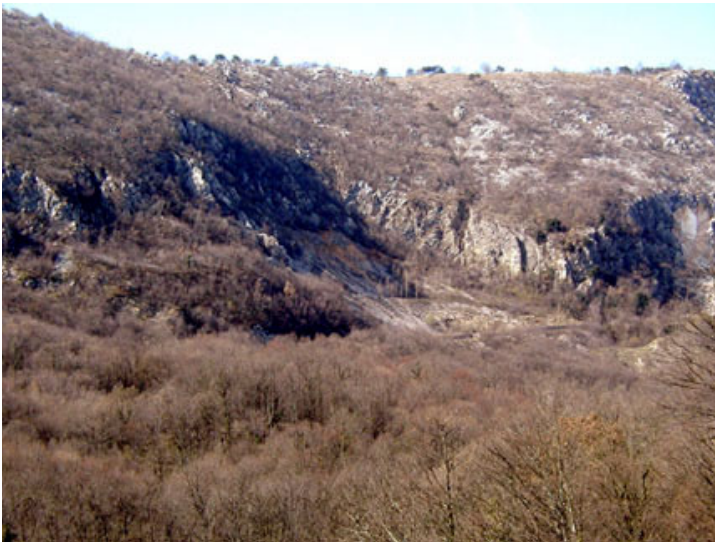
Debris avalanche on SW slope (Figure 4; marked as A on Figure 2):

The crown of this recent landslide is clearly bounded by limestone cliffs, while the toe reaches the regional road. The displaced mass is composed of coarse fragments to blocks in excess of 10 m³ in volume. The slip plane is probably predisposed by the flysch bedrock morphology. Excavation of rock materials caused the rock avalanche that buried the regional road in 1979. It was estimated that the mass movement had a volume over 170 000 m³. Estimated dimensions and geometry of this instability are described according to the 'World Landslide Inventory Working Party: Suggested Nomenclature for Landslides' (IAEG 1990):

- total length: $L = 110$ m;
- width of the displaced mass: $W_d = 150$ m;
- depth of the displaced mass: $D_d = 10$ m.

Figure 4. Debris avalanche and rock slide on SW slope of river valley, marked as A on Figure 2

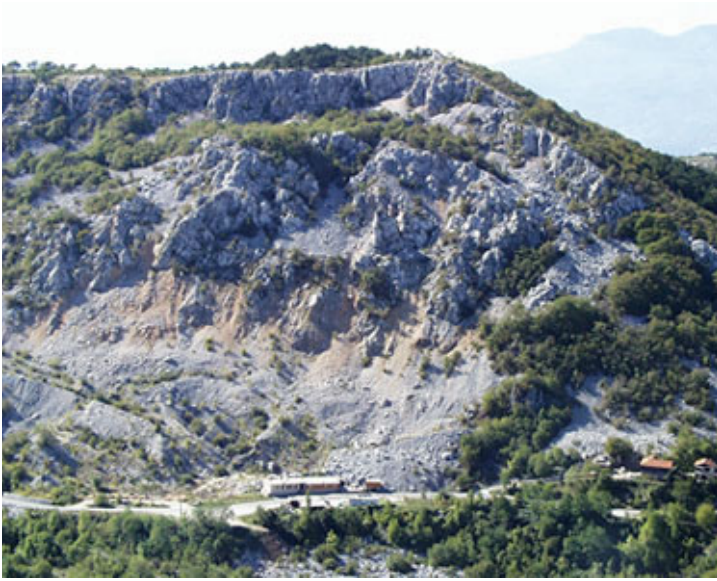
Debris avalanche and rock slide on SW slope (Figure 5; marked as B on Figure 2):

The material of this landslide is composed of coarse fragments to blocks up to 50 m³ in volume. The slip plane is probably predisposed by the morphology of flysch bedrock. In 1908, a debris avalanche buried the village of Grohovo and partially dammed the Rječina riverbed. It was estimated that this mass movement had a volume of 1 650 000 m³. Estimated dimensions and geometry of this instability are:

- total length: $L = 450$ m;
- width of the displaced mass: $W_d = 300$ m;
- depth of the displaced mass: $D_d = 10$ m.

The crown of the instability reaches to the foot of a rocky block of dimensions 450 m wide and 150 m long. The limestone rock mass comprising the block is disintegrated. Indications of recent movements are not evident and it can be considered as an inactive, dormant landslide. However, movements during a period of reactivation were very rapid. A large limestone block separated from the karst plateau can be considered as a separate phenomenon representing an inactive, dormant rock slide.

Figure 5. Debris avalanche and rock slide on SW slope of river valley, marked as B on Figure 2

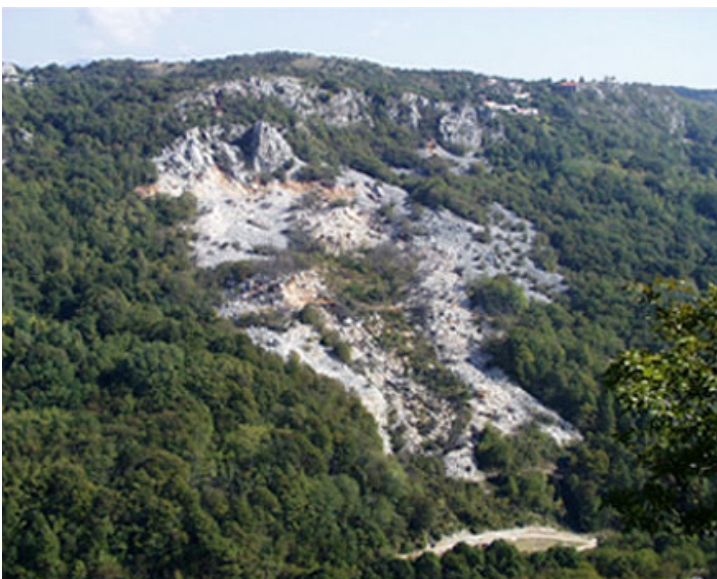
Landslide on the NE slope (Figure 6; marked as C on Figure 2):

The crown of this landslide is clearly marked by carbonate rock scarps that form the rim of the karst plateau (Figure 6). The slip plane was predisposed by the position of flysch bedrock. The limestone rock mass is very deformed and karstified with recently-opened fractures, and has been prone to rockfalls and sliding. At the foot of the limestone cliffs, coarse-grained slope deposits are found and debris slides have formed. In the lower part of the slope fine-grained material prevails and consequently earth slides are formed. Estimated dimensions and geometry of this instability are:

- total length: $L = 425$ m;
- width of the displaced mass: $W_d = 200$ m;
- depth of the displaced mass: $D_d = 6-20$ m;

Figure 6. Active landslide on NE slope of the river valley, marked as C on Figure 2

On the north-eastern slope, the slope deposits mostly range from a mixture of clayey silt formed by weathering of flysch bedrock and fragments originating from the rocky scarps on the top of the slope. Only in the area of the active complex landslide can coarse-grained slope deposits or rockfall talus, like those from south-western slope, be found. On the north-eastern slope a debris avalanche and a complex landslide (Figure 6) can be distinguished.

This landslide is not a recent phenomenon, and data concerning mass movements have been registered during the entire 20th century. On December 1996 approximately 850 000 m³ of material moved. Movement of isolated limestone

blocks and opening of new fractures in a rock 'mega-block' at the top of the slope can be observed. Results of geodetic monitoring also indicate that the largest displacements are occurring on the top of the slope, involving isolated blocks as well as the limestone mega-block that is separated from the karst plateau (Benac et al. 2002). The larger part of the landslide body is saturated by underground water penetrating through the covering material in a zone where it is in contact with the underlying flysch bedrock. Unlike the limestone, the flysch rock mass is more prone to weathering and a clayey weathering zone has formed at the flysch bedrock surface, thus impeding drainage. According to accepted classifications, the described instabilities have characteristics of a retrogressive landslide that started to develop from the foot of the slope to the top due to river erosion and undercutting at the slope foot. As the position of the slip plane was predisposed by the slope geology, the landslide can also be considered as dominantly translational in character (Cruden & Varnes 1996).
