# Cutting slope reinforcement in reconstructed migrant cities in the Three Gorges Reservoir area of China

**Abstract:** The Three Gorges project in Yangtze River is one of the biggest hydropower projects in the world. 20 counties and 277 towns are involved in the submerged area, 12 counties, 116 towns and 1629 enterprises have to be totally moved, and the total migration reaches 1.1056 million. This is a rare large-scale project in the history of the world. Up to now, 70% of emigrant people have been settled.

The author, commissioned by the state government, has conducted a program of the protection project for the remaining 1270 slopes. The slopes are classified into three categories and five sub-types in the programme, each with different kinds of deformation-failure modes. Six kinds of measures have been used for the reinforcement for different kinds of slopes including drainage, slope cutting, anchoring, cement jetting, retaining wall and anti-sliding-pile, etc. A series of photographs showing the slope deformation-failure modes and the slope reinforcement with different measures are illustrated.

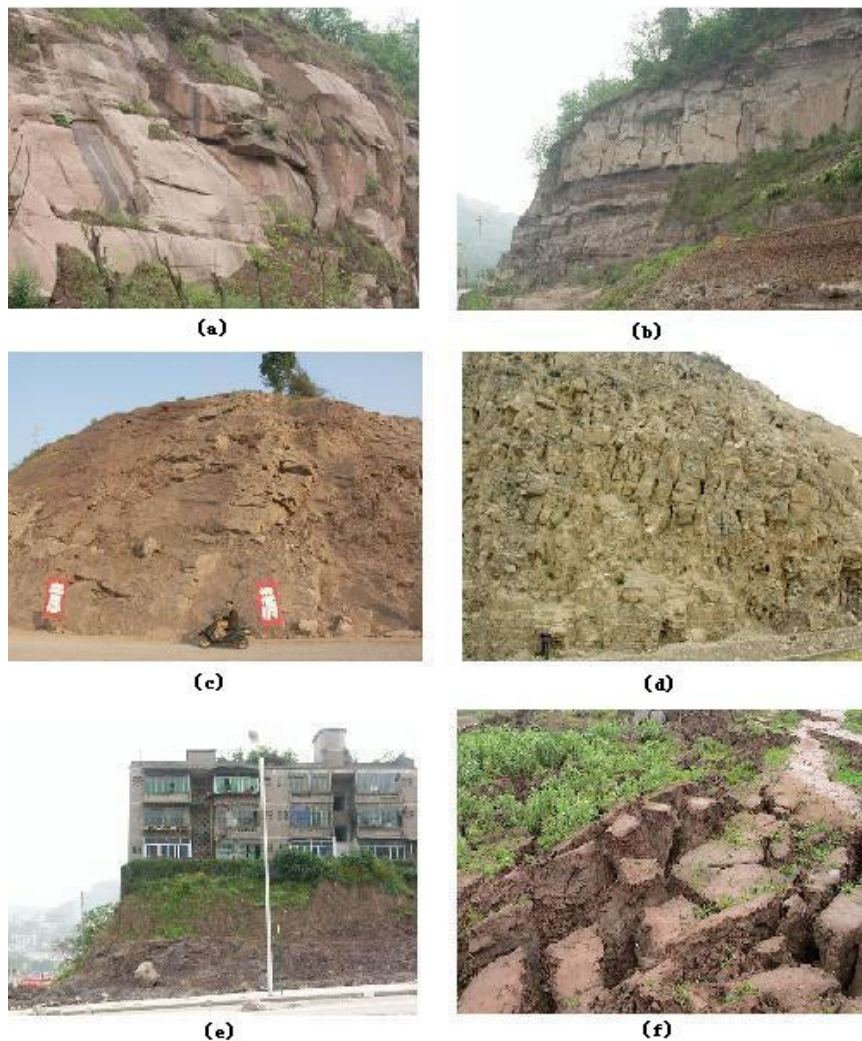
**Figure 2.** Failure modes for different types of slopes

- (a) Rockfall of thick layers of sandstone in Wanzhou city;
- (b) Rockfall of inter-layers of sandstone and clay caused by differential weathering;
- (c) Slipping of layers along bedding surfaces in Kaixian county;
- (d) Failure of marl by corrosion and weathering, Fengjie county;
- (e) Failure of slope with soil at upper part and rock at lower part of the slope, Wanzhou city;
- (f) Failure of soil slope in Wanzhou city induced by highway construction.

For the slope with block-rock as thick layer sandstone or granite, or with inter-layers of sandstone and shale, the slope may fail by rockfall (Fig.2a, b). Differential weathering leads to grooves at soft clay layers, thus the blocks of sandstone over the grooves lose their support and fall down. This is a very common mode of slope failure in the area.

The most likely failure mode for the layer strata with suitable angle inclining outwards the slope is slipping. Fig.2c shows a typical failure phenomenon in Kaixian and Fengdu county.

For the slope with soil over rock, it may fail in the mode that slides within soil or along the interface between soil and rock. Figure 2e is the structure of this kind of slope in Wanzhou city.

And for soil slopes, sliding will be the possible failure mode. Figure 2f shows the fissures on an expensive soil slope in Jianfenglin new town, Wanzhou, induced by highway construction.

Besides, Figure 2d shows a special failure mode of marl slope. Unlike our experience, marl is much more corrosible and more easily weathered than pure limestone, and the course of corrosion and weathering takes place almost isochronously at the surface of rock block and within the block. This makes the structure of the rock mass weaken and loose simultaneously in a large range of the slope, thus failure of the slope in structural collapse is much easier to take place.

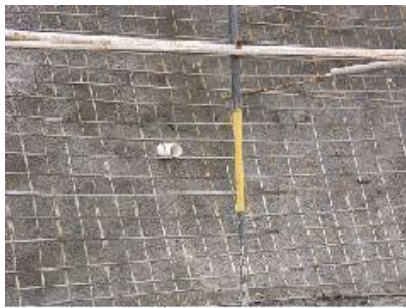
- (a) Cement jetting with reinforcing meshwork;
- (b) Anchor with concrete lattice in Wushan county;
- (c) Retaining wall in Fengjie county;
- (d) Anti-sliding-pile with baffle boards in Wanzhou city.

Figure 3 shows four major measures used for slope reinforcement in new migrant cities in Three Gorges Reservoir area. Cement jetting with reinforcing meshwork (Fig 3a) is the most popular measure for rock slopes, especially for weathered or fissured rock slopes. Meshwork is designed as  $200 \times 200$  or  $300 \times 300$ mm with a  $\phi$  6-8mm steel bar.

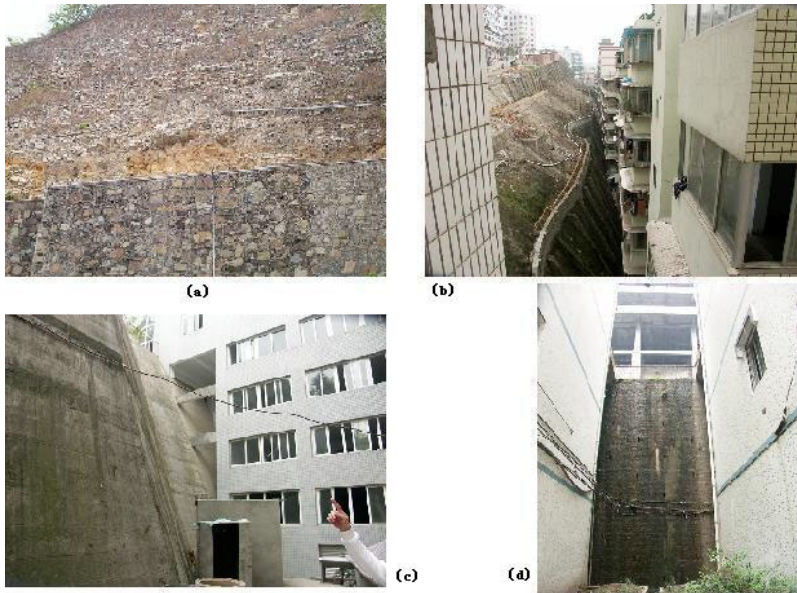
**Figure 4.** Problems in slope reinforcement

- (a) The retaining wall is not high enough;
- (b) Slope protection works are built too close to the buildings;
- (c) Building is rigidly connected to the retaining wall with concrete bridge;
- (d) The drainage pores fail to work.

Figure 4a shows that the retaining wall is not high enough to keep the detritus from moving down over the top of the wall. Many slopes have these problems and rock blocks fall down frequently, hitting people, buildings and vehicles, and blocking drain works.

Some retaining walls and slope protection works are built very close to the buildings as shown in Figure 3b, where it is only about 1~2 m spacing but more than 10 m high. Another case is that the building is rigidly connected to the retaining wall with concrete bridge (Figure 4.c). Any little displacement of the wall will induce deformation of the building.

Another problem is that the drainage pores fail to work. For a number of slopes, drainage pores in retaining walls have been plugged up, and groundwater overflows from the top of the wall (Figure 4c). This, as is well known, may lead to a remarkable increase of water pressure behind the retaining wall.
