Slide mechanisms of a giant ancient slide body at Huangtupo, Badong County in the Three Gorges Reservoir area

Abstract: Resettlement is one of the most important problems in the Three Gorges Project. In recent years, as one of the new locations in Badong County, Huangtupo landslide has been a regular focal point for engineering geologists from home and abroad. It has been listed as the key research item in the General Plan for Geological Hazard Prevention in the Three Gorges Reservoir Area. This paper describes the study of the slide mechanism of the Huangtupo landslide using comprehensive methods including engineering geological field investigation, measuring sections, statistical analysis of fractures, indoor observation of minerals and the microstructure of the rock, age testing and borehole verification. Research results demonstrate that Huangtupo is a giant ancient slide body composed of three sections: the upper, the middle and the lower. Achievements of this research lay a solid foundation for predicting the temporal and spatial stability of the Huangtupo landslide when sliding occurs, and preventive treatment. In addition, there are many giant ancient slide bodies similar

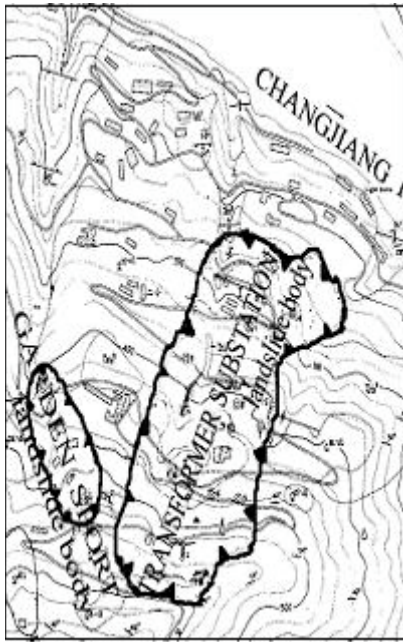
Figure 1. Garden Spot and Transformer Substation landslide

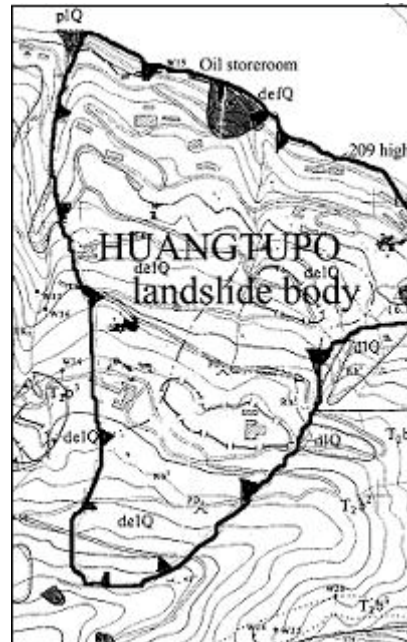
Figure 2. Huangtupo landslide

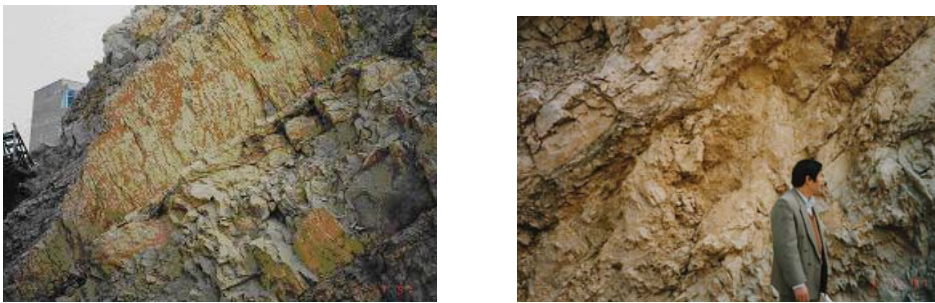
Figure 3. Field geological features of rock bodies within sliding masses of landslide at Huangtupo

- The entirety of the rocks within the sliding mass are often maintained after sliding because of short sliding distance of the landslide and high strength of the rocks;
The beddings of the rocks in the sliding body are often visible, and their orientations are often coincident with that of the bedrocks (Figure 3).

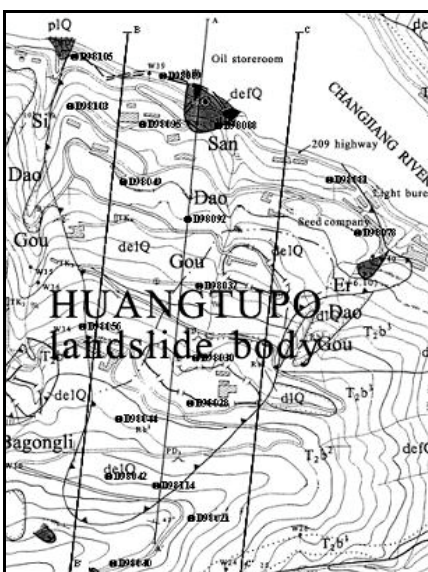
Figure 4. Engineering geological map of Huangtupo landslide

Statistic analysis of fractures is carried out carefully. First, the fractures are measured on the natural outcrops. The observation items include the orientation and area of the outcrop, the orientation, length, aperture, spacing, filling, ductility, weathering, cementation and roughness of the fracture. Figure 4 shows the positions of the measuring points. Then, the genetic property of the fracture is analysed and the rose map of the fractures (Figure 5) is obtained. Finally, the background fractures and sliding fractures are distinguished on the basis of above-mentioned results and a preliminary scale of ancient slide mass is determined.

According to Figures 4 and 5, there are 4 groups fractures developed in the background area of the landslide: NW, NE, NNE, and ENE. Most of them are shear fractures, and in accordance with regional tectonic pattern. In the landslide area, the number of fractures apparently increases, and the trends of them become disorderly. The directions of fractures are different in each statistic point, and the fractures show diverse mechanical features in various parts. Tension fractures (D98114), shear fractures (D98044), pressure fractures (D98049) appear respectively in trailing edge, inside, and leading edge shearing zone of the landslide. In addition, research shows that the whole Huangtupo landslide consists of 3 parts: the upper, the middle, and the lower, in term of joints attributes. Different parts of the landslide have different kinds of fractures: tensile fractures appear mainly in trailing edge, shear fractures emerge in the inside of the slide mass, and pressure fractures occur in the leading edge shearing zone.

Moreover, three engineering geological measured sections (in Figure 4, A-A', B-B', C-C') are arranged along the south-north direction. Take section A-A' for example, aerial density (the number of the fractures per unit area of outcrop) of the fractures in the background zone and landslide area are analysed along the section in this study (Figure 6). The figure shows that the statistical average value of the background fractures is about 16 on the upper part of section A-A' whose elevation is more than 600m; the average value in upper sliding body is 23, and there are 10 fractures in syncline counter-inclined segment (hereafter referred to as "the upper"), which is between leading edge of

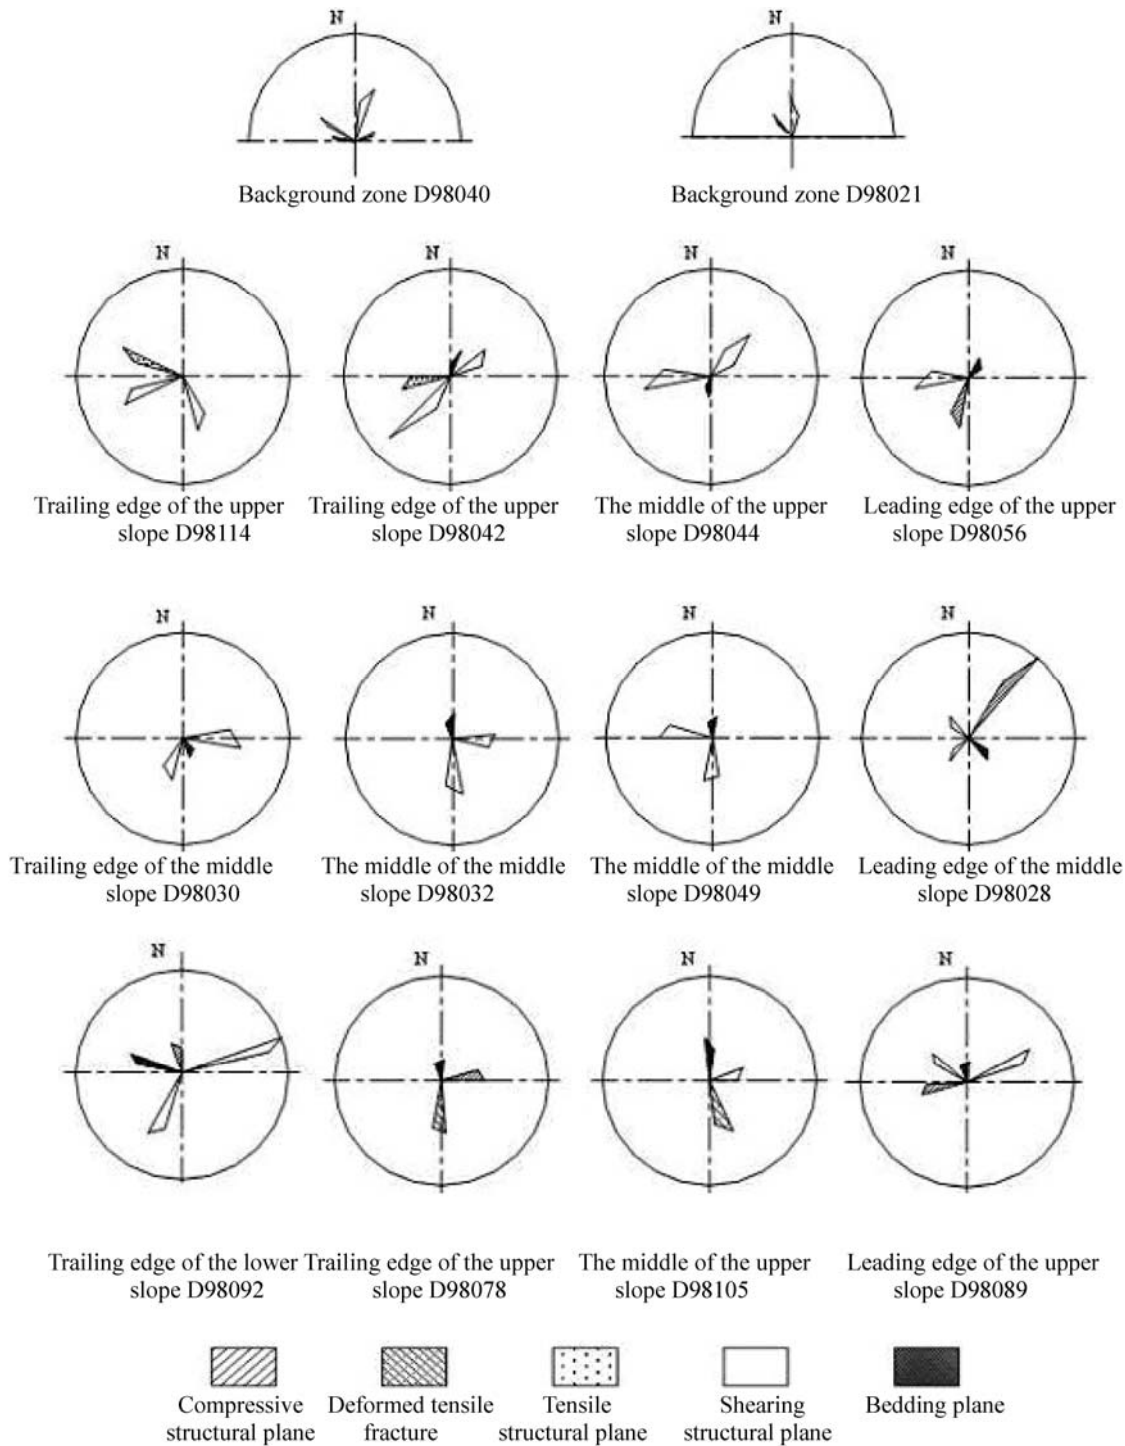
Figure 5. Joints rose of Huangtupo landslide, Badong County

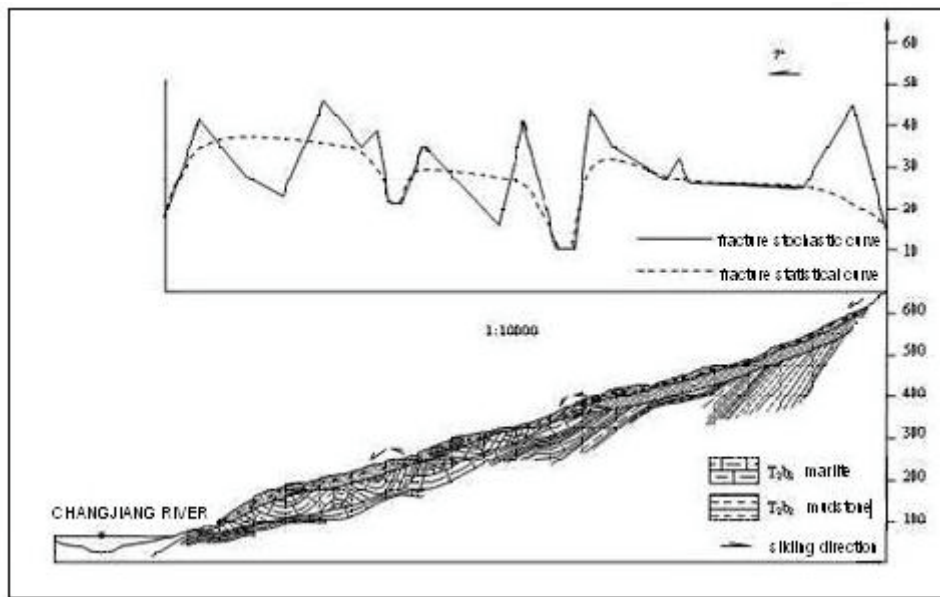
Figure 6. Fractures density on section A-A' in Huangtupo landslide

the upper sliding body and trailing edge of the middle sliding body, and 380m ~ 400m in elevation. Average value of fractures in the middle slide body is 26, and 16 in syncline counter-inclined segment (about 240m ~ 260m in elevation) between leading edge of the middle sliding body and trailing edge of the lower sliding body, 32 in the lower sliding body, and 14 between the outboard of the upper sliding body and river (about 80m ~ 100m). All of these reflect continuous deformation and failure process of engineering rock mass caused by endogenic and exogenic geological process of slope.

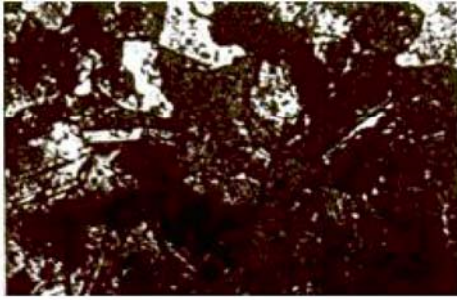
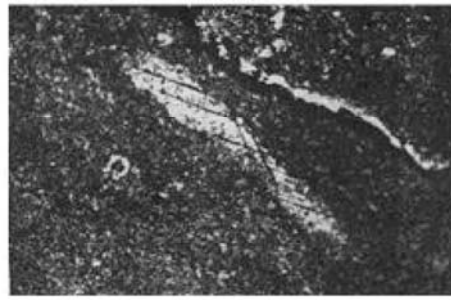
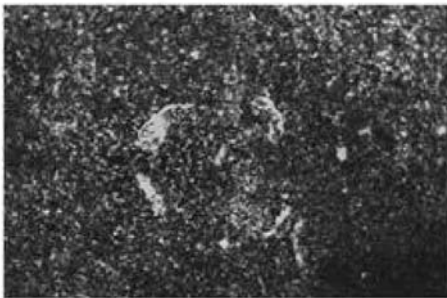
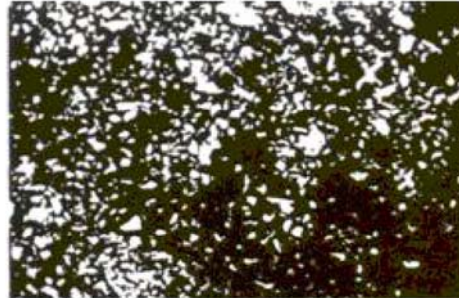
Calcite polythentetic twin in background rock masses

Calcite porphyroblast in the upper section

Calcite porphyroblast in the middle section

Calcite porphyroblast in the lower section

Figure 7. Minerals microstructure in T_2b^3 Marlite of Huangtupo ancient sliding body

Changes of microscopic geological evidences of rock masses under sliding dynamic action are studied using micropolariscope and stereoscan in microscopic research, and then identified rock masses within sliding masses of the landslide^{[1] [5] [6] [7]}. During the course of research, at first, field oriented specimens are collected and marked upper and lower end and N, S directions using compasses; then thin section cutting is undertaken in the laboratory, and each sample is cut respectively in the horizontal and vertical directions, and marked N, S in horizontal direction and upper and lower end in vertical direction; finally, slices observation is conducted, contents of which include damage fracture property, mineral fabric feature, marginal grained effect, alteration etc. Section A-A' is chosen for gathering the background rock and oriented specimens of the rock masses within sliding masses of landslide. As space is limited, the paper presents only the results of mineral microscopic fabric feature (Figure 7).

In contrast with background rock masses, rock masses within sliding masses of landslide not only contain less calcite, more pelitic components, but mineral fabric of calcite becomes rather broken and imperfect, and mainly appears in the formation of porphyroblast. At the same time, the phenomenon that tenuous calcite grains and pelitic components construct the matrix together comes forth.
