Geotechnical characteristics of the formation of “Tourkovounia” Limestones and their influence on urban construction - City of Athens, Greece

JOHN KARFAKIS¹ & CONSTANTINOS LOUPASAKIS²

Abstract: All the hilltops of the city of Athens are occupied by the formation of "Tourkovounia" Limestones. Some of the most important monuments in the city and also many residential areas are founded on these formations. The world renowned monument of Acropolis, the ancient Supreme Court (Arios Pagos), and the Pnika are prime examples of monuments founded on these limestones. A detailed knowledge of the geotectonic data and geotechnical characteristics regarding these formations are clearly important for construction work in these areas.

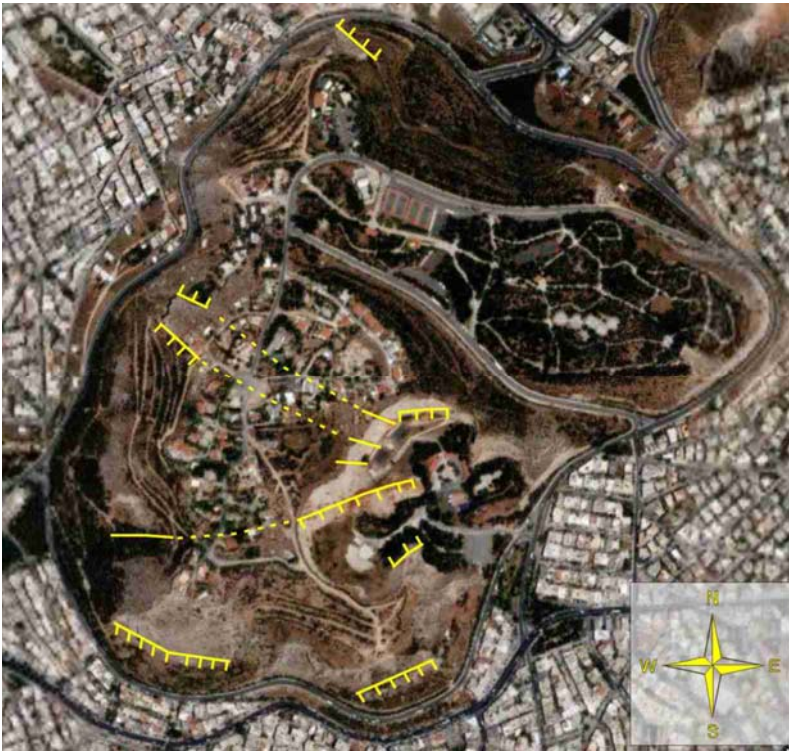
Figure 1. Aerial photograph of Tourkovounia hill. The “Attiko Alsos” park is located in the SE section of the hill. This park consists of a public garden, an open air theatre, a volley-ball and a basket-ball field, a coffee-bar and an extensive parking area. This figure presents some of the normal faults which, in spite of the intensive alteration of the morphology, are visible in the aerial photograph. The covered extensions of those faults go across the built-up area located on the top of the hill and under the foundations of the houses.

The findings of the paper are based on the data collected during the geotechnical study of the stability problems that have occurred on the slopes of an inactive quarry on Tourkovounia Hill (Karfakis J. & Loupasakis C., 2005) and it is supplemented by information collected through an extensive literature search. During the last decade, this quarry was turned into a park (“Attiko Alsos” park) and as a result of the stability problems, concerns arose for the safety of the infrastructure and park visitors (Figure 1).

Figure 1 presents some of the normal faults which, in spite of the intensive alteration of the morphology, they are visible in the aerial photograph of Tourkovounia Hill. Besides the Tourkovounia Hill, major tectonic fractures of ENE-WSW to SE-NW direction are visible on the aerial photographs of Acropolis and Likavitos hills (Figures 4 & 5). This fact confirms that the limestones of the hill tops of Athens were subjected to the same tensile tectonic stress field.

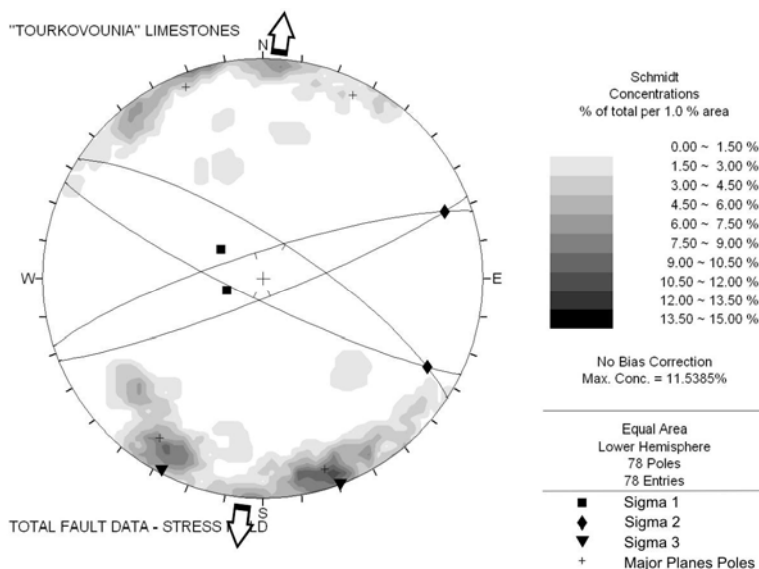
Figure 3. Schmidt diagram presenting the orientation of the main direction of the faults, the distribution of the main stresses and the procedure applied for the estimation of the tensile stress (σ_3) direction.

distribution of the main stresses and the procedure applied for the estimation of the tensile stress (σ_3) direction are presented on the Schmidt diagram of Figure 3.

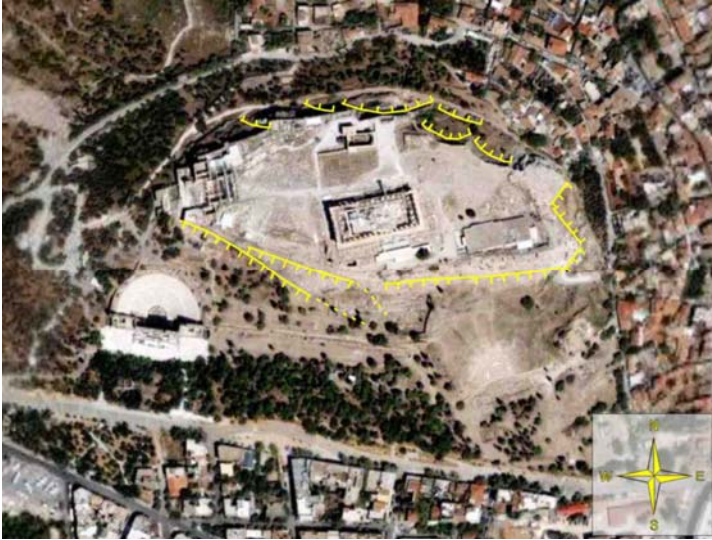
Figure 4. Aerial photograph of Acropolis hill. Major tectonic fractures – normal faults of ENE-WSW to SE-NW direction traced on the photograph.

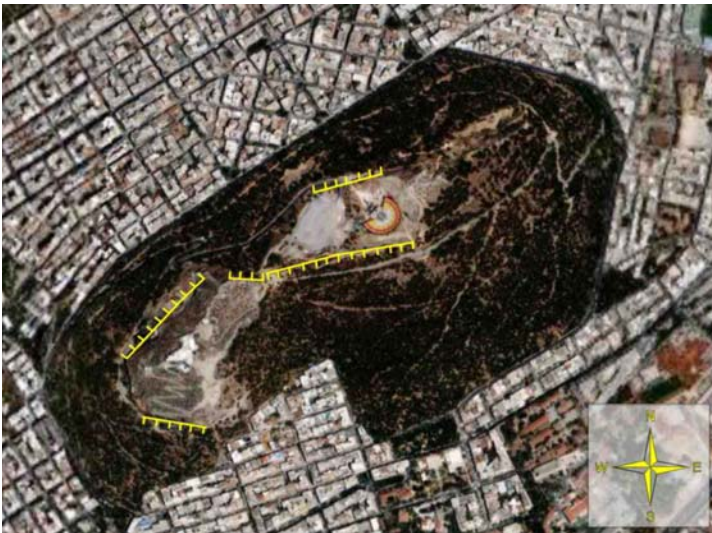
Figure 5. Aerial photograph of Likavitos hill. Major tectonic fractures – normal faults of ENE-WSW to SE-NW direction traced on the photograph.

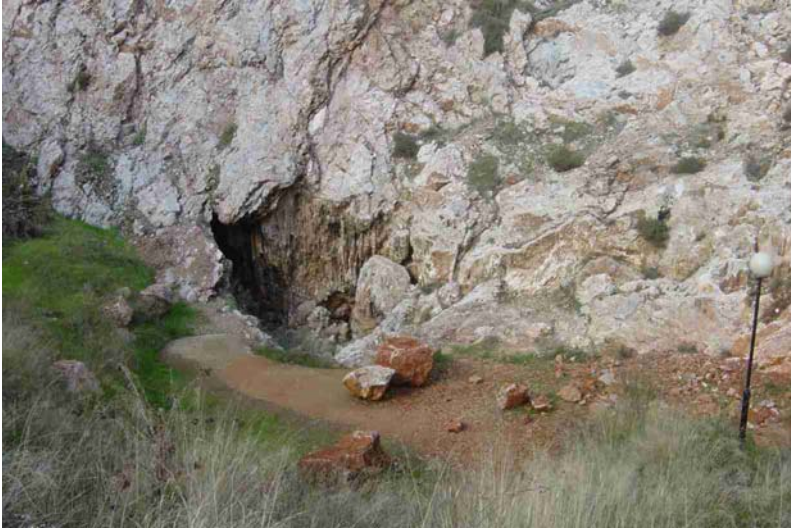
Figure 8. Extremely wide karstic void (up to 10 m) – small cave formed along a normal fault.

Most of the normal faults exhibit intensive karstic weathering, resulting in wide karstic fissures. These voids are 0.5 to 2 m wide and are partially or completely infilled with clay (Figures 6, 7) or stalagmitic materials (Figure 8). When the karstic fissures intersect the void structures can become extremely wide. In some places structures reaching up to 15m wide were observed (Figures 9, 10).

The infill materials of the fractured zones include blocks of the parent limestone. The blocks are supported in the clay matrix (Figures 8, 9) or lodged into the stalagmitic net (Figure 10). Gradual erosion of the surrounding materials or dynamic loading of the slopes (earthquake) can lead to the releasing of these blocks which end up at the base of the slopes (Figures 8, 10). These slope stability problems should be taken into consideration when the slope is to remain open permanently (e.g. cuttings for roads).

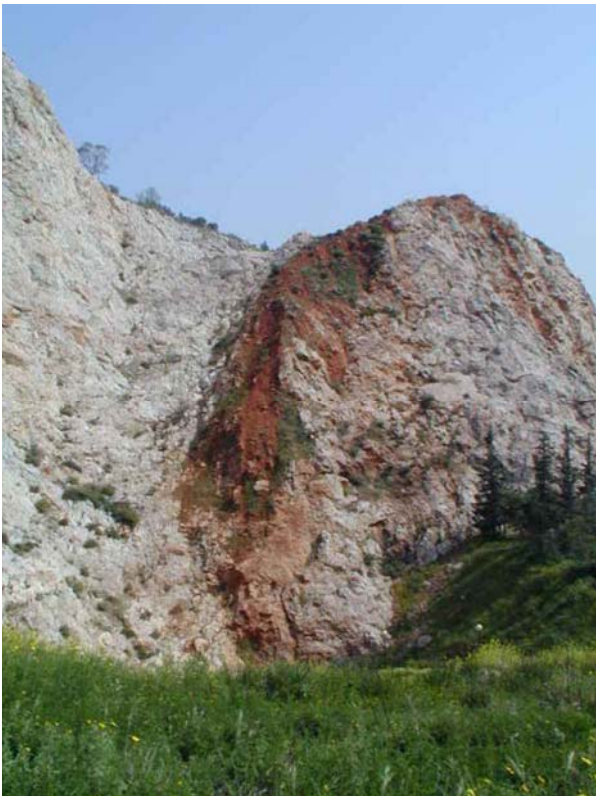
Figure 9. Extremely wide karstic fissure (up to 15 m) formed along the intersection of normal faults, filled with clay materials. The matrix includes blocks of the “Turkovounia” limestone. During the excavation of the quarry the surrounding limestone was left in place in order to avoid destabilising the infill material.
