# Rainfall triggered flow-like landslides: Understanding from southern hills of Kathmandu, Nepal and Northern Shikoku, Japan

**Abstract:** Flow-like landslides triggered by rainfall are very prominent in Nepal and Shikoku, Japan. In July 2002, many landslides occurred in the southern hills of the Nepalese capital, Kathmandu, because of torrential rainfall. A single flow-like landslide occurred at Matatirtha, a small village situated at the south marginal hill of Kathmandu, killing 16 people who lived at the foot of the hill. Much damage was caused to roads and houses because of landslides and debris flows in small streams.

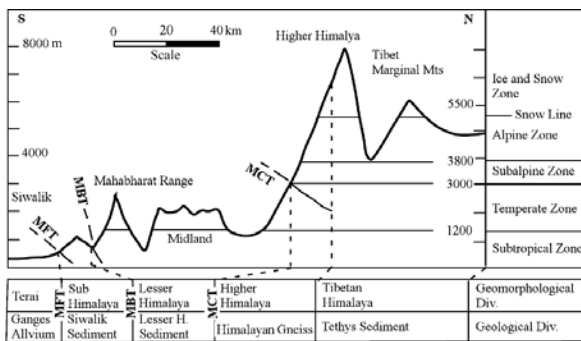
**Figure 1.** Cross section of Nepal Himalaya, MCT (Main Central Thrust), MBT (Main Boundary Thrust) and MFT (Main Frontal Thrust) make Himalaya tectonically active and dynamic mountain of world (modified after Upreti and Yoshida, 2005 and Kizaki, 1994).

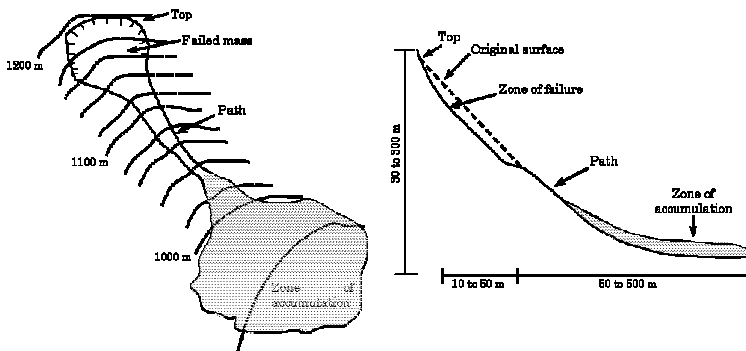
**Figure 3.** Diagrammatic indication of a typical flow-like landslide feature in Nepal Himalaya

In Nepal, it is felt that flow-like landslides affect human settlements, bridge and roads by destroying and burying (Figure 3). In the year 2002, many flow-like landslides occurred along southern marginal hills of Kathmandu and damaged many infrastructures. Single flow-like landslide occurred in Matatirtha, a small and beautiful village situated at the south western marginal hill of the capital city Kathmandu killed 16 people inhabiting on the base of the hill (Figure 4 and Figure 5). Although some more flow-like landslides occurred in southern marginal hills, the Matatirtha was most devastating one. Some of flow-like landslides also damaged road of hills (Figure 6) but casualty was not reported.

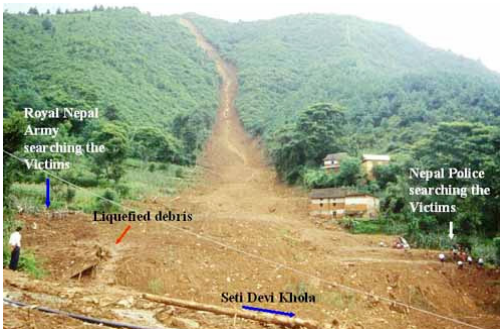
**Figure 4.** Flow-like landslide of Matatirtha, July 2002, site after 40 hours

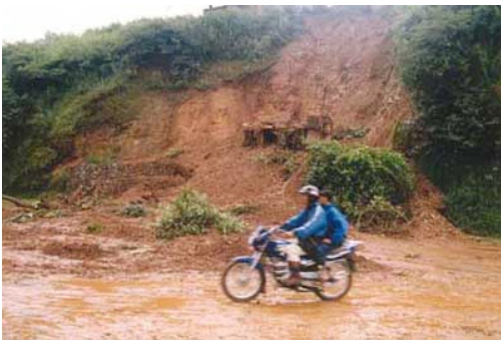
Figure 6. Flow-like landslide on roadside slopes of southern hills of Kathmandu, triggered by Rainfall of July 2002

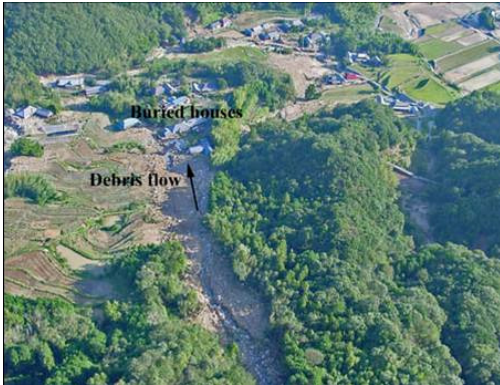
Figure 9. Buried village in Moriyeiki (see Figure 7 for location)

There is a good rainfall measurement system in Shikoku Region and it is available on the internet also. During typhoon of 2004 August to October, there is extreme rainfall occurred in central northern Shikoku and north east Shikoku (Figure 8, Figure 9 and Table 2).

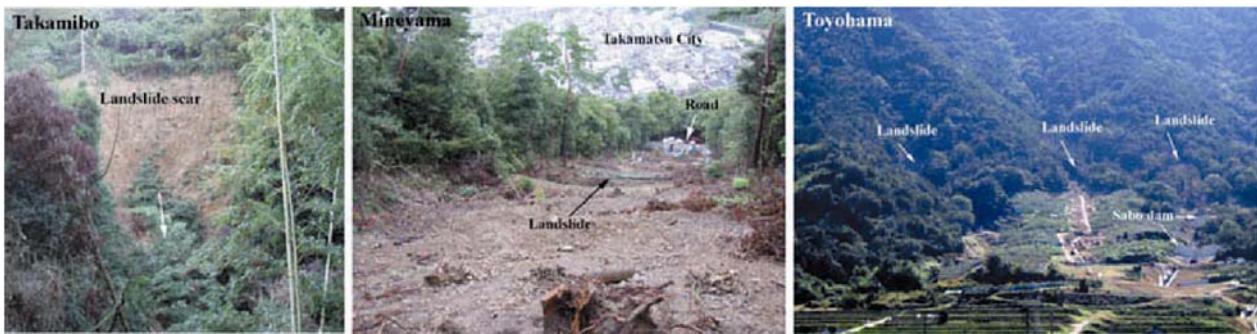
**Figure 11.** Rainfall triggered flow-like landslide in Kagawa (Takamibo, Mineyama and Toyohama)

There is much local scale damage in highway and forest areas around Takamatsu City (regional headquarter of Shikoku). Middle Kagawa is also affected by the typhoon and there are many slides in forest area also (see Figure 7). Takamibo forest area and Mineyama landslide near to Central Takamatsu are some examples. Landslides occurred at base of hills in Toyohama city (Figure 11 and see Figure 7 also) are some other examples of flow like landslides of west Kagawa.

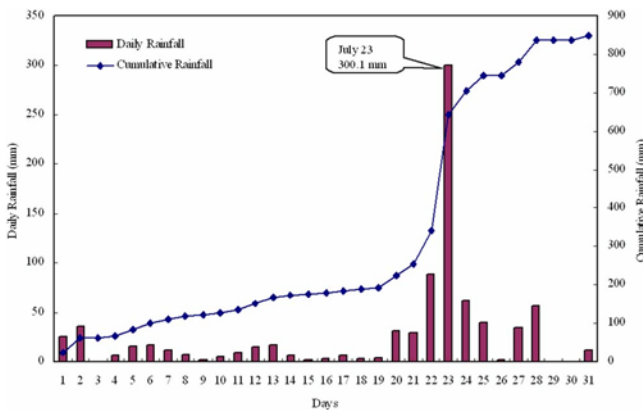
Figure 14. Rainfall pattern of Thankot area in the year 2002

From the meteorological point of view, the month of July is very critical for the southern hills. There are not much rain gauge station and hourly rainfall data is also not available. Most nearest rain gauge station from the failure area is in Thankot (situated at about 1.5 to 3 km aerial distance from Matatirtha and other slides see Figure 12). Plotting of last 32 years rainfall data of south and south-west Kathmandu reveals that month of July of every year has been facing maximum rainfall (Figure 13). Rainfall data recorded by the Department of Hydrology and Meteorology (DMG) at its Thankot station is 300.1 mm at 24 hr in the day of major failures, i.e. 23 July 2002 (Figure 14).

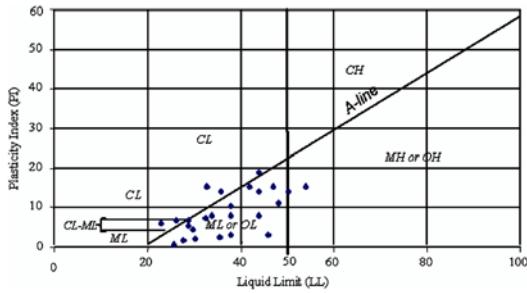
Figure 16. Plot of liquid limit and plasticity index in plasticity chart of Casagrande

The thickness of soil is also varied from crown part to lowest part of failure in all failure. At crown part of many failures, the thin veneer of porous silty gravel of thickness 0.5 m to 1.5 m is found over the extensively jointed calcareous rock. In almost all slides, the soil thickness at end of failure zone is 4 to 5.5 m. Unified Soil Classification of soil shows that the soil type of the all failure area ranged between GM-GC to SM-ML with considerable amount of gravel. The plastic limits of the soils from different locations vary from 20% to 35% whereas the liquid limit of the soil generally varied from 20% to 45%. Almost all failure mass plots of liquid limit and plasticity index (Figure 16) lie below the A-Line of Casagrande Plasticity Chart (USBR, 1963). The calculated dry unit weight of the soil is ranged between 15 kN/m<sup>3</sup> to 19 kN/m<sup>3</sup>. The shear strength parameters from undisturbed samples were not determinable due to considerable amount of rock fragment in samples. So the shear strength test carried out on reconstituted specimen and variable friction angle value ranged from 25° to 30°. The value of apparent cohesion also ranged from 4 kN/m<sup>2</sup> to 7 kN/m<sup>2</sup>.

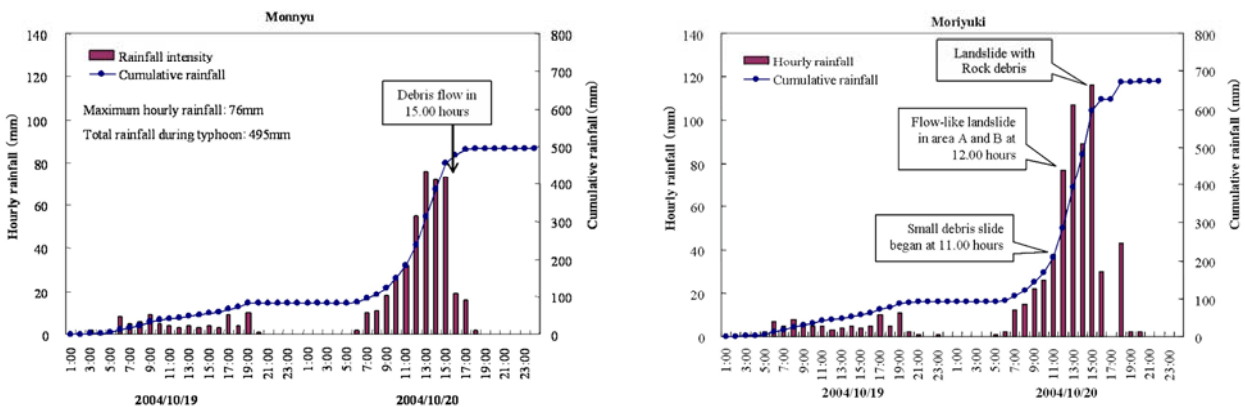
**Figure 18.** Rainfall pattern in Monnyu and Moriyuki area during typhoon of October 20, 2004, see Figure 10 to get information of area A and B for plot of Moriyuki

From the meteorological point of view, the month of August, September and October is very critical for the hills of northern Shikoku. There is very good rainfall data recording system in Shikoku in comparison to Nepal. There are many rain gauge stations and hourly rainfall data is also available. Rain gauge station in Moriyuki is 700 m far (Kusaka Pass) from the failure area and Monnyu area has rain gauge station. Thus, rainfall correlation during failure time is possible. Rainfall data of Typhoon 23 are presented in Figure 18 and Figure 19 for Moriyuki and Niihama area respectively.

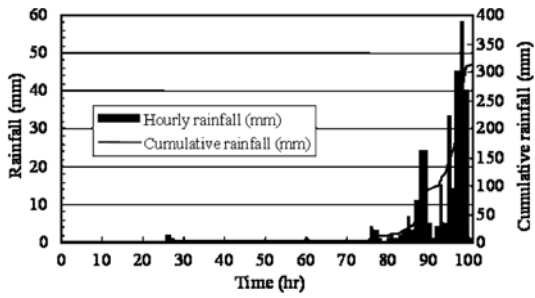
Figure 19. Rainfall in Niihama area during typhoon of September 29 2004 (Modified after Bhandary & Yatabe, 2005)

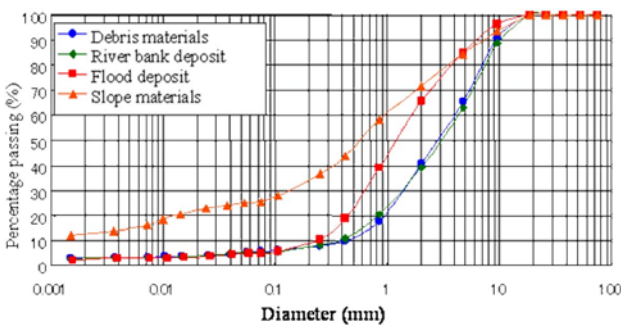
Figure 20. Grain size distribution of slope, debris and deposited materials in Monnyu area and it shows that slope materials has considerable amount of clay.

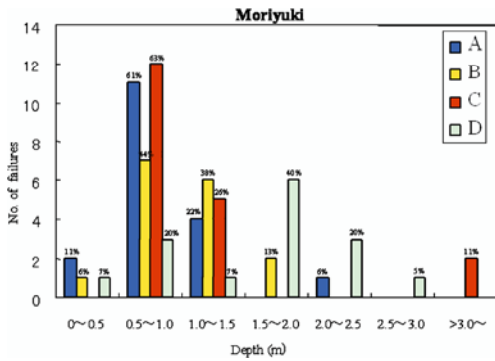
Figure 22. Variation of depth of failure in Moriyuki area (see Figure 7 for reference of area A, B, C and D)
