Repairing sinking of the bridge over Guadalquivir River in Alcalá del Río, Seville, Spain

Abstract: The bridge over Guadalquivir river, near Alcalá del Río in Seville (Spain), has nine spans of 30 m with a total length of 270 m. In 1993 two of the central piers located in the centre of the river sank by 140mm and 60mm. The superstructure is isostatic and is formed of six prefabricated concrete T-beams 1500mm high. The foundations for each support are formed of two circular pier-piles with a diameter of 1.5m.

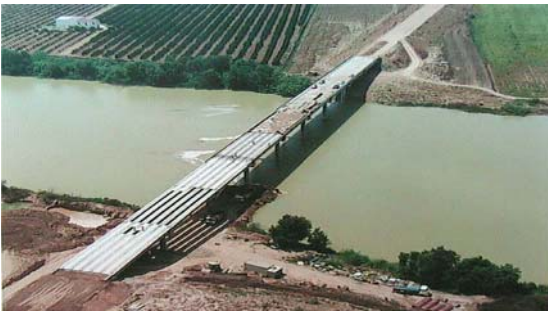
Figure 1. Bridge in phase of construction

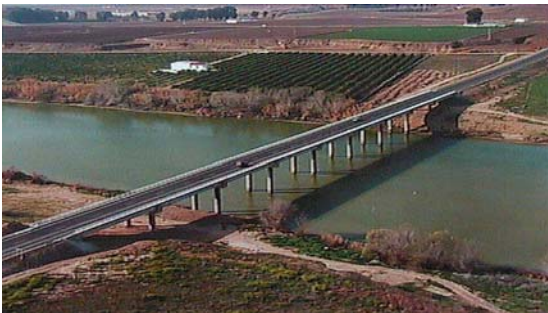
Figure 2. Finished bridge
