The Mam Tor landslide, geology & mining legacy around Castleton, Peak District National Park, Derbyshire, UK

Abstract: This guide provides information to support a one-day field trip to the Mam Tor landslide and Castleton which is situated in the Peak District National Park, North Derbyshire. The village is surrounded by dramatic, often spectacular and rare sites of geological significance and geological interest. Mam Tor forms the highest point in the area and contains the ramparts of a prehistoric hillfort, on a ridge of sandstone, running almost east to west, separating the Hope Valley (to the south) from the Edale Valley (to the north). This site provides an excellent opportunity to inspect Carboniferous stratigraphy showing the relationships between the Mam Tor Beds, Edale Shales (both of Namurian, or 'Millstone Grit' age) which unconformably overlie Limestone (Dinantian, or Lower Carboniferous age). Between about 3000 and 4000 years ago a huge section of the Mam Tor Beds and Edale Shales began to fail. This generated an 80m high scarp on the western face of Mam Tor and a landslide over 750m long and 300m wide. The slipped mass has been in a state of continual, gradual, creep

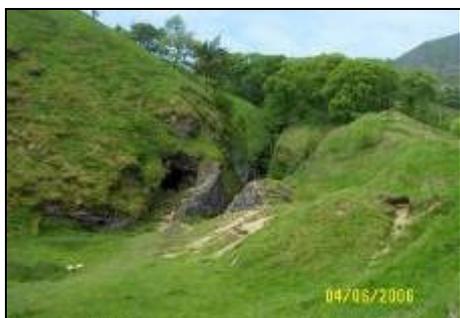
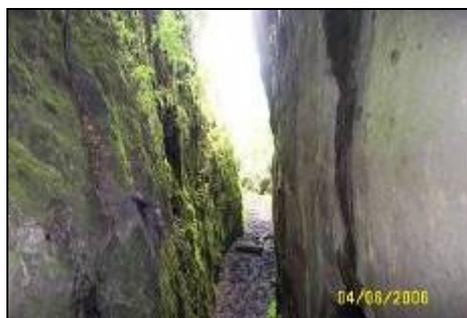
Figure 1. (Left) Odin Cave and Odin Mine, note the mine waste tips on the lower right of the photograph. (Right) The worked-out Odin mineral vein with mineralised, horizontal slickensides on the hanging wall.

The working of minerals around Castleton is of considerable antiquity. Odin Mine was worked for lead in Saxon and Roman times (Figure 1). The mineral vein is exposed as a deep, narrow gully, no more than 3m wide and 20m long. The lode (a local term for mineral vein) is dipping about 45° south and has been almost completely exhausted by mining and mineral collectors. The ‘worked out’ mineral vein leads to an open shaft, some 20m deep (known as Weasel Pit) opening out to a stope. This is dangerous and inaccessible without abseiling equipment and roped access. The earliest recorded evidence for a mine called Odin was in 1280 (possibly the oldest record of a named mine in Derbyshire). There are records for working the mine in 1663, with references to drainage problems. The mine closed

in 1869, with an annual production of 100 to 800 tons of lead ore. The main production periods were in the 1720s, 1770s and around 1800. Workings extend under the southern slopes of Mam Tor for at least 1500m and at a depth of about 70m. Mine plans show that the miners followed a series of interlinking *en-echelon* fractures. A small branch from Odin Mine can be seen on the northern side of the workings. This has white deposits of amorphous clay (allophane) at its entrance. A sough (drainage channel) was proposed in 1772 and completed in 1845. The flat grass covered area at the front of Odin Mine represents the tailings from a spar washing plant in the 1940s. This filled a 6m deep hollow, which buried the original entrance to Odin Mine. The adjacent bedrock is exposed, consisting of mainly crinoidal limestone in a dark, shelly matrix. This is the pre-Namurian boulder bed which rests on coarse crinoidal fore-reef limestone, with blue fluorite. The walls of the worked out vein show horizontal slickensides demonstrating wrench faulting. The overlying shales, exposed at the top of the cut are lower on the south side which suggests that the vein was also subject to normal faulting. Given that there was at least 2m of minerals in the vein then dilation must have also occurred at some time in the geological past. Traces of galena and other minerals line the walls and the marks from miners' picks may still be seen in places along with sockets for stemples (wooden beams across the vein). To the west of Odin Mine is Odin Gorge, this 'gully' is not natural gorge but represents the complete surface extraction of the mineral vein where it outcrops. The reef limestone here is fossiliferous with abundant brachiopods, algal tufa and outward dipping bedding planes. Odin Cave is located to the south of the Mam Tor landslide, marking the end of the public highway and the start of the road, which climbs the landslide (now closed). The cave is a natural feature but there is evidence that it has been occupied during past mining. Mine waste tips, located to the east of Odin Cave and the road provide a variety of mineral specimens.

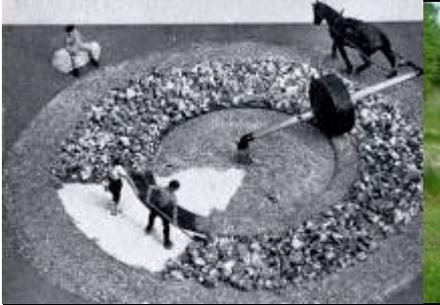
Figure 2. (Left) The Odin Mine crushing circle and wheel. Note that the crushing circle is now tilted and slightly buckled due to 'recent' movement on the landslide. (Right) Model of a crushing circle (model by H. E. Chatburn, H. M Parker, in Ford & Rieuwerts 1975).

The crushing wheel, constructed in 1823, consisted of a Millstone Grit Sandstone wheel, about 2m in diameter, 300mm wide and had a square hole passing through the centre. It had an iron tyre about 50mm thick and it ran on a

circular iron track about 310mm wide and around 4.5m in diameter. The track was bedded into granular material (mining waste and gangue minerals) and consisted of 8 segments, about 50mm thick and was bolted together on the under side. Most of the power was provided by carthorse the waste rock being manually shovelled onto the crushing circle (Figure 2). To the east of the road, the continuation of Odin vein is marked by the presence of mine waste tips. Knowles Shaft is still open, although flooded, and now probably collapsed; it was constructed to a depth of about 75m to intersect the mineral vein. A series of soughs were constructed, in 1711 to 1713 and 1810 to 1821, to drain the mine workings and evidence for these can be seen to the east of Knowles Shaft. Some of the waste containing galena and fluorite particles has washed onto adjacent farmland which is grazed by animals and is a health hazard to breeding stock. From this location the fore-reef slope is visible towards Treak Cliff, less than 100m away.

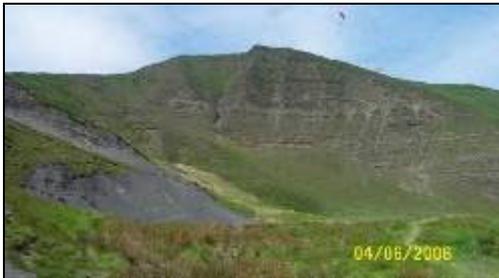
Figure 3. View of the main back scarp of the Mam Tor landslide consisting of interbedded sandstone, siltstone and shale sequences (Mam Tor Beds), which overlie the Edale Shales (exposed on the lower left).

Mam Tor is one of the most easily accessible, dramatic, impressive and active inland landslides in the British Isles (Figure 3). The landslide is of the slump-earthflow type according to the classification by Varnes (1958). The failure consists of a large arcuate scarp where the Mam Tor Beds are seen to dip 5 to 10° NNE. The crest of the scarp forms the summit of Mam Tor at about 500mAOD. The landslide has a total length of over 750m, from its crest to its toe; it reaches 280 m high, a maximum width of 450m and covers an estimated area of 34 hectares. The average slope of the sliding mass, from the base of the scarp to the toe is about 12°. The landslide reaches a maximum thickness of about 30 to 40m. It contains 3.2Mm³ of slipped material. The angle of the original hillside has been estimated at 30 to 35° and the mean slope angle of the slipped material is around 12°. The landslide consists of four distinct zones; (1) the scarp; (2) the upper slipped/slumped mass; (3) the central (or transition) zone and (4) the lower debris flow (Figure 4).

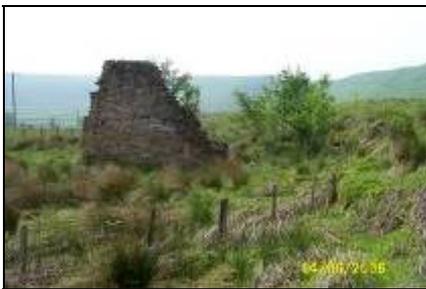
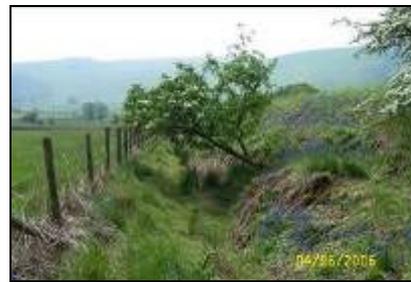
Figure 5. (Left) View of the toe of the Mam Tor landslide advancing from the right and the ruins of Blacketlay Barn. (Right) The landslide toe with a tree growing horizontal from an advancing lobe and the flat glacial head filled Hope Valley to the left of the fence.

The lower zone of the Mam Tor landslide (sometimes referred to as the toe or foot) is a bracken and hawthorn-covered debris flow where main body of the ‘slump’ transforms into the head of the ‘earthflow’. The earthflow has moved as a plastic deformable mass which extends for about 420m. It has a hummocky topography with transverse compression ridges, pools of standing water and gentle slopes at about 5 to 10°. Ground movement are likely to have taken place by translation on, or just below the original ground surface. Seasonal variations in groundwater levels result in the appearance of numerous seeps, springs, ponds and marshy vegetation in local depressions and troughs. A traverse across the toe of the landslide shows clearly defined flow lobes that may be seen to stand proud and contrast strongly with the smooth, original, natural ground alongside (east) the toe of the landslide. Some ground fissures, the misalignment of electricity poles (to the north), bending trees and overturned vegetation provide evidence for ongoing movement of the landslide toe. Barnsfield Barn collapsed in the early 1980s and has since suffered further damage by the advancement of the landslide. Fences recently constructed beyond the toe of the landslide give a general appreciation of the periodic progression of the landslide. Borehole evidence suggested that the sliding surface was about 10 to 20m below current ground level (Skempton *et al.* 1989). Measurements for the rates of advance of the landslide toe range from 0.25m/yr between 1981 and 1983 (Al-Dabbagh 1985) to 0.07m/yr (Skempton *et al.* 1989) (Figure 5).

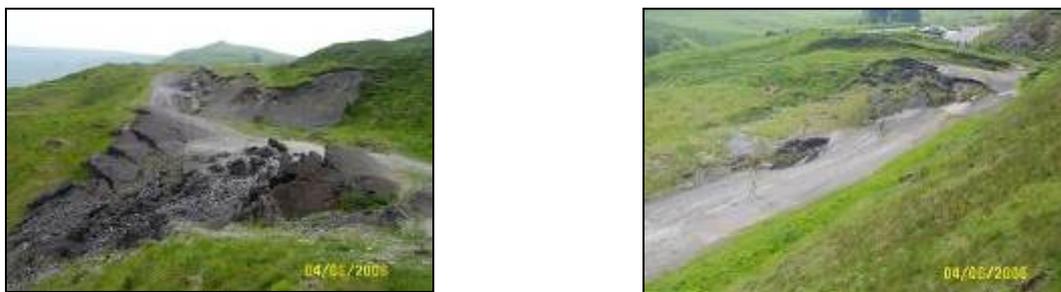
Figure 6. Severe damage to the A625 Manchester-Sheffield road which crosses the Mam Tor landslide. The road was finally closed to traffic in 1979 following repeated ground movements. Note the partly rotational slipped blocks with inward dips of up to 45°.

The former Manchester to Sheffield (A625) road crosses the landslides at two locations due to the presence of a hairpin bend. The road has suffered repeated, extensive, displacements and damage. It was finally closed to traffic in 1979, following ground movements, which severely damaged the road in 1977. This, in conjunction with the absence of large-scale remediation and stabilisation measures and the slow rate of erosion of debris from the toe of the landslide, provides a unique opportunity to examine a complete active landslide. The lower road segment has suffered considerable misalignment and deformation, which may be observed as stretching, horizontal distortion and local subsidence. Adjacent to the road the edge of the landslide is marked by a 2m high compression ridge which has been generated by uplift and a component of motion at right angles to the direction of main (downslope) failure. Faults, generating vertical steps and tears across the road and grass verge, near to the 'turning circle' demonstrate that this lower segment is still active.

The upper slide zone is a slipped, slumped mass, which extends south-easterly from the scarp towards the upper road segment. Movements have occurred by the non-circular, rotational failure of the original ground surface. This is supported by the presence of rock slices and a series of back-tilted strata dipping between 30 to 50°. The upper road segment may be followed, across the main body of the landslide, from the road bend towards the scarp. Here the road has been spectacularly, severely damaged by localised ground deformation and over-steepening. Several metres of ground movements have occurred since the road was originally built in 1810. Numerous layers of tarmac and gravel (with mini-unconformities) may be seen in disturbed and back-tilted cross sectional slices. These represent various historical efforts to stabilise the landslide and repair the deformation. On the road there are numerous, extensive, graben, tension cracks, active fissuring and vertical displacements of up to 4m, indicative of present movements of the landslide. Secondary toppling and rotational sliding occurs on many of the subsidiary scarps. The remains of white painted central road alignments are truncated abruptly laterally and vertically displaced and are useful in providing a 'bench mark' indicating the scale and magnitude of ground movements. In some areas the entire width of the road has been rotationally displaced downslope causing the stretching and spreading of the displaced slice. The hard, brittle, nature of the tarmac responds differently from the underlying bedrock and the relatively more plastic Edale Shales. These properties are reflected in the type of displacements observed. The road tends to fracture and shear whereas the shales tend to 'flow' and buckle (Figure 6). Displaced, rotated blocks of Mam Tor sandstones are exposed on the sides of the road and are back-tilted in a westerly direction at angles of up to 20°. Orange-brown ochrous deposits coat the road surface and represent iron-oxides deposited from groundwaters flowing from the Edale Shales. The landslide predates road construction in 1810. Records and observations of movements are available for about the past 200 years. Geological evidence however, suggests that the landslide has been active for at least 3600 years before present (BP) and will possibly remain active for at another 2400 years.

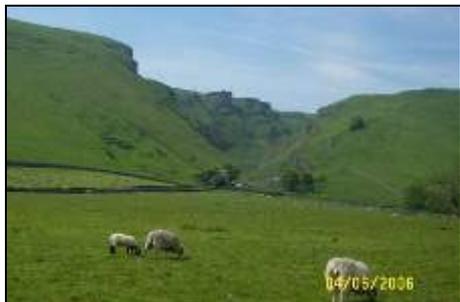
Figure 12. Winnats Pass, to the west of Castleton and south of the Mam Tor landslide. The entrance to Speedwell Cavern is on the lower left (south) side of the pass. Fan-shaped beach beds are exposed along the foot of the pass and continue along the foot of the hill slope towards Treak Cliff Cavern. Lines of shafts, hollows, surface excavations and waste tips mark the course of mineral veins which have been historically worked on either side of the pass.

Winnats Pass is a steeply incised gorge, which dissects the margin of the reef limestone complex. It is approximately 600m long, 400m high, 300m wide at its top and less than 50 m wide at its base. The valley sides range from about 45° to vertical. The lower slopes are partially obscured by a cover of thin soil and turf or less steep scree accumulations, composed entirely of blocky limestone (Figure 12).

The origin of Winnats Pass gorge has been subject to debate by geologists. It probably began as an inter-reef channel in Brigantian times eroded between the reefs, occasionally swept clear by tides washing in and out of the lagoon. It was deepened further and subsequently filled with sandstone and shale by the Namurian deltas prograding from the north. Further deepening occurred during the Pliocene (Ice Age) which subsequently eroded the weaker Namurian deposits to re-excavate the channel through the reefs. This was likely to have been further deepened by stream/river erosion during periglacial periods when the groundwater was not able to flow through the frozen ground, in otherwise highly permeable limestone bedrock. The pass has a little catchment area for the highly erosive stream that once must have flowed through it, unless a tongue of ice occupied the Rushup Valley and provided the melt waters in the vicinity of Windy Knoll in late Wolstonian times. There is no evidence to suggest that the pass originated by the collapse of a cave system. The Castleton reefs do not always show a mound like form and this has generated much controversy concerning their origin. However, it is now generally agreed by geologists that they represent an apron-reef, a margin facies between a deeper marine basin (extending to the north) and a shelf plateau (extending to the south). The structure of the reefs may be divided into three distinct areas; the back-reef, algal-reef and fore-reef. Winnats pass provides a cross section through the reef complex. Fan-shaped beach beds are exposed at the foot of the pass and represent a fossil beach or debris which has washed down the pass from the lagoon. Steeply inclined reef limestones dip towards the mouth of the pass (adjacent to Speedwell Cavern) in their general direction of the relatively deeper marine basin. Near the bend of the pass nearly horizontal beds lie on top of outward dipping fore-reef beds. Shelf facies, then apron-reefs (forming the high ground on either side known as Shining Tor on the south and Old Tor on the north), to flat-lying lagoon limestones are exposed in the slopes at the top of the pass. Numerous abandoned mine adits are exposed along the entire length of the pass (such as Old Tor Mine at the top of the gorge and Suicide Mine and the bottom of the gorge). A mediaeval trackway known as the 'Roman Hollow' is located near to the top of the north side of the pass which leads to worked ground representing a former opencast fluorspar mine which was worked during World War II. An abandoned limestone quarry also occurs at the top, south side of the pass near the small entrance to Winnats Cave. This leads to a huge cavern on the southern side of Winnats Pass, about the size of cathedral, of which there is no surface expression to infer its existence. Blue John Fluorspar is exposed on the sides of Winnats Pass and may be found in the scree slopes along the toe of the gorge.

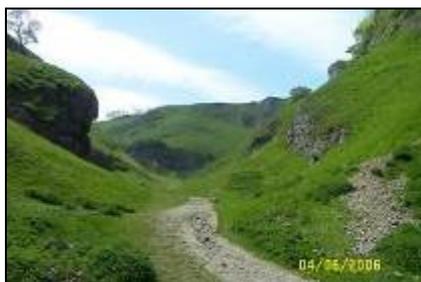
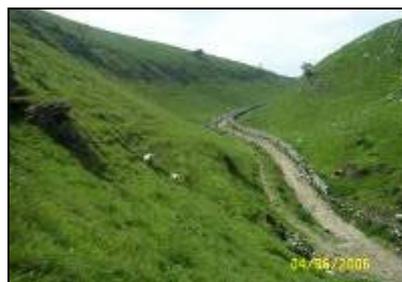
Figure 13. (Left) The entrance to Cave Dale, a dry valley near the centre of Castleton. (Right) The upper part of Cave Dale with olive basalt lava exposed on the left (south) side of the gorge.

Cave Dale, located at the eastern part of Castleton village, is a classic dry valley. It is a picturesque gorge which has been incised through the limestone and it grades into the head of the Hope Valley. This was incised by run-off across frozen ground in largely post-Wolstonian times. The gorge provides an opportunity to examine in cross section the back-reef facies, which are well exposed. A small quarry at the entrance to Cave Dale and a number of abandoned adits in the sides of the gorge have been left by 17th and 18th Century miners who attempted to explore the valley sides for galena, glauconite, hydrocarbons, sphalerite, baryte, fluorite and smithsonite. In the entrance to Cave Dale mammalian fauna and flint of 'Neolithic', 'Bronze' and 'Iron' ages have been discovered. Less than 20m below the floor of Cave Dale are the cave systems forming part of the Peak Cavern complex. The entrance to Cave Dale shows fore-reef limestones dipping northwards at about 25°. About 100m there is a change in stratigraphy and facies and the prominent crags are composed of horizontally bedded fossiliferous limestone forming the centre of the reef. On the northern side of the dale, near to Peveril Castle, the crags are poorly fossiliferous and both reef and fore-reef facies interdigitate and contain reef tufa and geopetal fabrics. Back-reef facies are exposed on inaccessible parts of the valley. Cave Dale narrows and steepens where it is crossed by 'New Rake', which contains less than 0.5m of calcite, exploratory adits and minor workings. Small amounts of water flowing down the valley sink at this point to re-emerge in Peak cavern below. The upper section of Cave Dale takes on the appearance of a typical dry valley cut through the Bee Low Limestone (Upper Asbian). Variations in the dip of the Cave Dale (thalweg) may be related to the incision of Hope Valley in the Pliocene forming a 'knick point' (Figure 13).

An isolated occurrence of lava outcrops at the southern end of Cave Dale. The flow is marked by a conspicuous ridge containing outcrops of multiple flows of fine-grained, vesicular, olive-basalt with occasional zeolites around the periphery of some of the cavities (Walters & Ineson 1981, Shirley & Horsfield 1940). The lava is poorly columnar jointed in places and basalt pillars stand proud, caused by differential weathering, some have a coating of chalcedony. Individual flows may be distinguished consisting of either massive basalt or vesicular basalt (some of the vesicles are filled with calcite or chlorite, producing an amygdaloidal texture). The flow reaches a maximum thickness of approximately 20m above the limestone and can be traced for approximately 200m along the upper part of the dale before it disappears below the stone. The lava is confined to the reef-belt, dying out in the back-reef facies. A small landslide has developed on the north facing lava slope. Underground evidence from caves and mines suggest the lava thins rapidly westwards. Great thicknesses of volcanic rock have also been found in boreholes drilled to the east of the

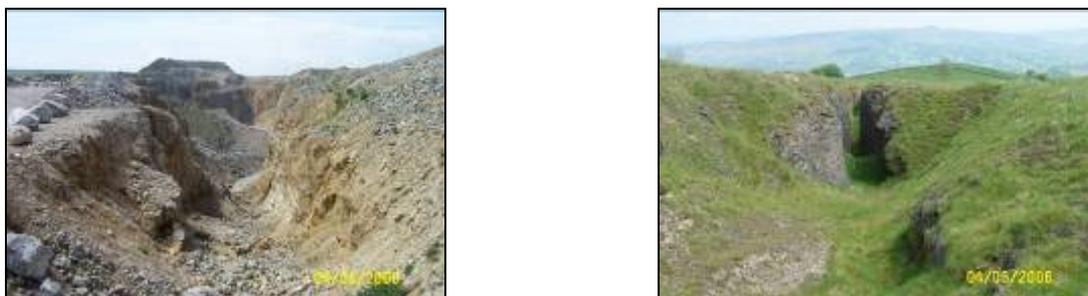
Figure 14. (Left) Open pit workings at Dirtlow Rake. (Right) Narrow 'gorge' caused by the historical, complete extraction of minerals in Dirtlow Rake.

Dirtlow Rake forms one of the most principal epigenetic mineral veins in Derbyshire. It is a north-west trending replacement deposit with a downthrow to the south of about 70m and considerable lateral movements in places (observed as mineralised slickensides of the footwall and hanging wall). The entire length of the rake contains three complex, parallel, distinct veins. Where the vein crosses reef-complexes and natural caves, fluorite lenses are well developed, sometimes associated with chert. The rake has been mined by both surface and underground extractions (for example at Ashton's, Hollandtwine and the Hazard mines). Towards Pindale (a gorge to the east of Castleton village) evidence of historical workings exist and the surface outcrop of the vein has been completely extracted to leave a deep, steeply inclined gorge. A small open-pit mining operation presents an ideal opportunity to inspect the mineral vein in cross section which is seen to dip at about 70° to the south. The open pit is situated where Dirtlow Rake crosses pre-Namurian solution collapse structures (Butcher & Hedges 1987). The main economic and productive part of the vein is along the wall rocks which contain large masses of radiating columnar jointed calcite and veins of fluorite, baryte and galena. The limestone host rock has been altered and tectonised and in places silicification is common extending over 400m parallel to the vein on the south side. To the east Dirtlow Rake and associated scrins are marked by numerous shafts, lines of spoil heaps and narrow 'gorges' representing worked-out sections of the vein. Several hundred thousand tonnes of fluorite have been mined from Dirtlow Rake. Lead is no longer exploited and the fluorite, baryte and calcite historically discarded as 'gangue' or waste, now form important commodities. Fluorite is needed as a raw material in the chemical industry as well as being required for the fluoridation of water and in toothpaste. Baryte is used as a filler in paper and as an additive to drilling mud in the North Sea hydrocarbon industry to help control high gas pressures (Figure 14).

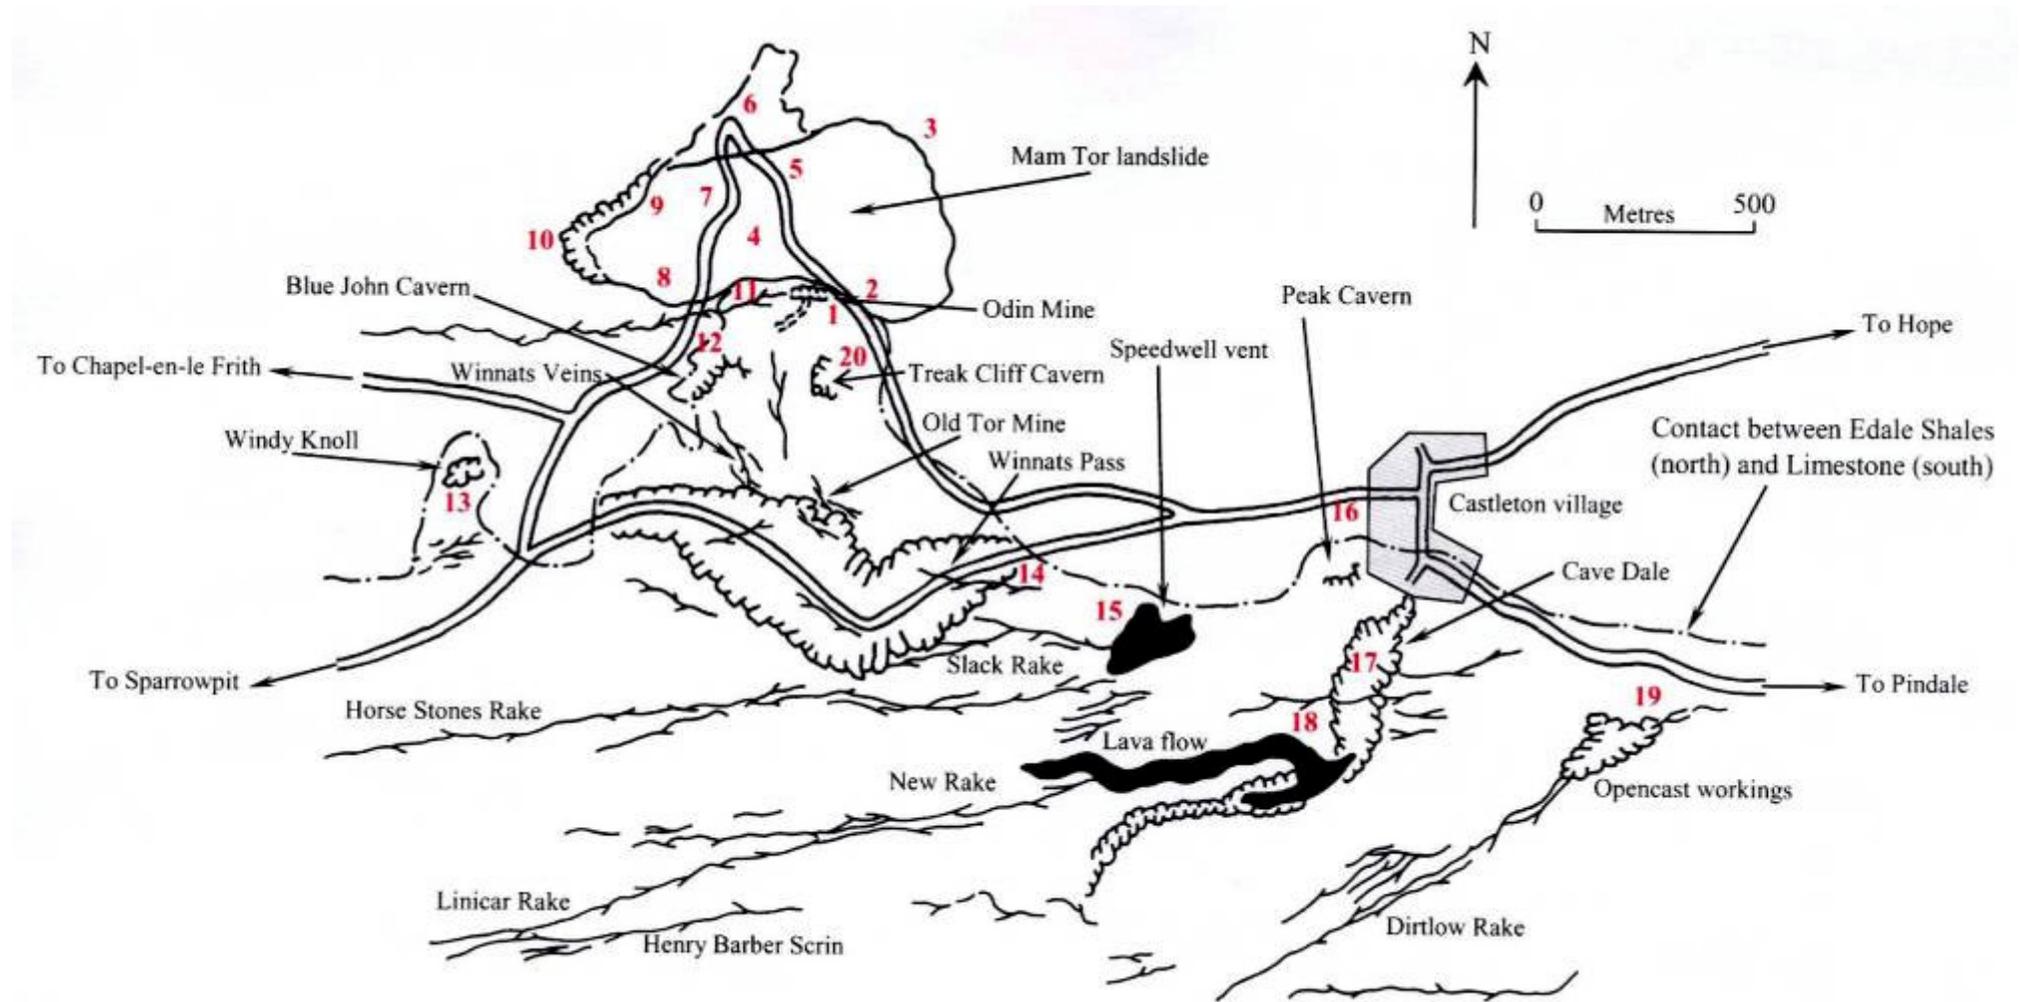
APPENDIX III

Schematic map to show the field visit locations around the Mam Tor landslide and Castleton.
