# Gypsum dissolution geohazards at Ripon, North Yorkshire, UK

ANTHONY H.COOPER<sup>1</sup>

**Abstract:** This guide is for a one-day field excursion to examine gypsum dissolution geohazards at Ripon in North Yorkshire. Gypsum is a highly soluble rock and under suitable groundwater flow conditions it can dissolve forming caves and karstic features including collapse and suffosion dolines. These have the capability of causing subsidence damage of the type that affects much of the Ripon area. The guide details the processes involved, the localities visited and some of the remedial measures undertaken.

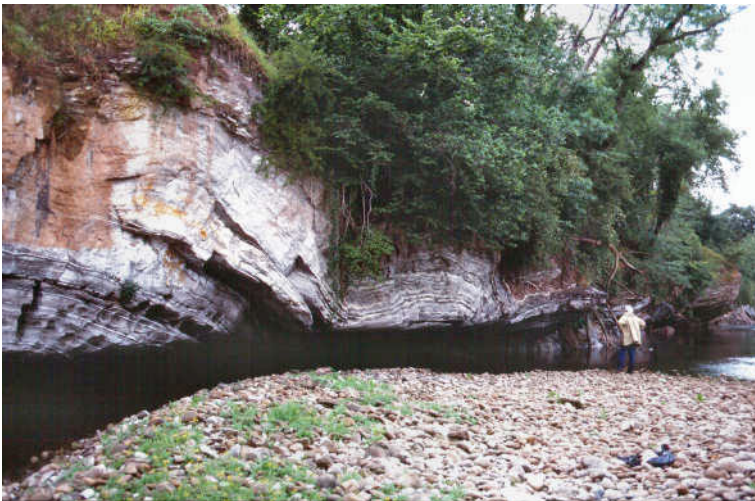
**Figure 6.** The gypsum cliff in 1990 just before it collapsed showing the complete flow of the River Ure going under the face.
