Landslides and slope deformation caused by water impoundment in the Three Gorges Reservoir, China

Abstract: The Three Gorges Dam on the Yangtze River in China is the largest hydro-electricity project in the world. The first impoundment started from 95 m and reached 135 m on June 15th, 2003. Shortly after the water reached 135 m, many slopes began to deform and some landslides occurred. In this paper, two landslides, the Qianjiangping landslide which occurred on July 14, 2003, and the Shuping landslide which is deforming actively, are discussed. Concerning the Qianjiangping landslide, field investigation revealed that failure occurred when the reservoir reached 135 m, but the stability of the slope was already reduced by pre-existing bedding-plane shears, quarrying of mudstone from the landslide toe, and previous heavy rain. The Shuping landslide is located on a slope in the main stream of the Yangtze River. After the first impoundment, obvious deformation appeared and became intense from February 2004. Through monitoring, bore-hole investigation and physical exploration, the possible deformation mechanism is analyzed.

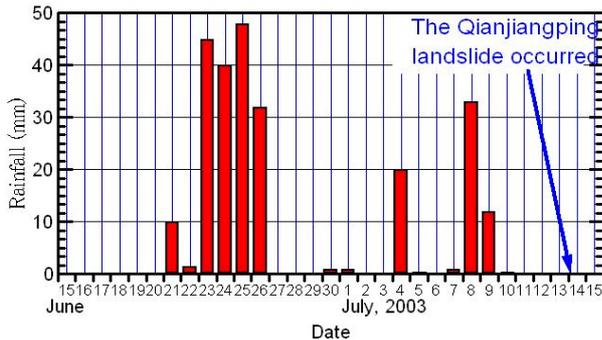
Figure 7. Precipitation data monitored in Yichang City, 70 km from the landslide.

Precipitation is monitored in Yichang City (Figure 1), about 70 km from the landslide site. Intense rainfall from June 21st to 26th, and rainfall from July 4th to July 9th (Figure 7) may have saturated the sliding mass, and increased its unit weight. However, considering the high permeability of the slickensided sandstone, and the transverse fissures crossing the sliding mass, it is not likely that high pore pressure would have resulted.

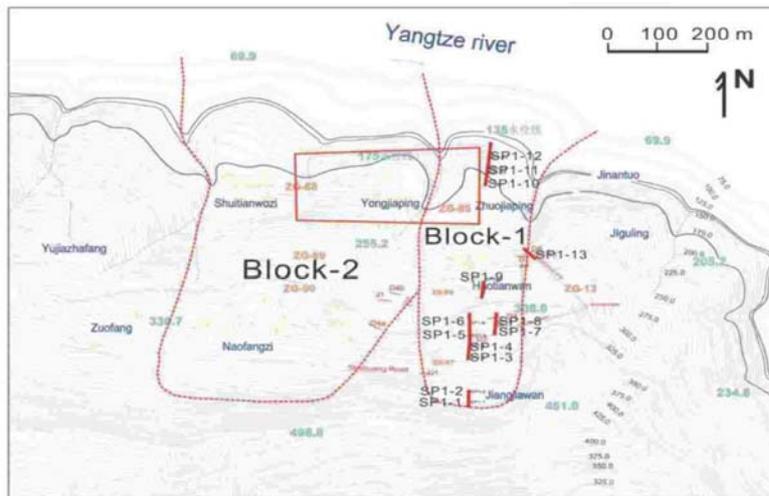
Figure 11. Plan of the Shuping landslide showing the locations of monitoring sites (extensometers and ground temperature measurements).

Figure 16 shows the extensometer installed in Shuping landslide. The positions of all of the thirteen extensometers were shown in Figure 11 as "SP1-x". Among them, SP1-1 and SP1-2 were set across the main scarp; SP1-3 to SP1-6 were set below the Shahuang road which has a high traffic. SP1-7 and SP1-8 were set almost parallel with SP1-5 and SP1-6. SP1-9 was set at the low part. Then, SP1-10, SP1-11, and SP1-12 were set near the Yangtze River at the toe part of the landslide. SP1-13 was set at the right boundary of Block 1 shown in Figure 12, because the fissure extension was apparent.

Ground temperature measurements were conducted, 1 m below ground level, to detect the groundwater channels in the lower part of the Shuping landslide. The area where the measurements were taken is shown as a square in Figure 11.

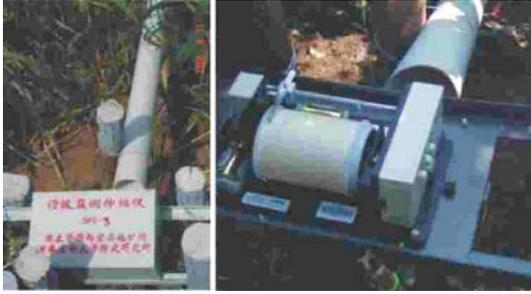
The automatic monitoring system with the extensometer was confirmed to be operating satisfactory (Zhang *et al.* 2004b). However, two extensometers are considered to be not sufficient for such a large landslide. In August 2004, a further 11 extensometers were installed along the central line of the longitudinal section of Block 1, with emphases on the more severely deformed parts of the slope. However because of the limit of funds, the extensometers did not form a continual longitudinal section line.

Figure 16. An extensometer installed in the Shuping landslide. The deformation was recorded on the rolled paper and also saved electronically to the instruments memory (visible in the right side)

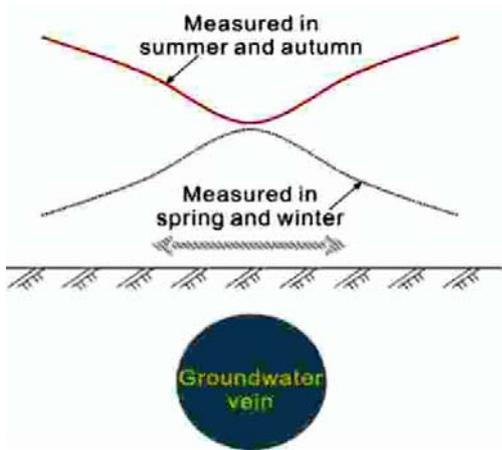
Figure 18. Principle of the ground temperature measurement, undertaken 1 m below ground level.

Figure 18 shows the principle for ground temperature measurements, above groundwater channels, 1 m below ground level. Compared with the ground which does not contain any water, saturated ground has a temperature similar to that of the groundwater. Generally, groundwater temperature does not change throughout a year. Temperature in dry ground is controlled by the atmospheric temperature. This will generally be higher than groundwater in summer and autumn and lower in spring and winter. By measuring the temperature distribution in the landslide area the distribution of groundwater channels may be estimated.
