# Observations on the tilting of multi-story buildings founded on Pliocene sands in Maputo, Mozambique

ALAN FORSTER<sup>1</sup>

<sup>1</sup> British Geological Survey. (e-mail: [af@bgs.ac.uk](mailto:af@bgs.ac.uk))

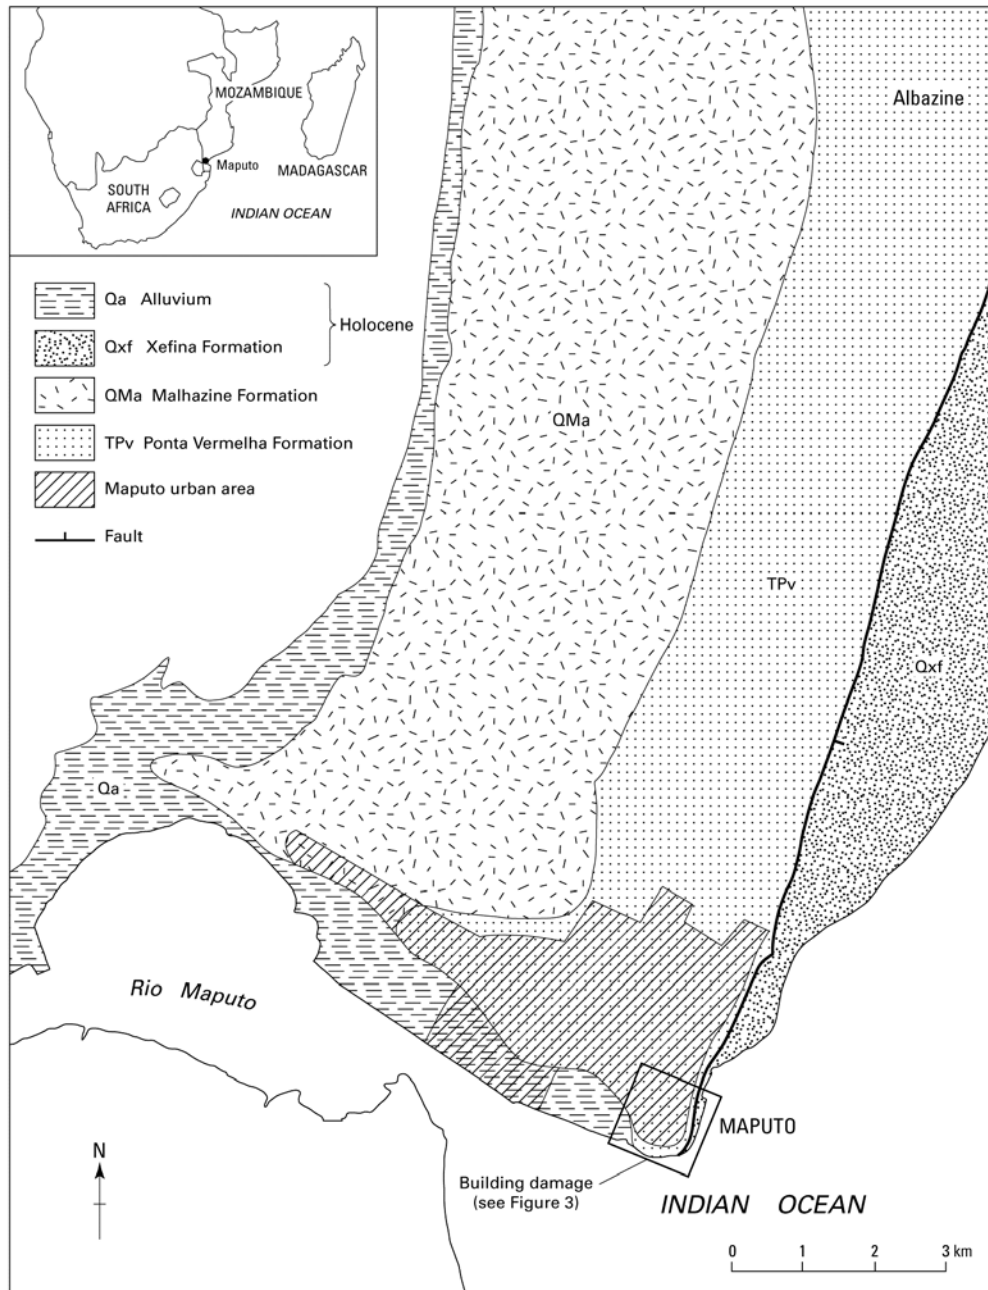
**Figure 1.** Geology of the Maputo area and location of the site of the damaged buildings.

The area under investigation is on the coastal slope that forms the eastern boundary of the City of Maputo (Fig.1). It falls on the 1:50 000 geological sheet 2532 D3 Maputo (Ferrara *et al.* 1995).

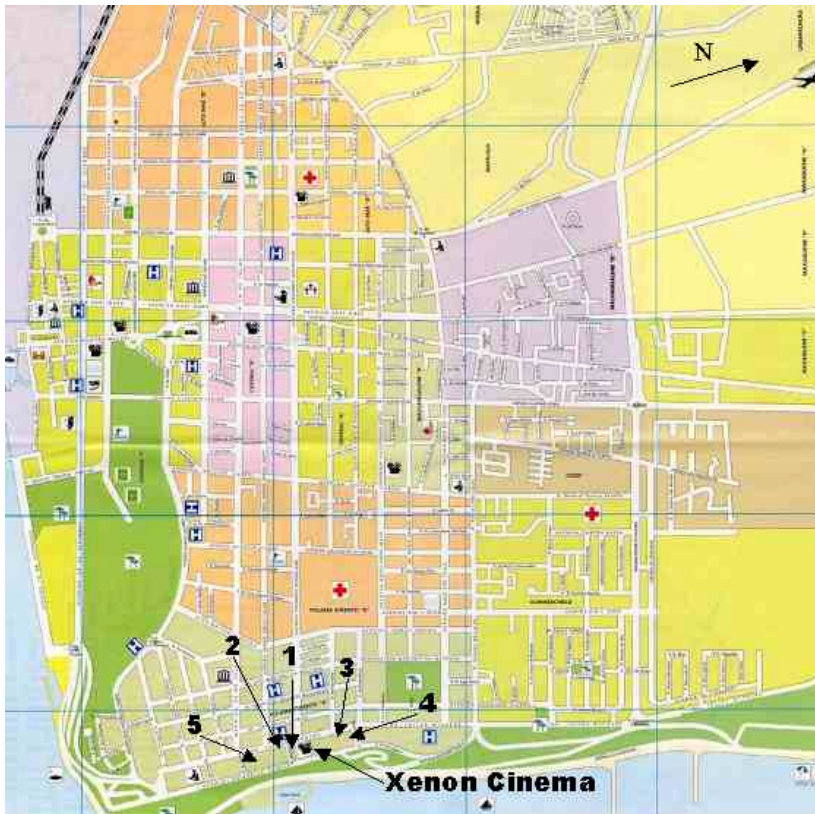
Figure 3. Location of buildings where tilting was observed

The buildings that showed an obvious tilt were located between the eastern side of Avenida Julius Nyerere and Avenida Frederich Engels at the top of the steep coastal slope (Fig. 3).
