Weathering and deterioration evaluation of a Brazilian cultural heritage building

Abstract: Rio de Janeiro's Municipal Theatre building was built in an eclectic style at the beginning of the 20th century (1905-1909). Its design was inspired in the Paris Opera of Garnier and blocks of gneissic rock were used as masonry on the first floor. It has been considered a Brazilian cultural heritage since 1973.

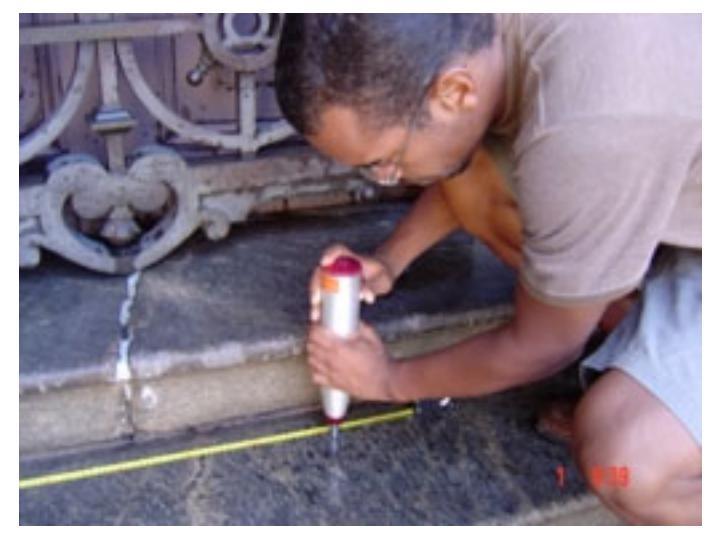
Figure 10. Schmidt's hammer test being carried out on stairs of Municipal Theatre.

The Schmidt hammer proved to be very useful to map the rocks' fissures. This was only possible due to the fact that the values near these physical discontinuities became really low if compared with the remaining points of the rock. This investigation was held on the staircases of the Municipal Theatre and the data can be seen in Table 6. In Figure 11 there is a histogram that represents the condition of the external stairs of the Theatre. In order to map the fissures, Schmidt hammer data have been linearly interpolated on the sampling mesh. The shadow diagram presented in Figure 12 exemplifies the use of the technique on one of the steps of the staircase. The dark colours are low values of SHI and represent the presence of fractures or fissures on the rock when its distribution occurs in a stretched form.
